The 2 earthquakes of February 6th 2023 in Turkey

Preliminary Report

Failures of Multistorey Buildings in Turkey and Syria Due to the M 7.8 and M 7.5 Earthquakes

PART B: Structural Collapse and Interpretation

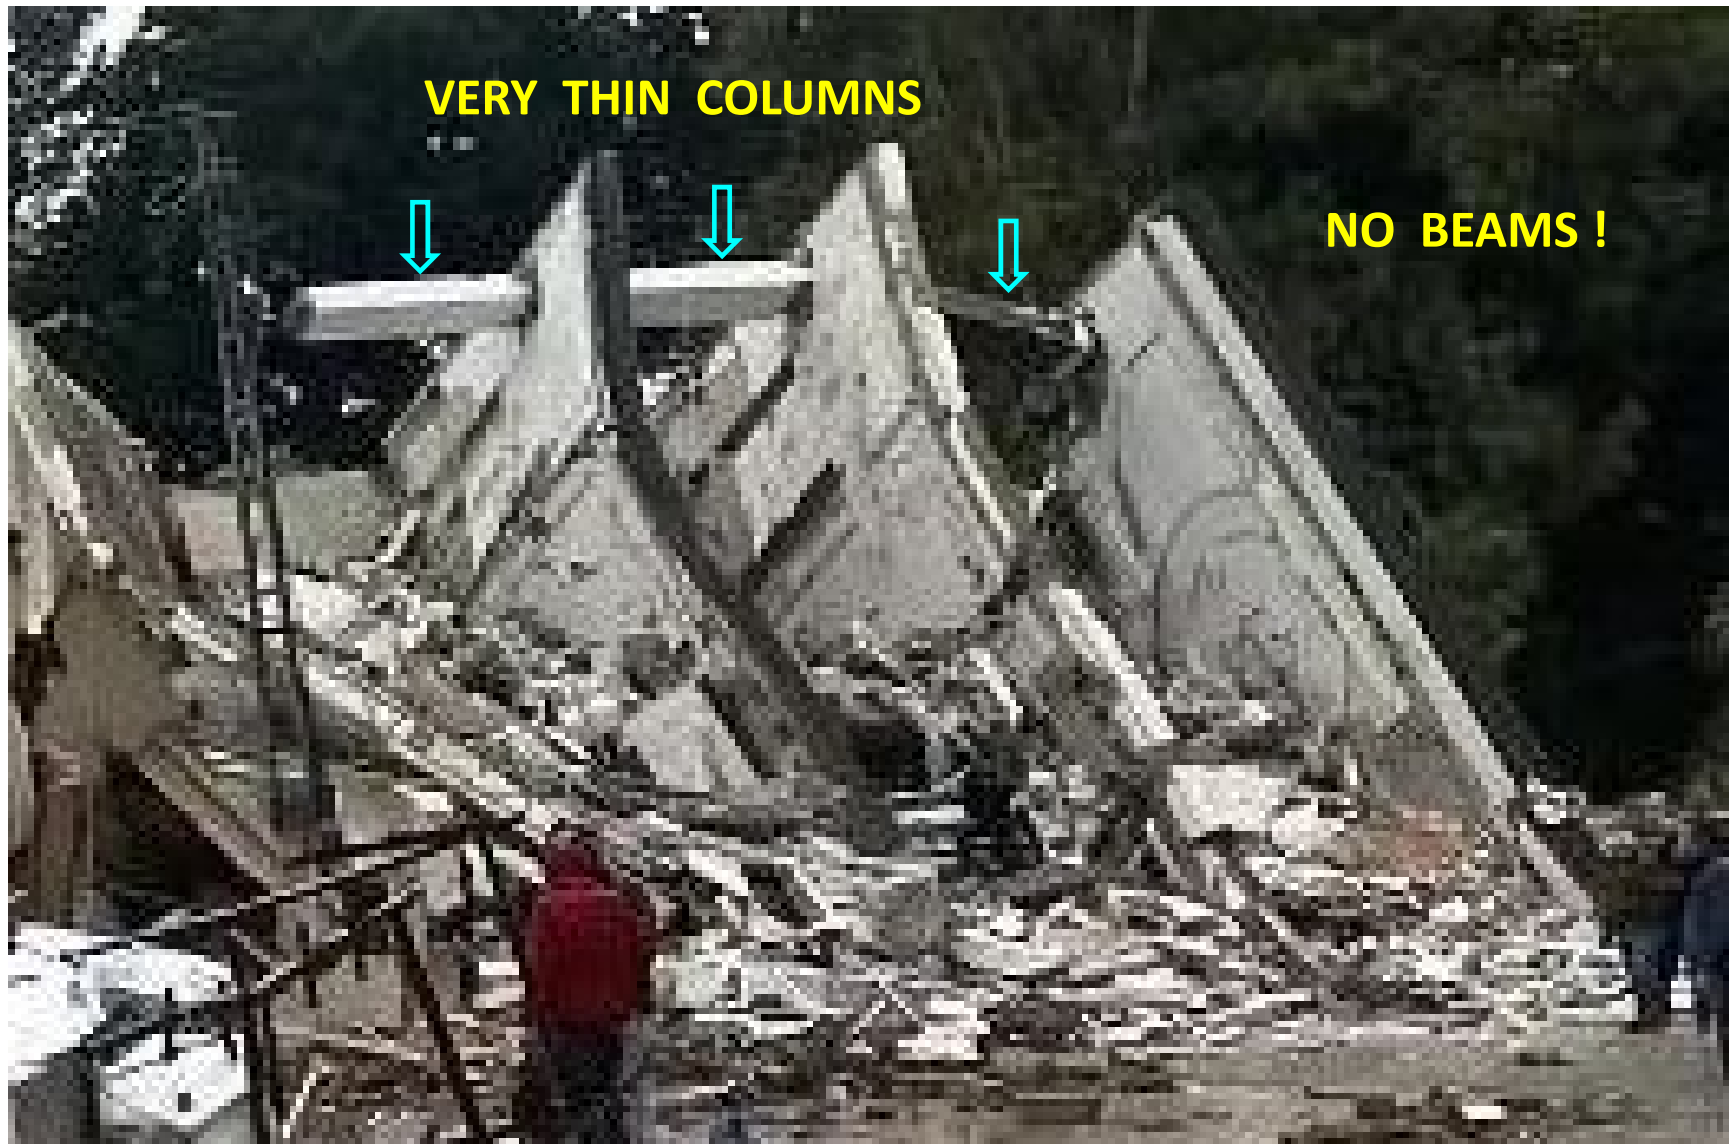
Numerous buildings without any beam, with small size columns (inappropriate even for 1-story buildings in a region of moderate seismicity).²⁴

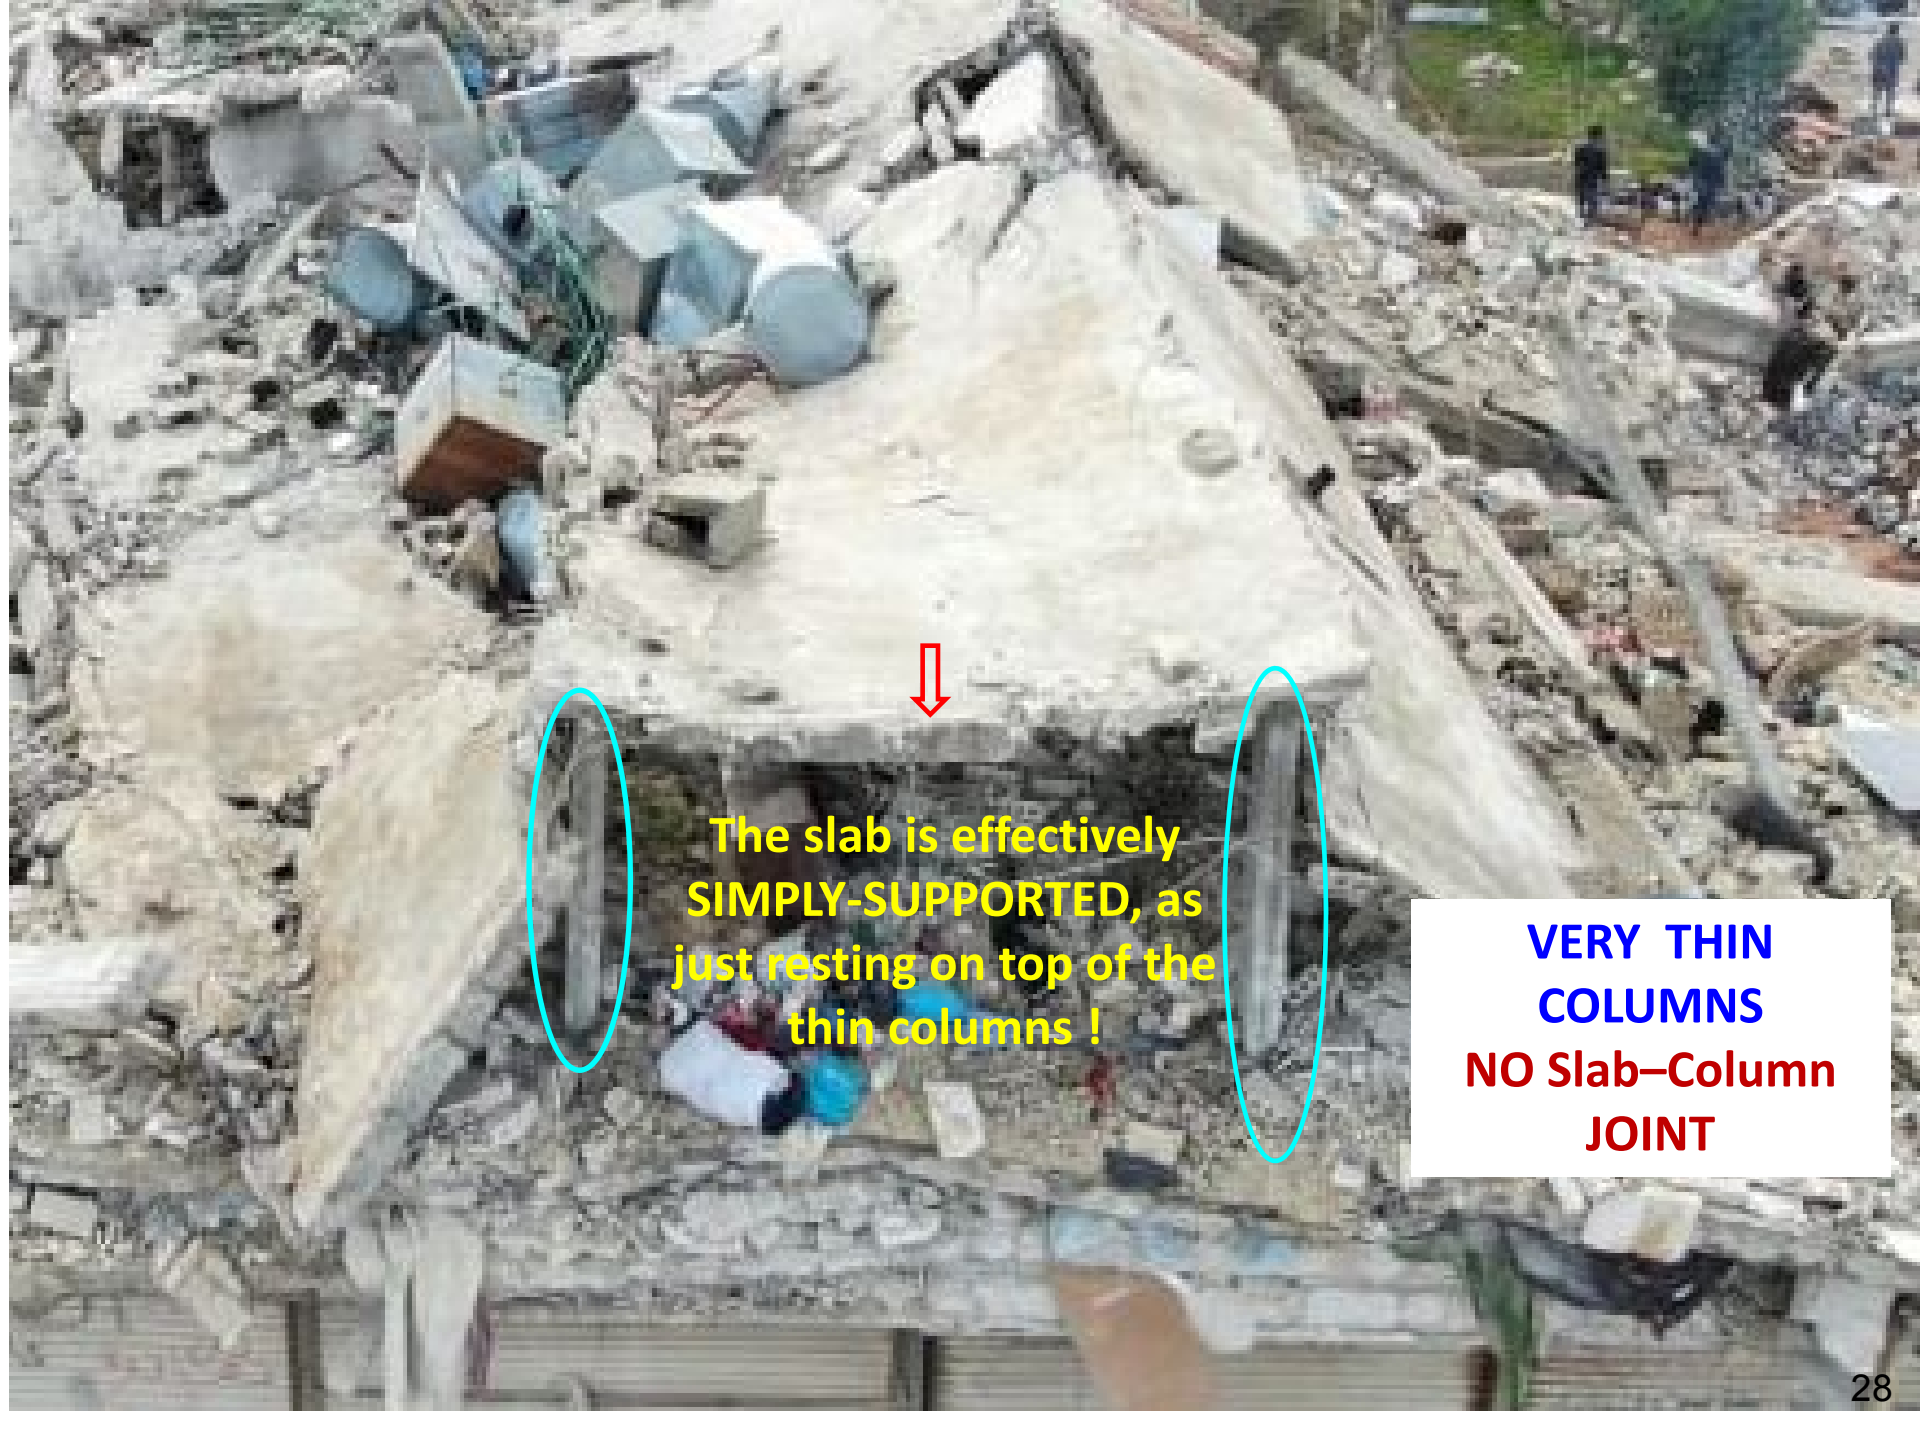
The slab is effectively
SIMPLY-SUPPORTED, as
just resting on top of the
thin columns !

**VERY THIN
COLUMNS**
**NO Slab-Column
JOINT**

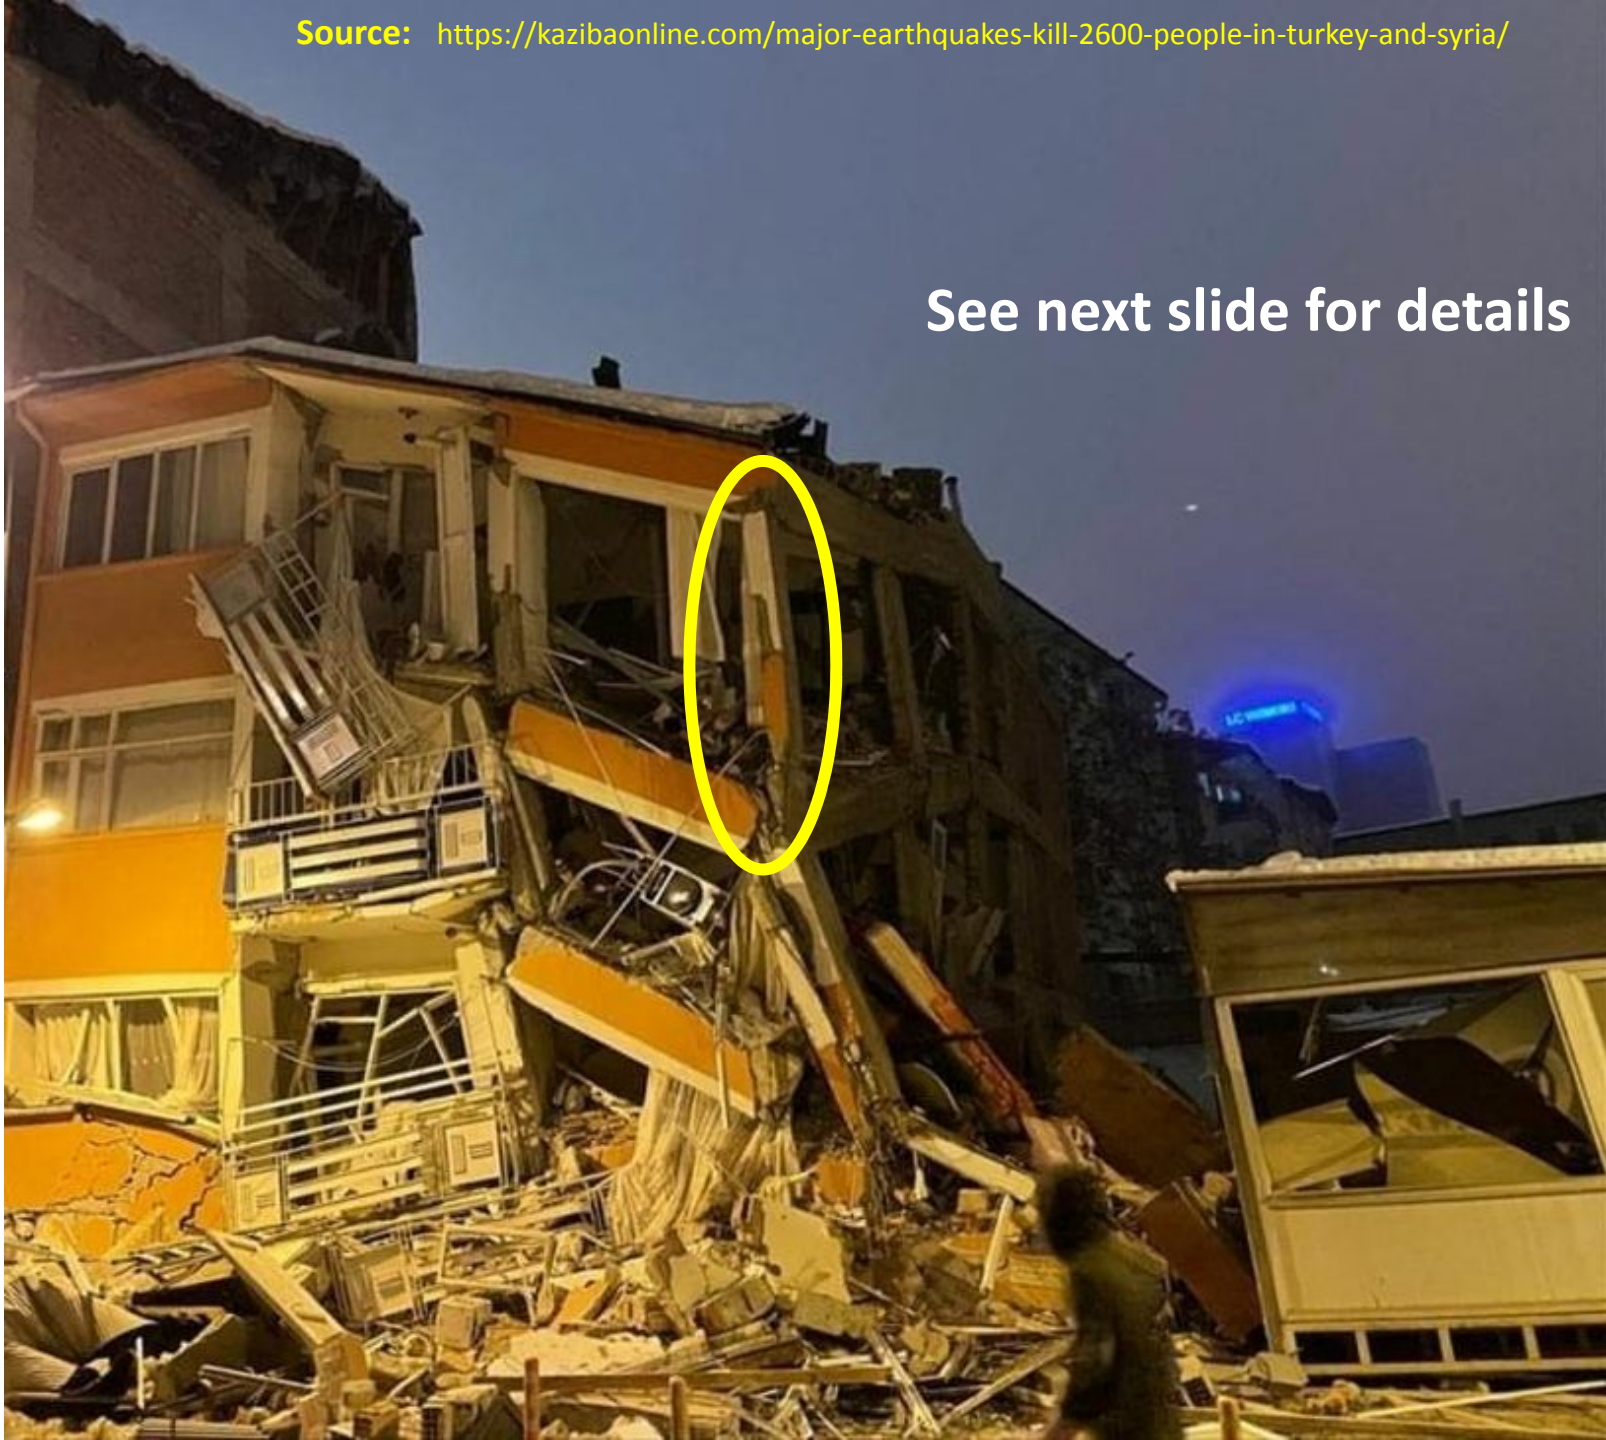
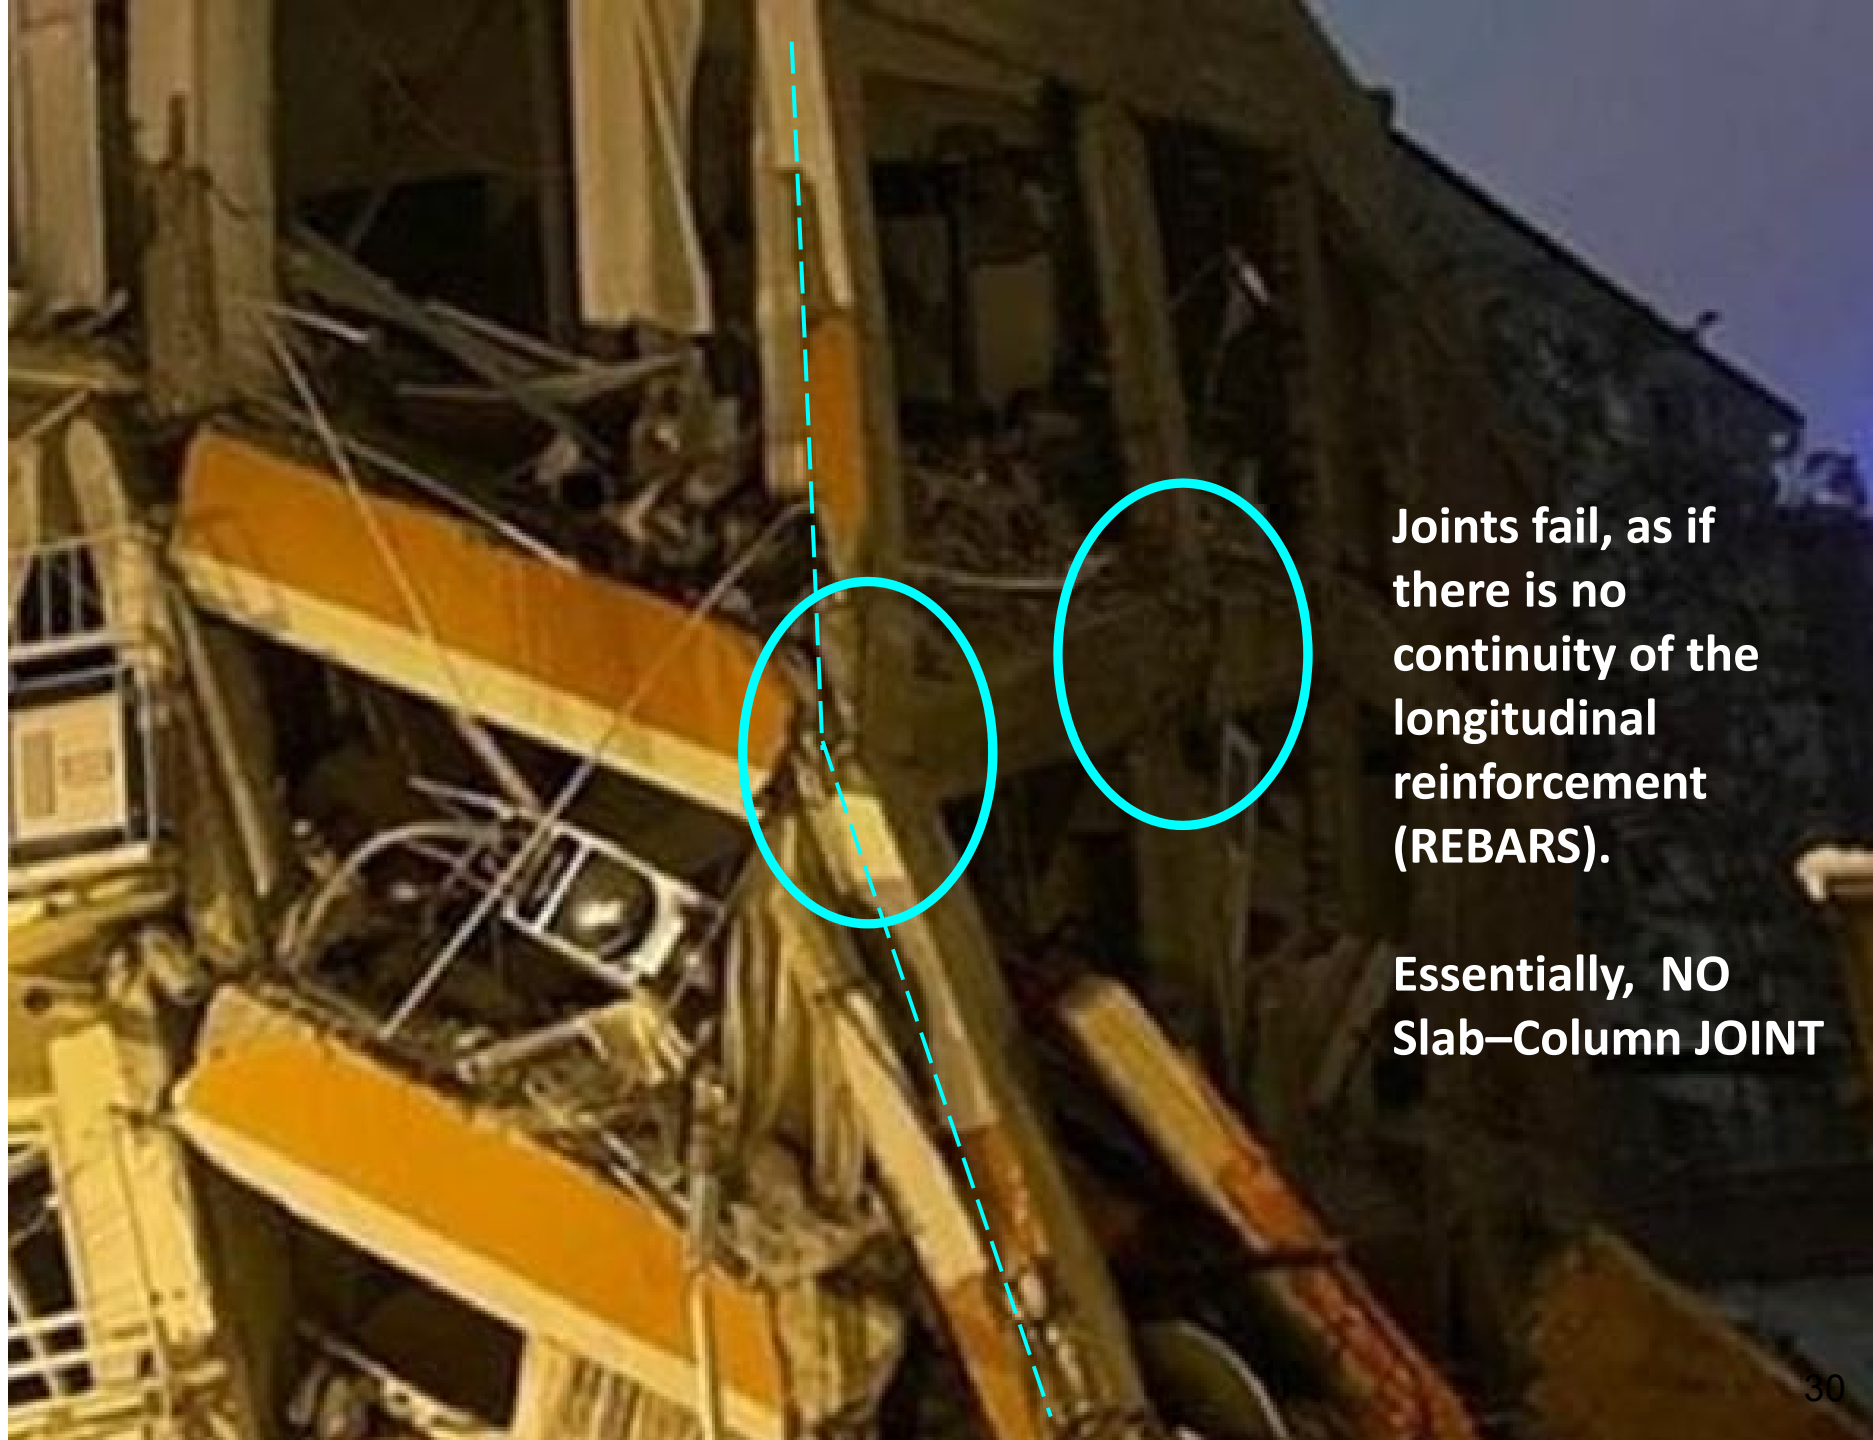
Joints fail, as if there is no continuity of the longitudinal reinforcement (REBARS).

Essentially, NO Slab–Column JOINT

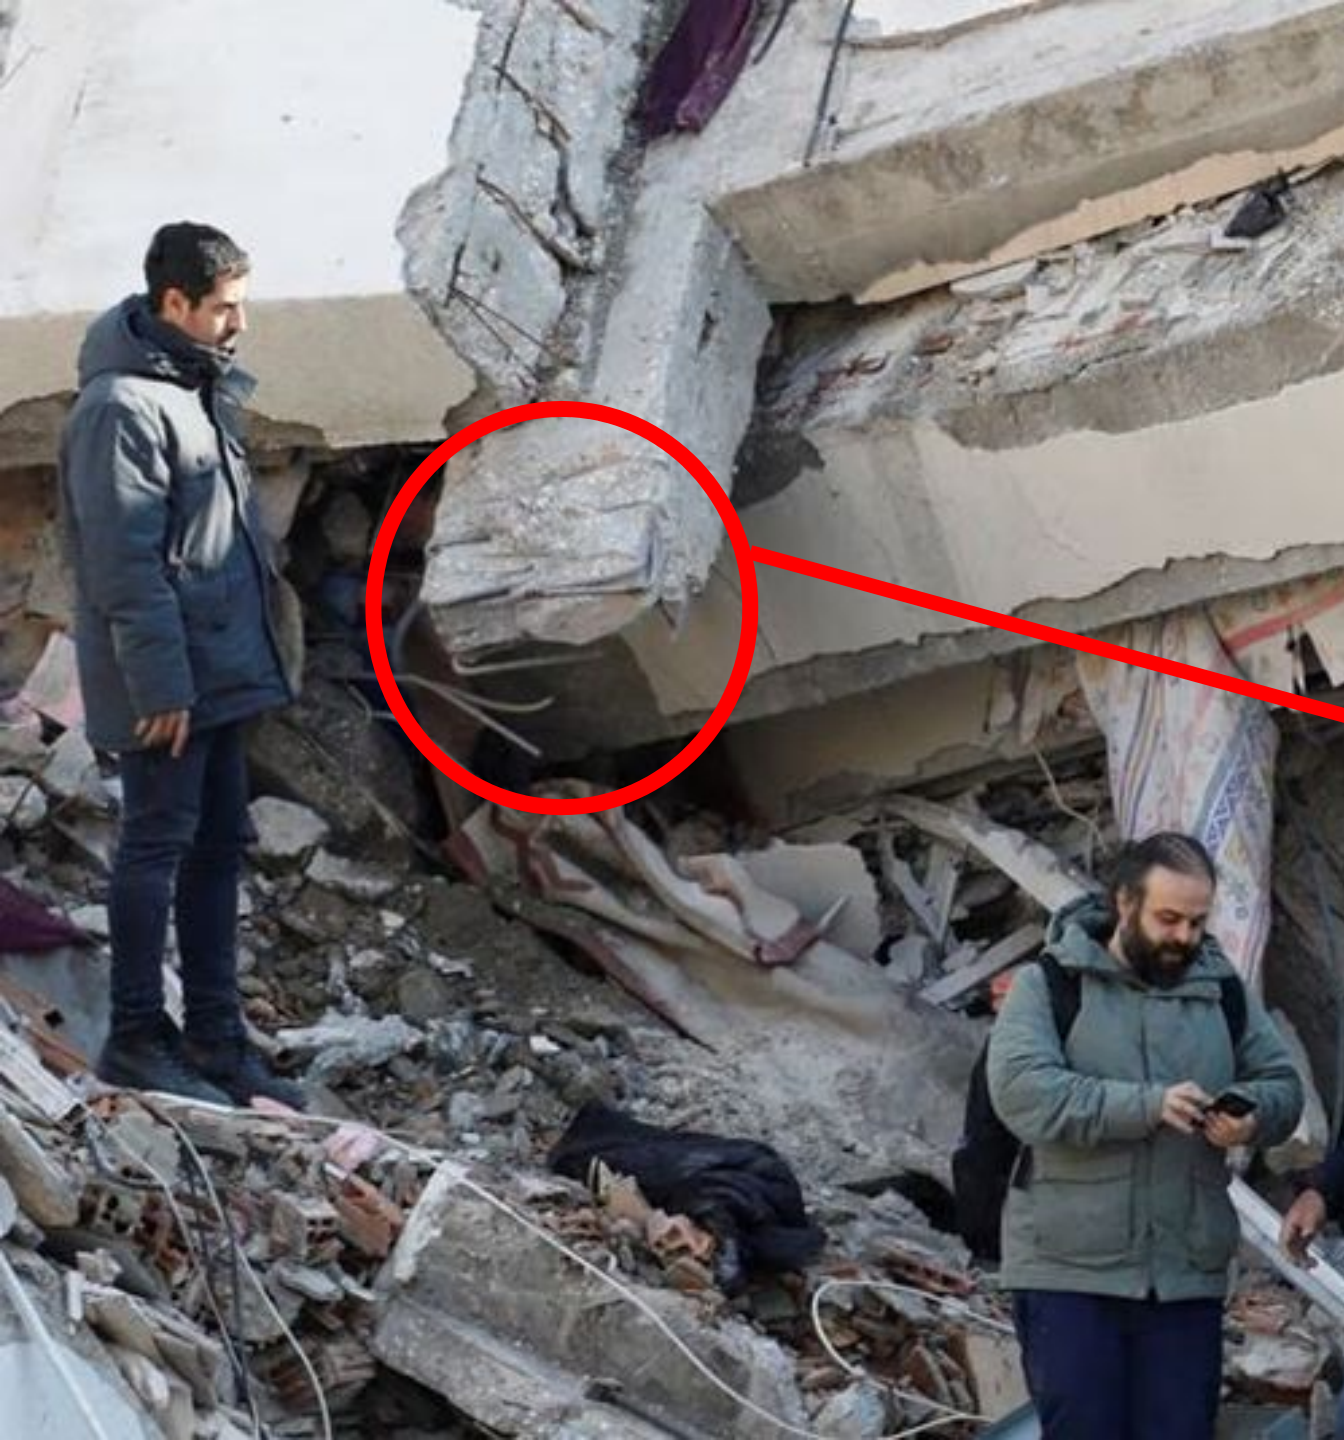
**VERY FEW REBARS,
OF VERY SMALL
DIAMETER**

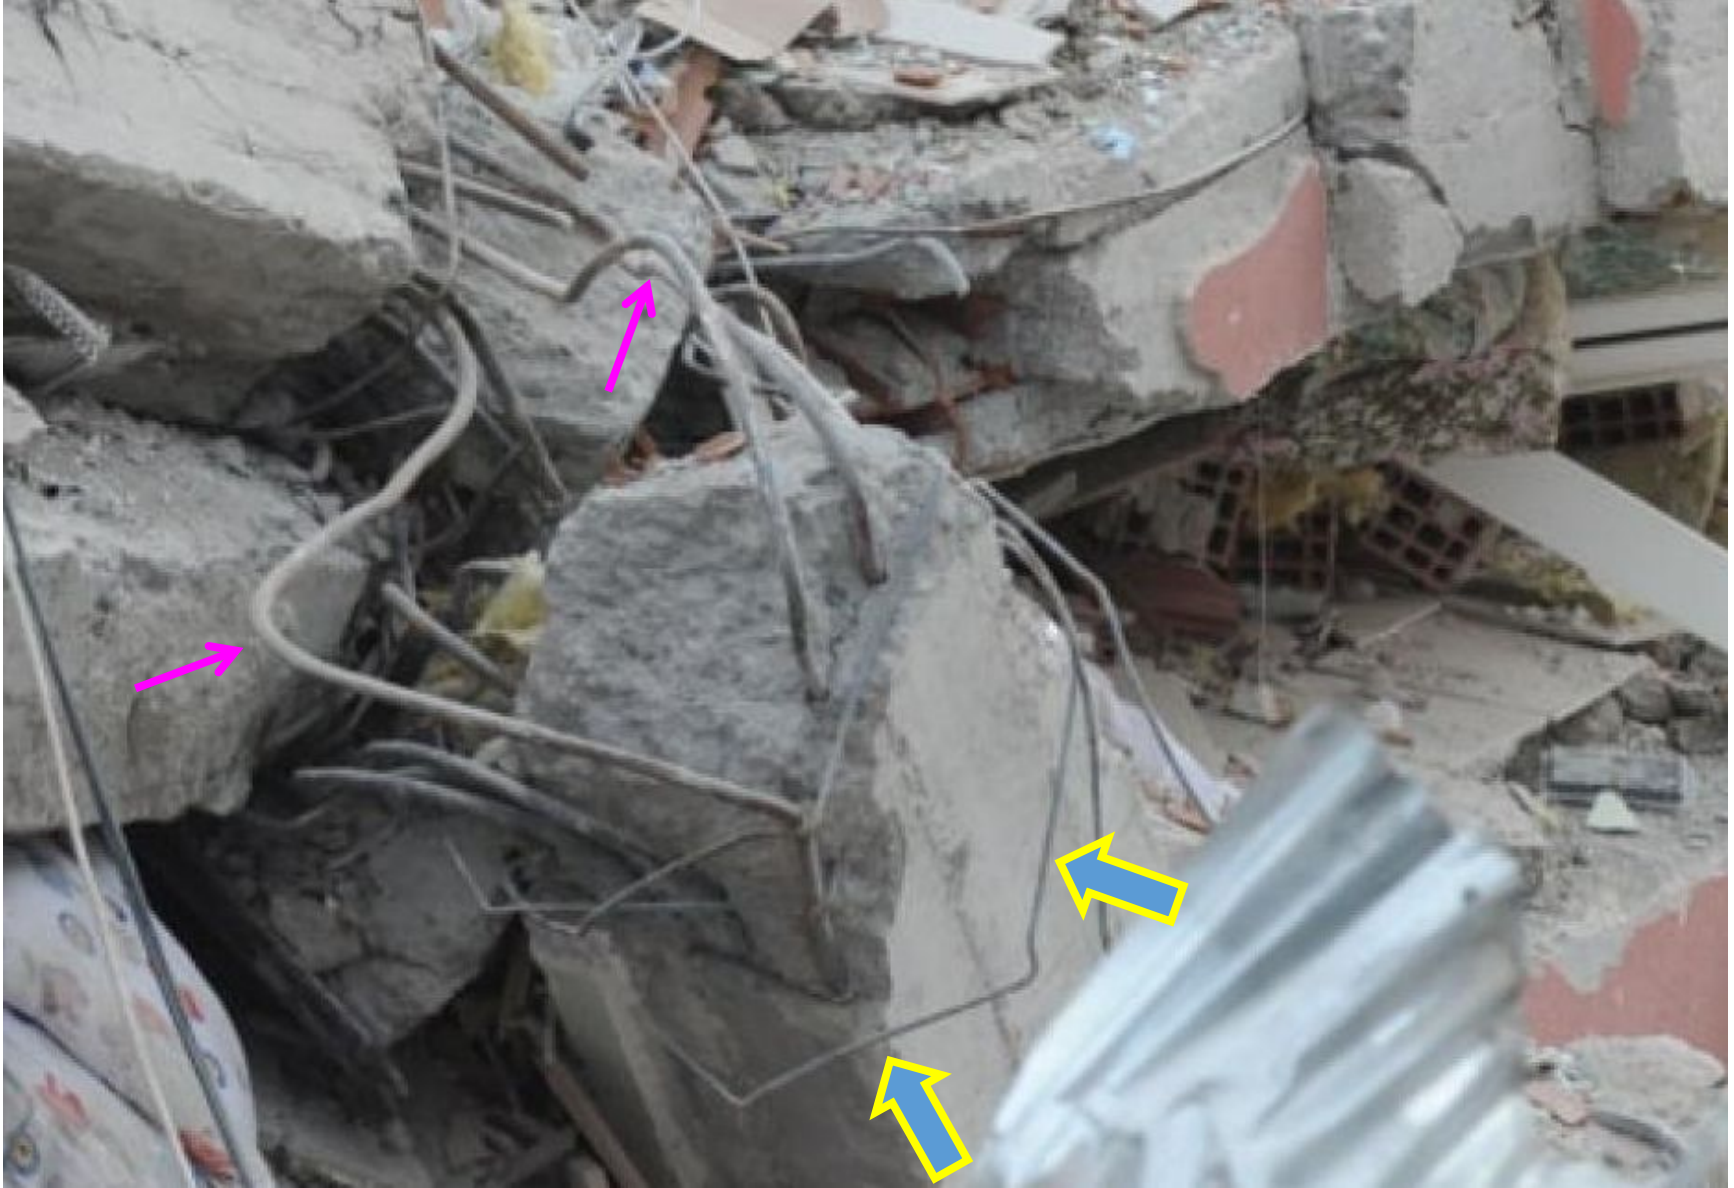
Transverse reinforcement almost effectively non-existing... it was untied, leading the inadequate longitudinal rebars to buckle.

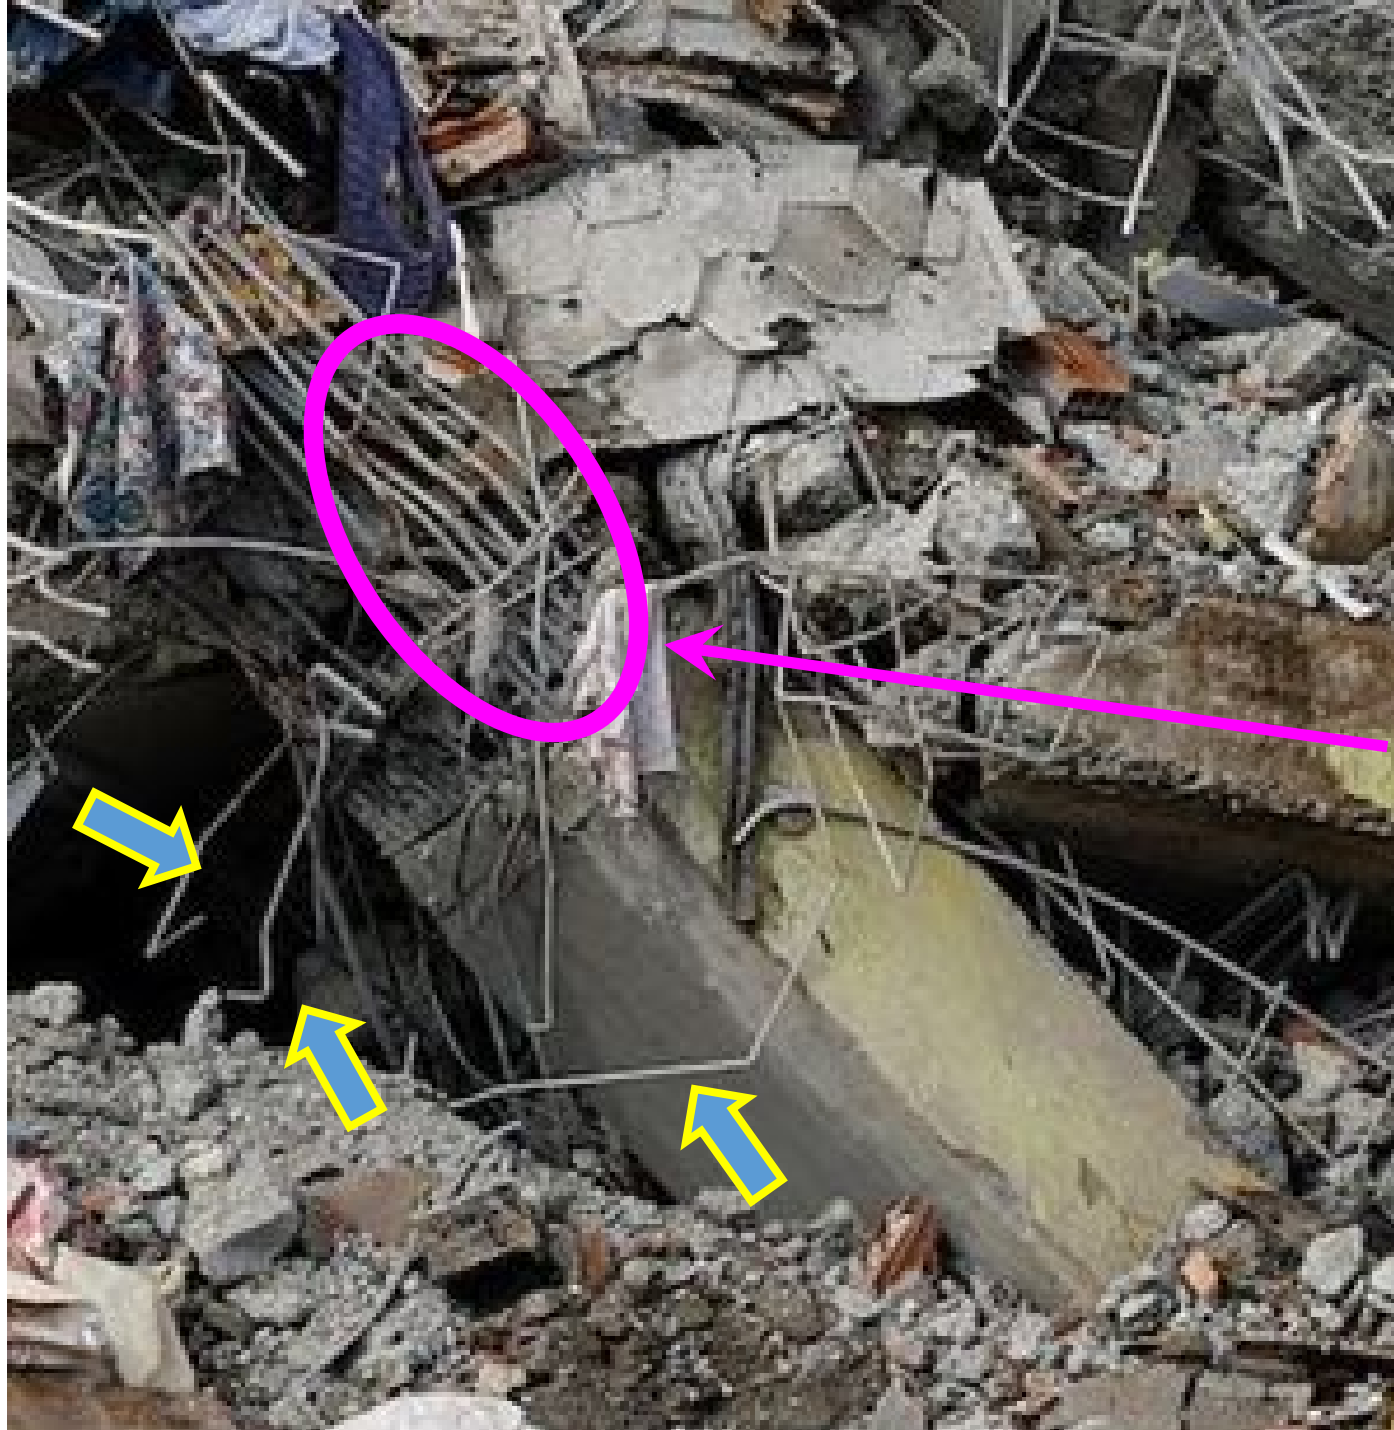
**Transverse bars
were un-tied.**

**Longitudinal
REBARS are of
VERY SMALL
DIAMETER**

**NO BEAMS, POOR (or rather No)
JOINTS !**

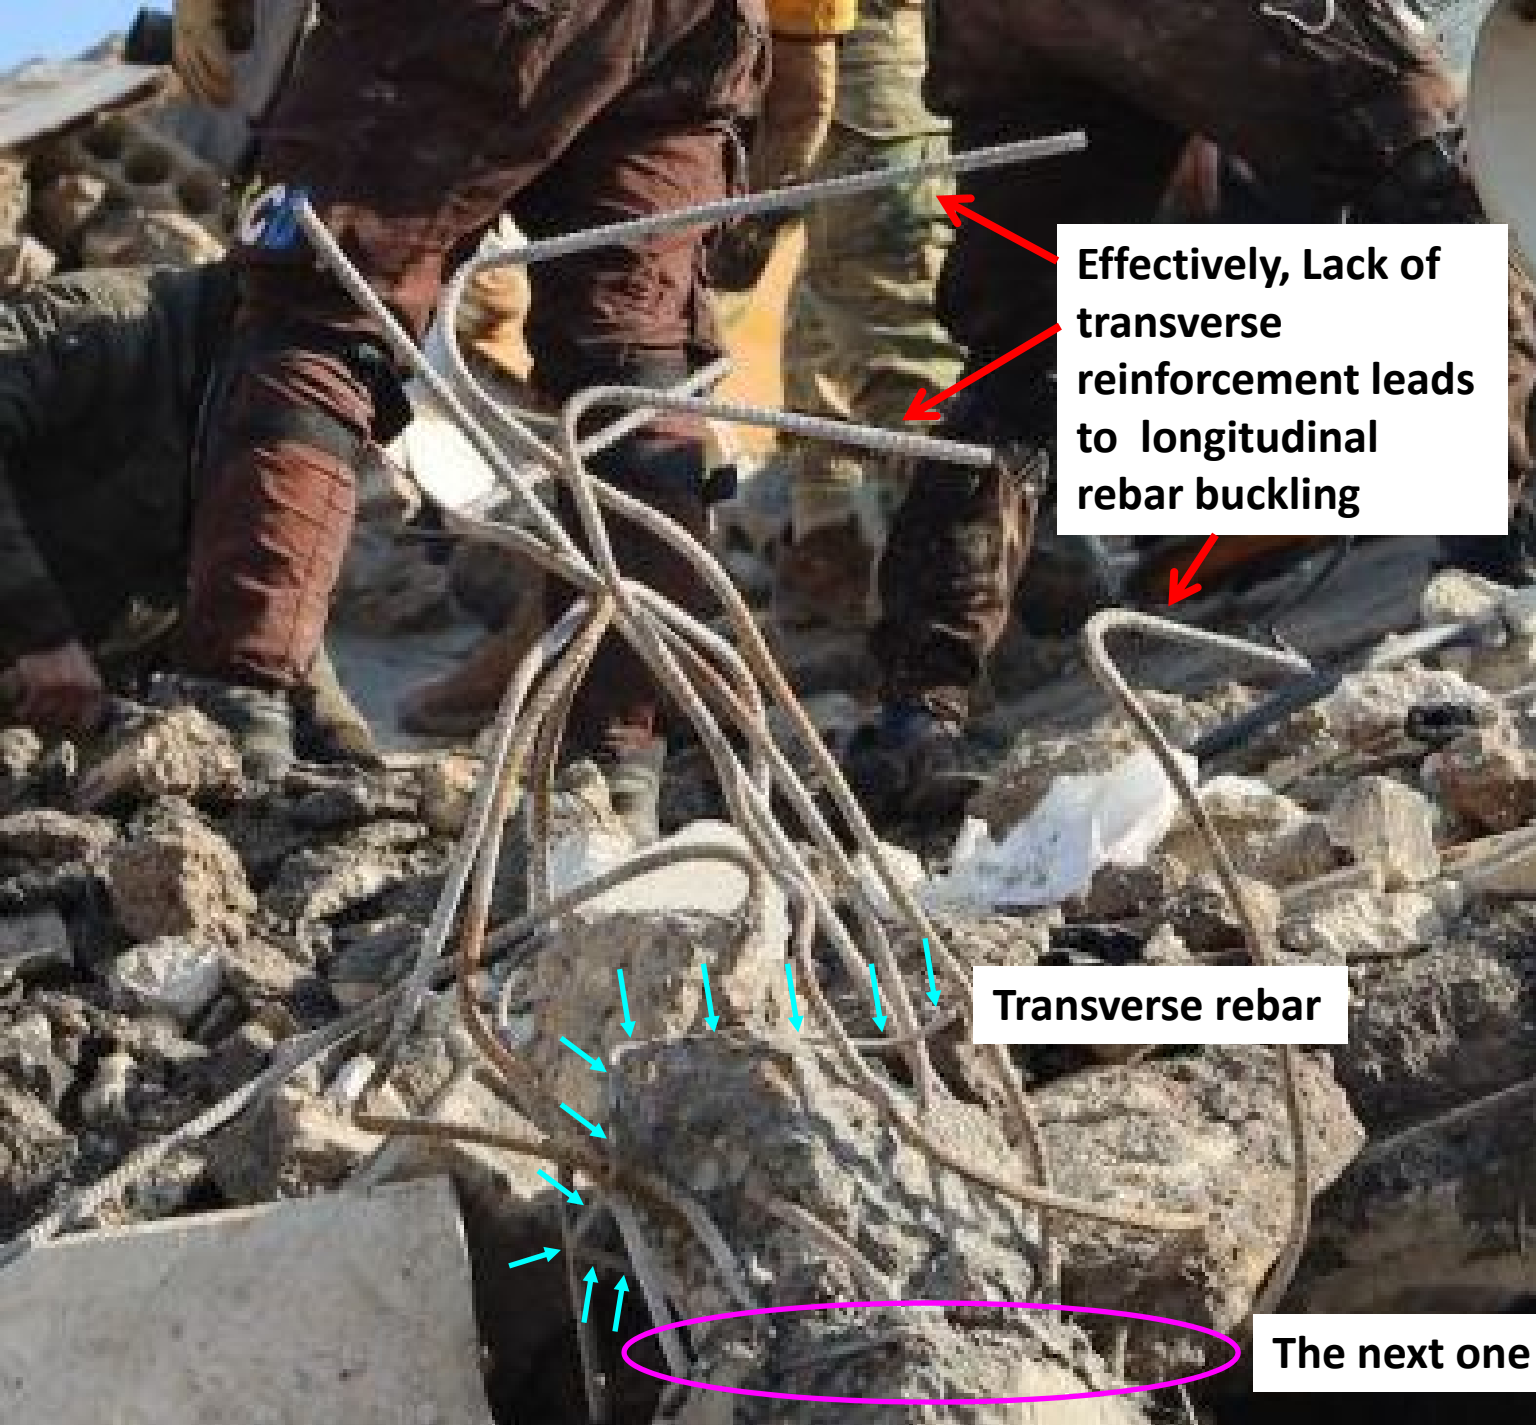
Effectively, Lack of transverse reinforcement leads to longitudinal rebar buckling

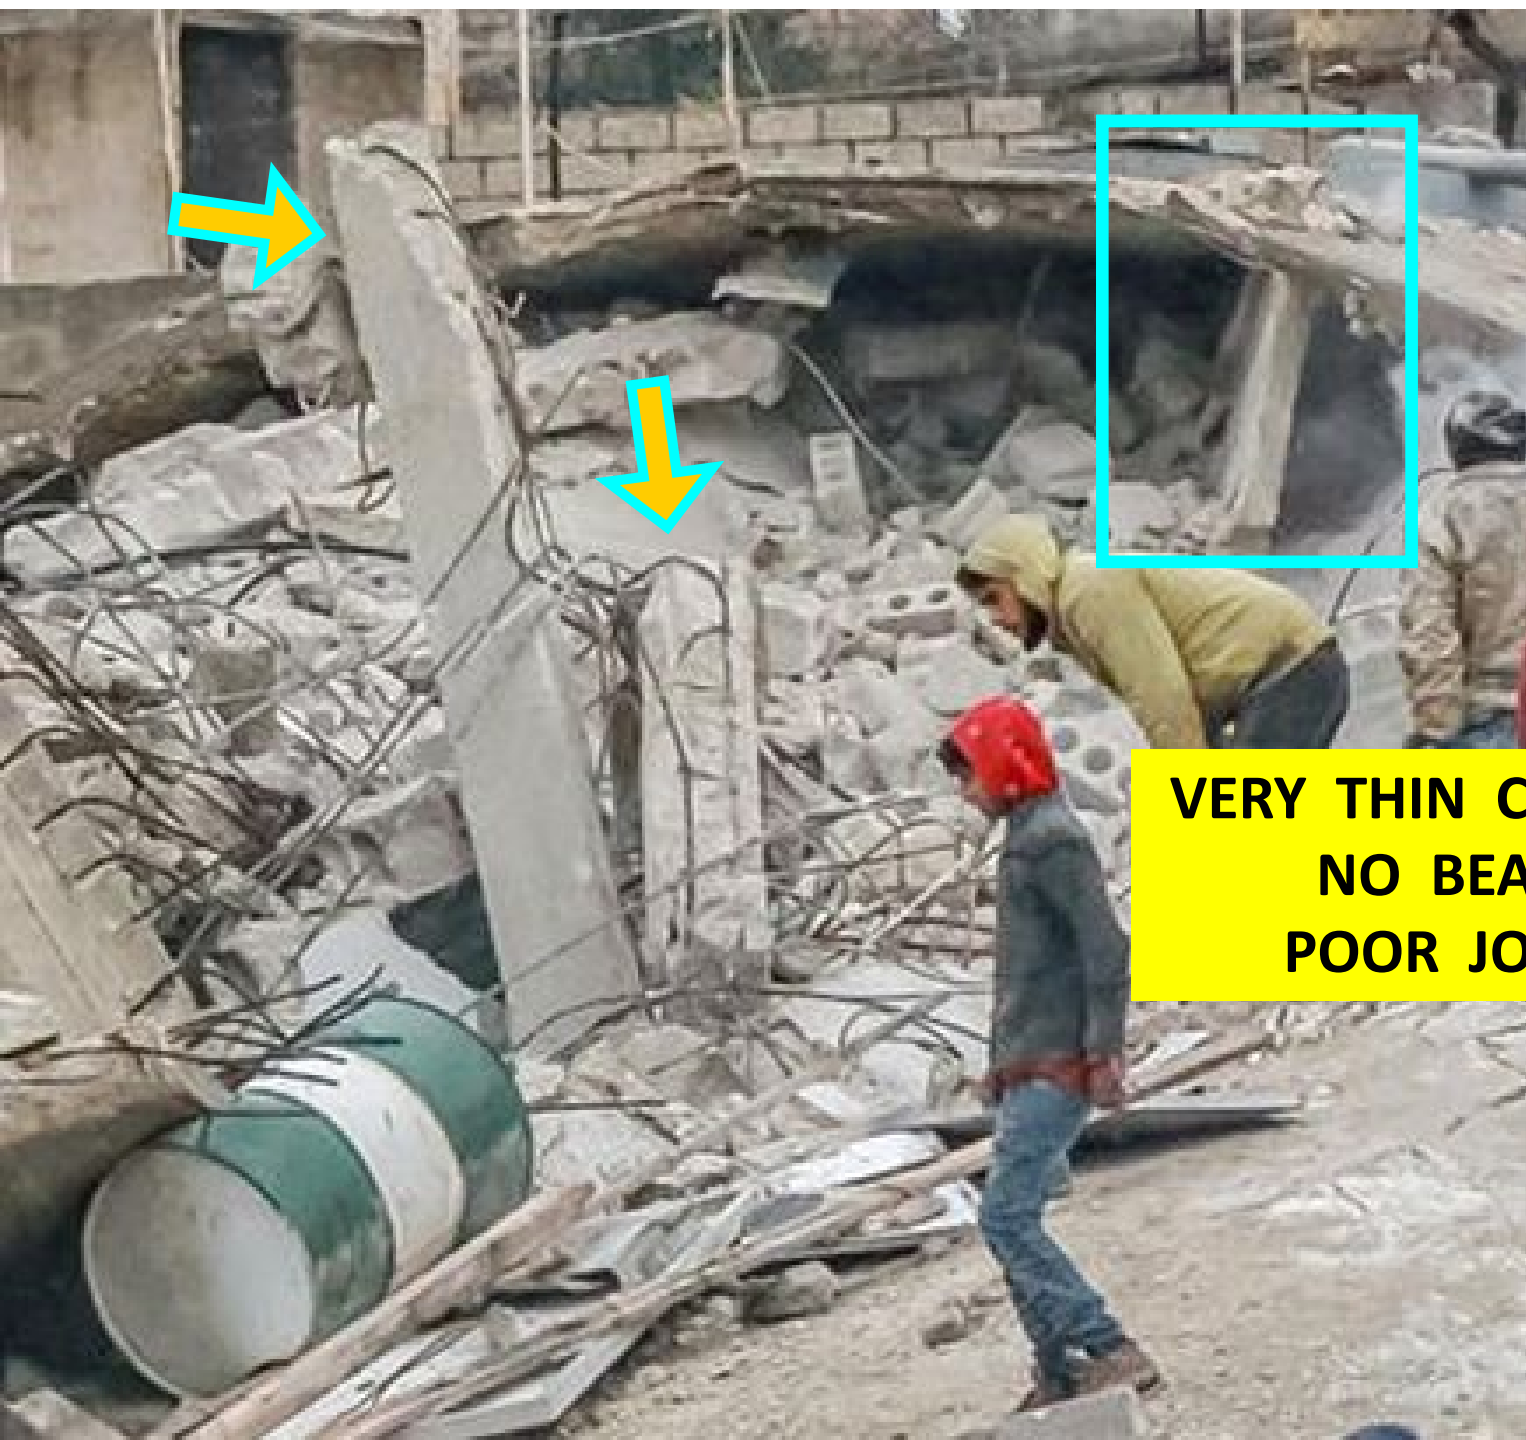
**VERY THIN COLUMNS
NO BEAMS
POOR JOINTS**

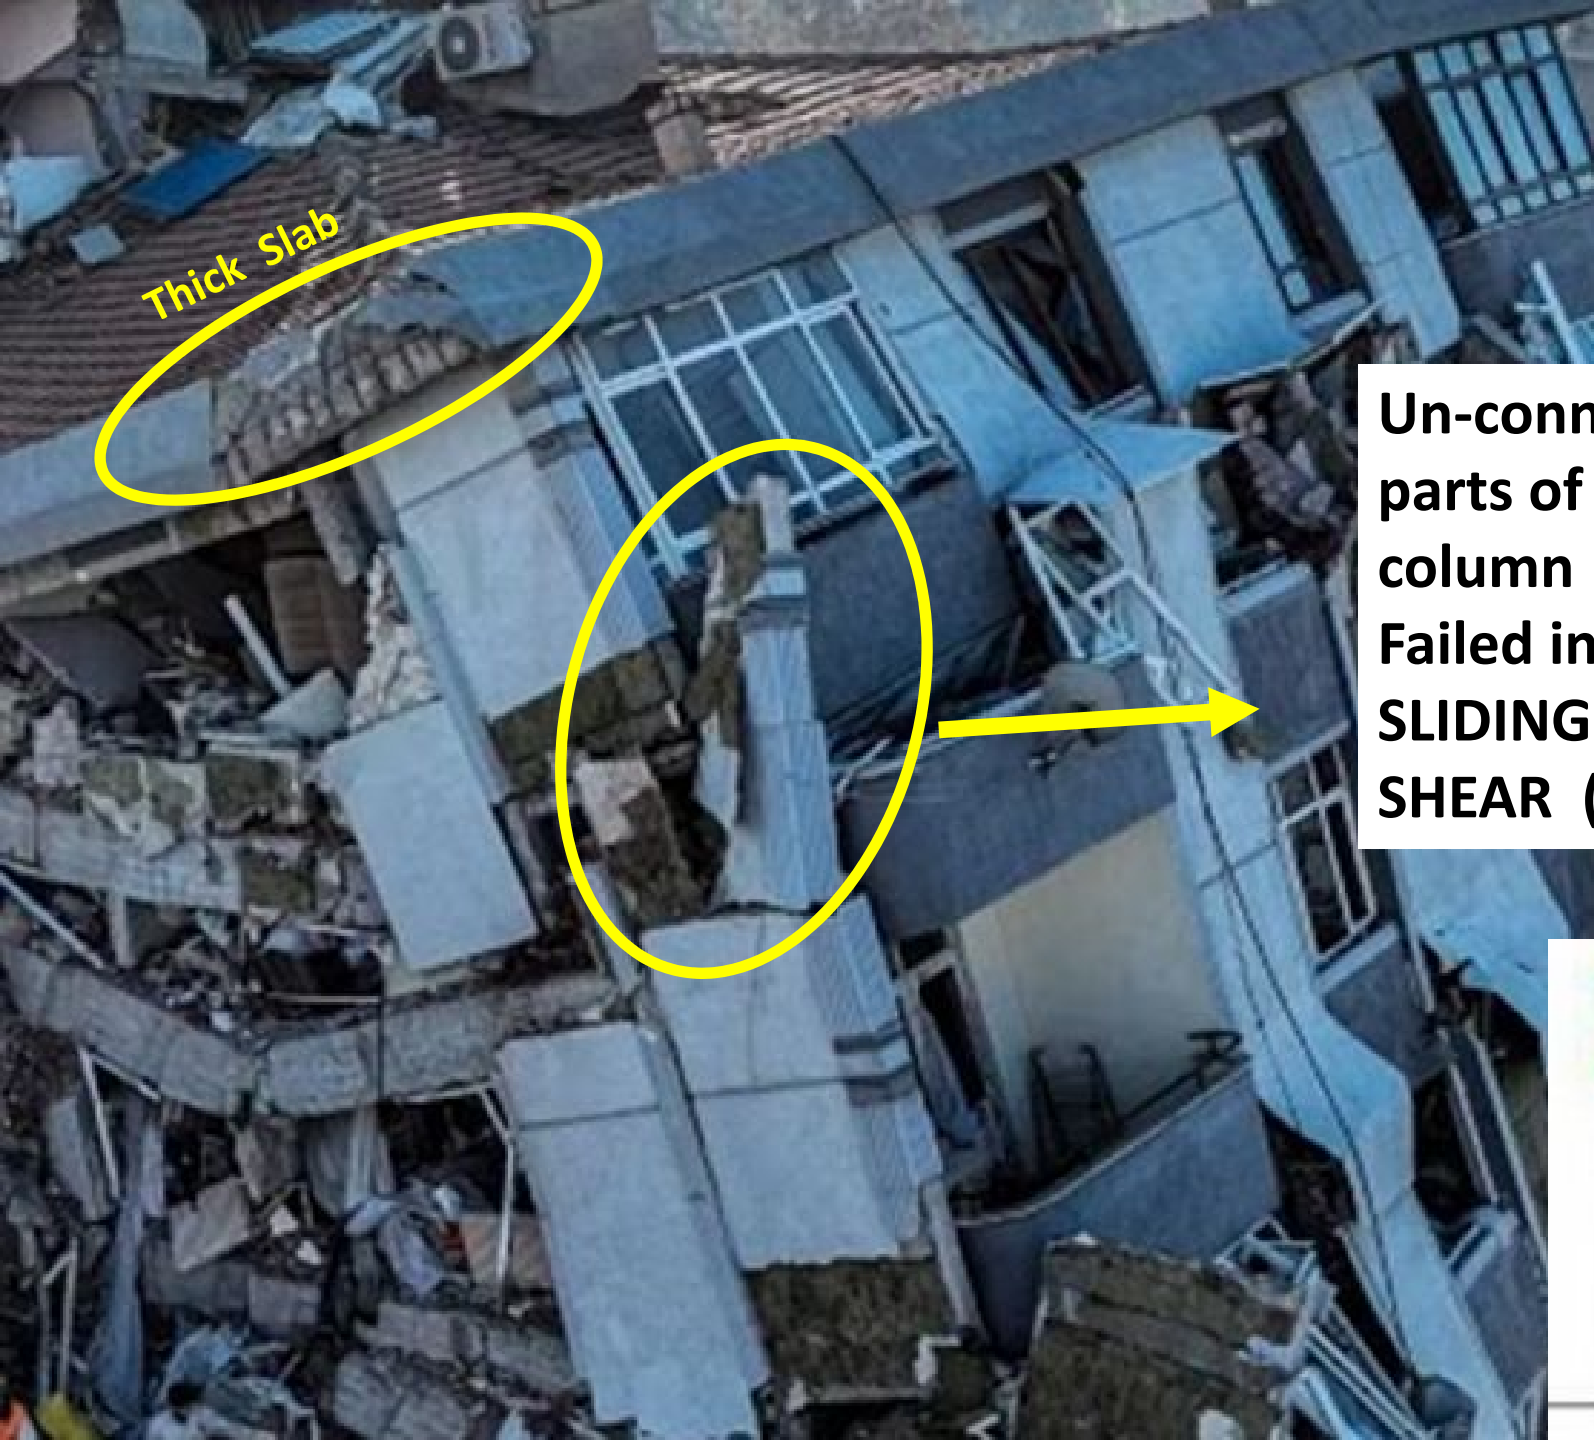
**Un-connected
parts of a
column !!
Failed in
SLIDING or
SHEAR (??)**
