The 2 earthquakes of February 6th 2023 in Turkey

Preliminary Report

Failures of Multistorey Buildings in Turkey and Syria Due to the M 7.8 and M 7.5 Earthquakes

PART B: Structural Collapse and Interpretation

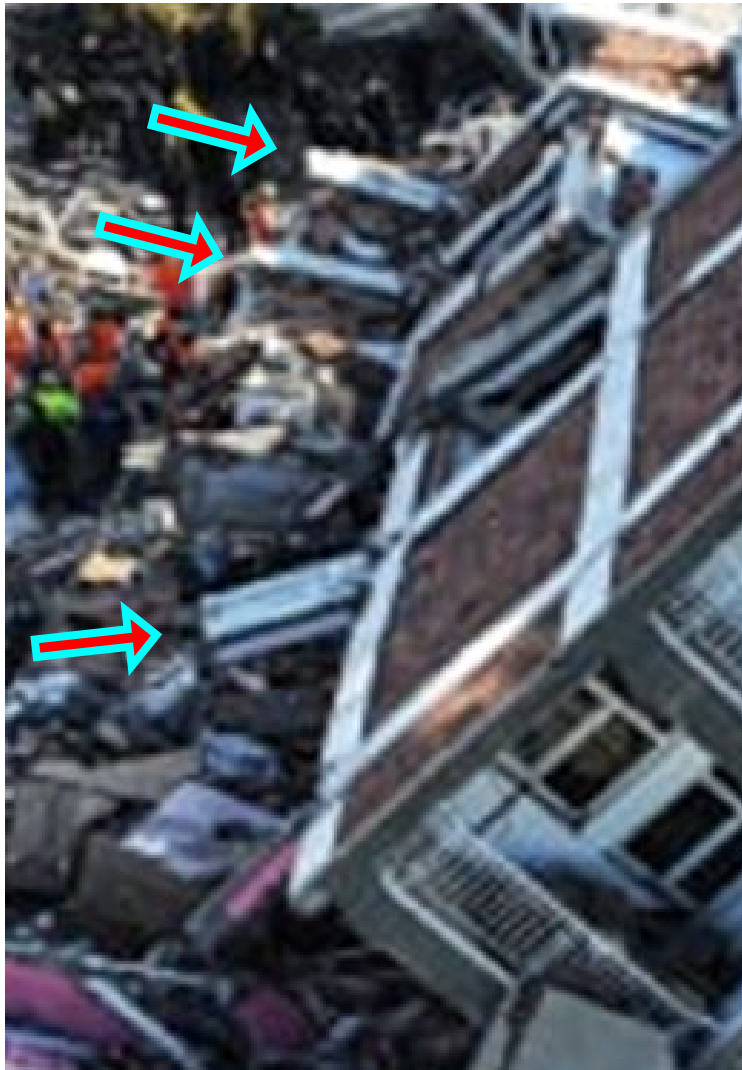
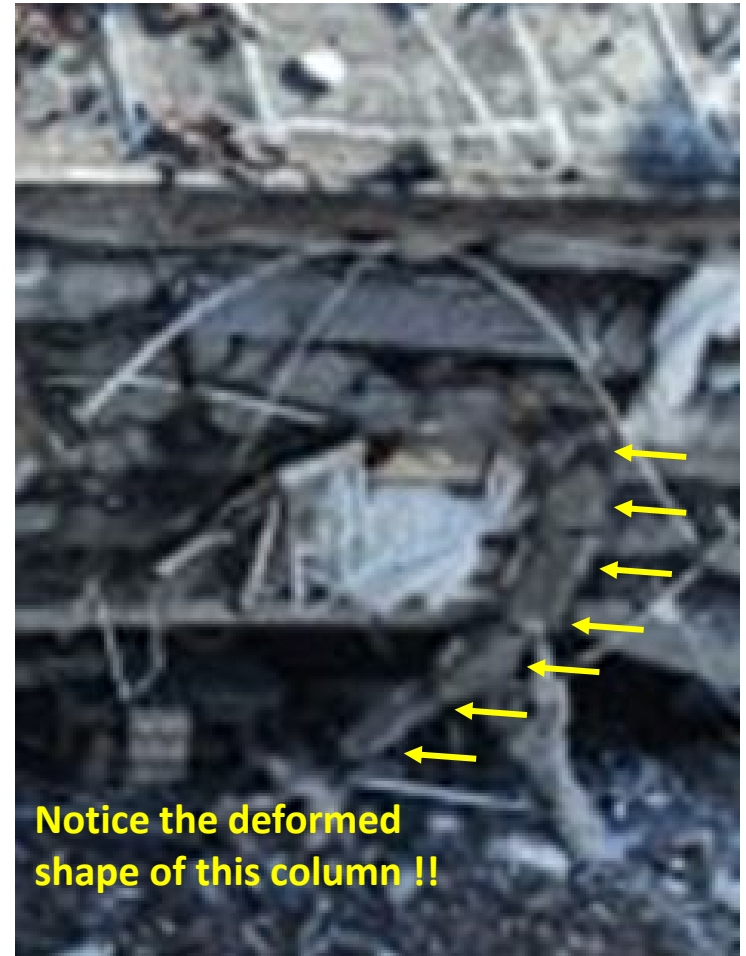
**Inadequate columns cannot
“follow” the above building on
its lateral movement**

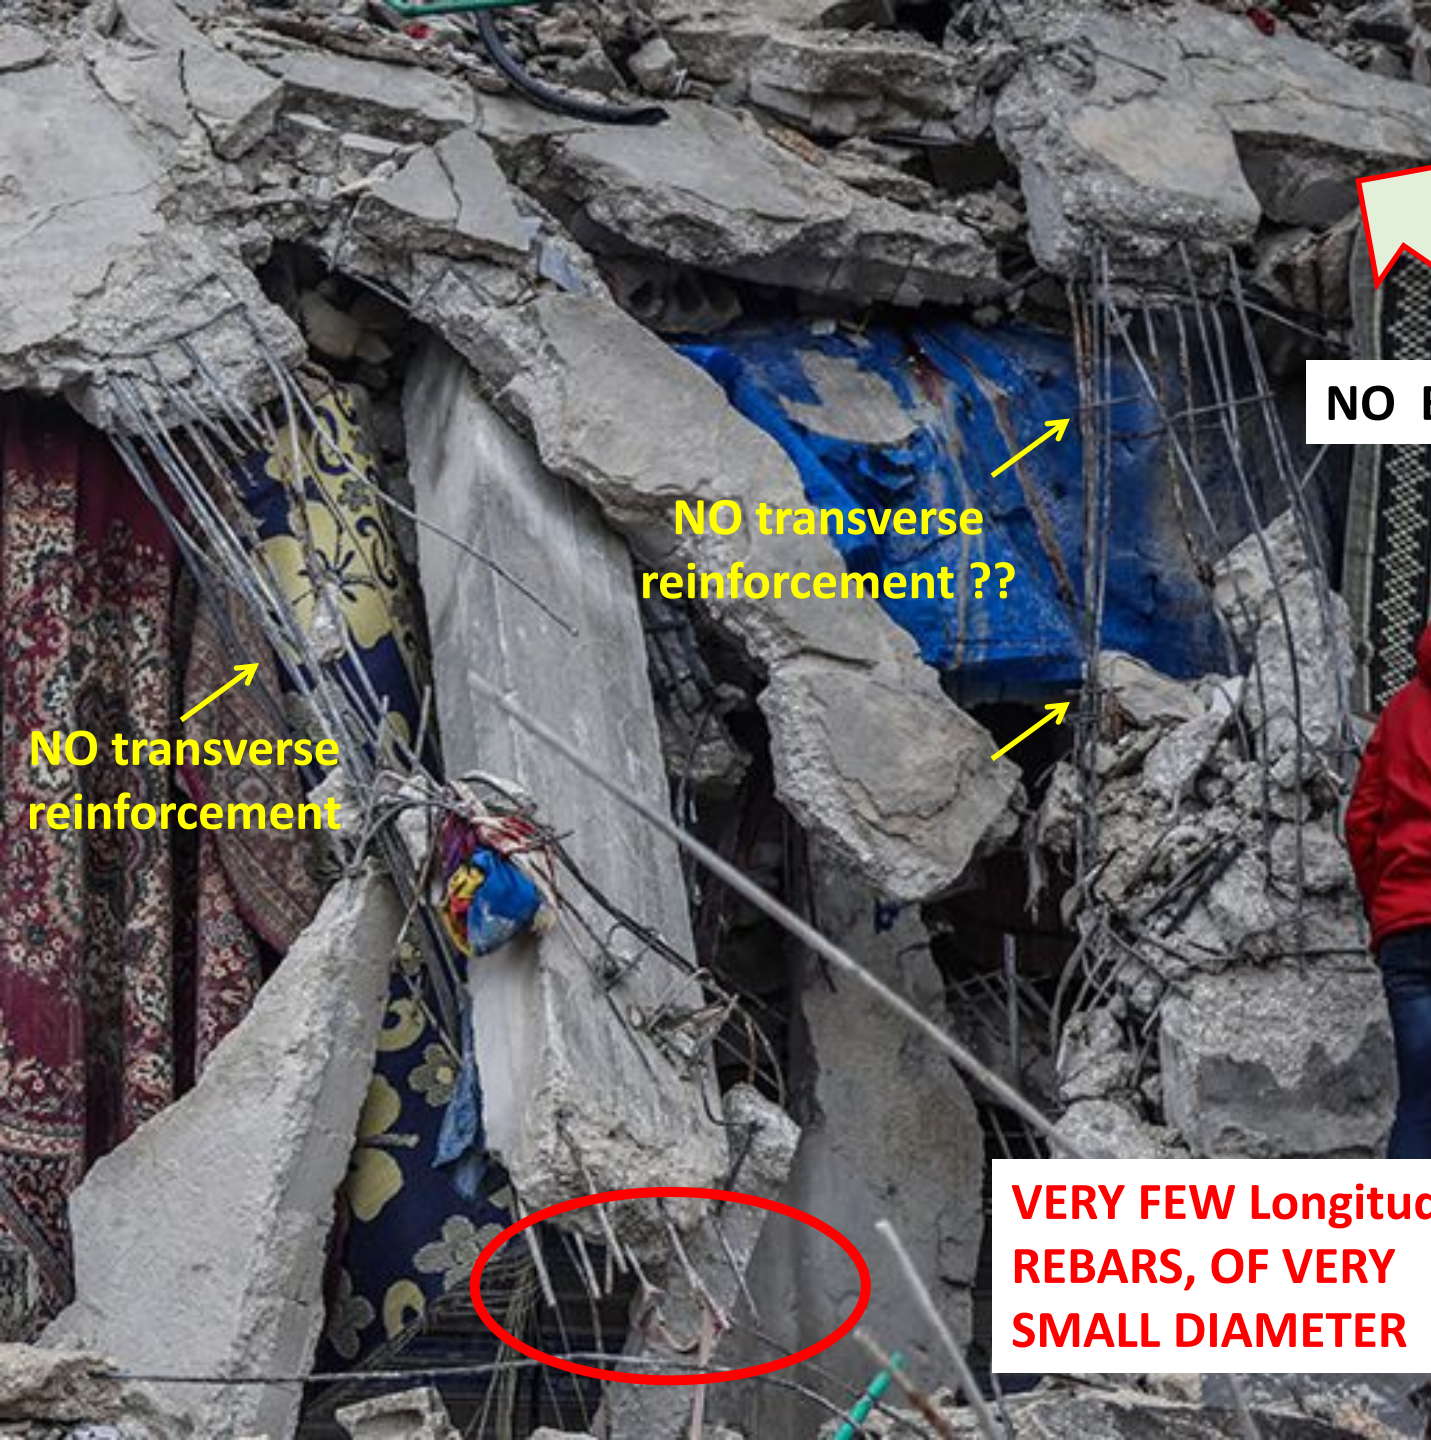
NO BEAMS !

**NO transverse
reinforcement ??**

**NO transverse
reinforcement**

**VERY FEW Longitudinal
REBARS, OF VERY
SMALL DIAMETER**

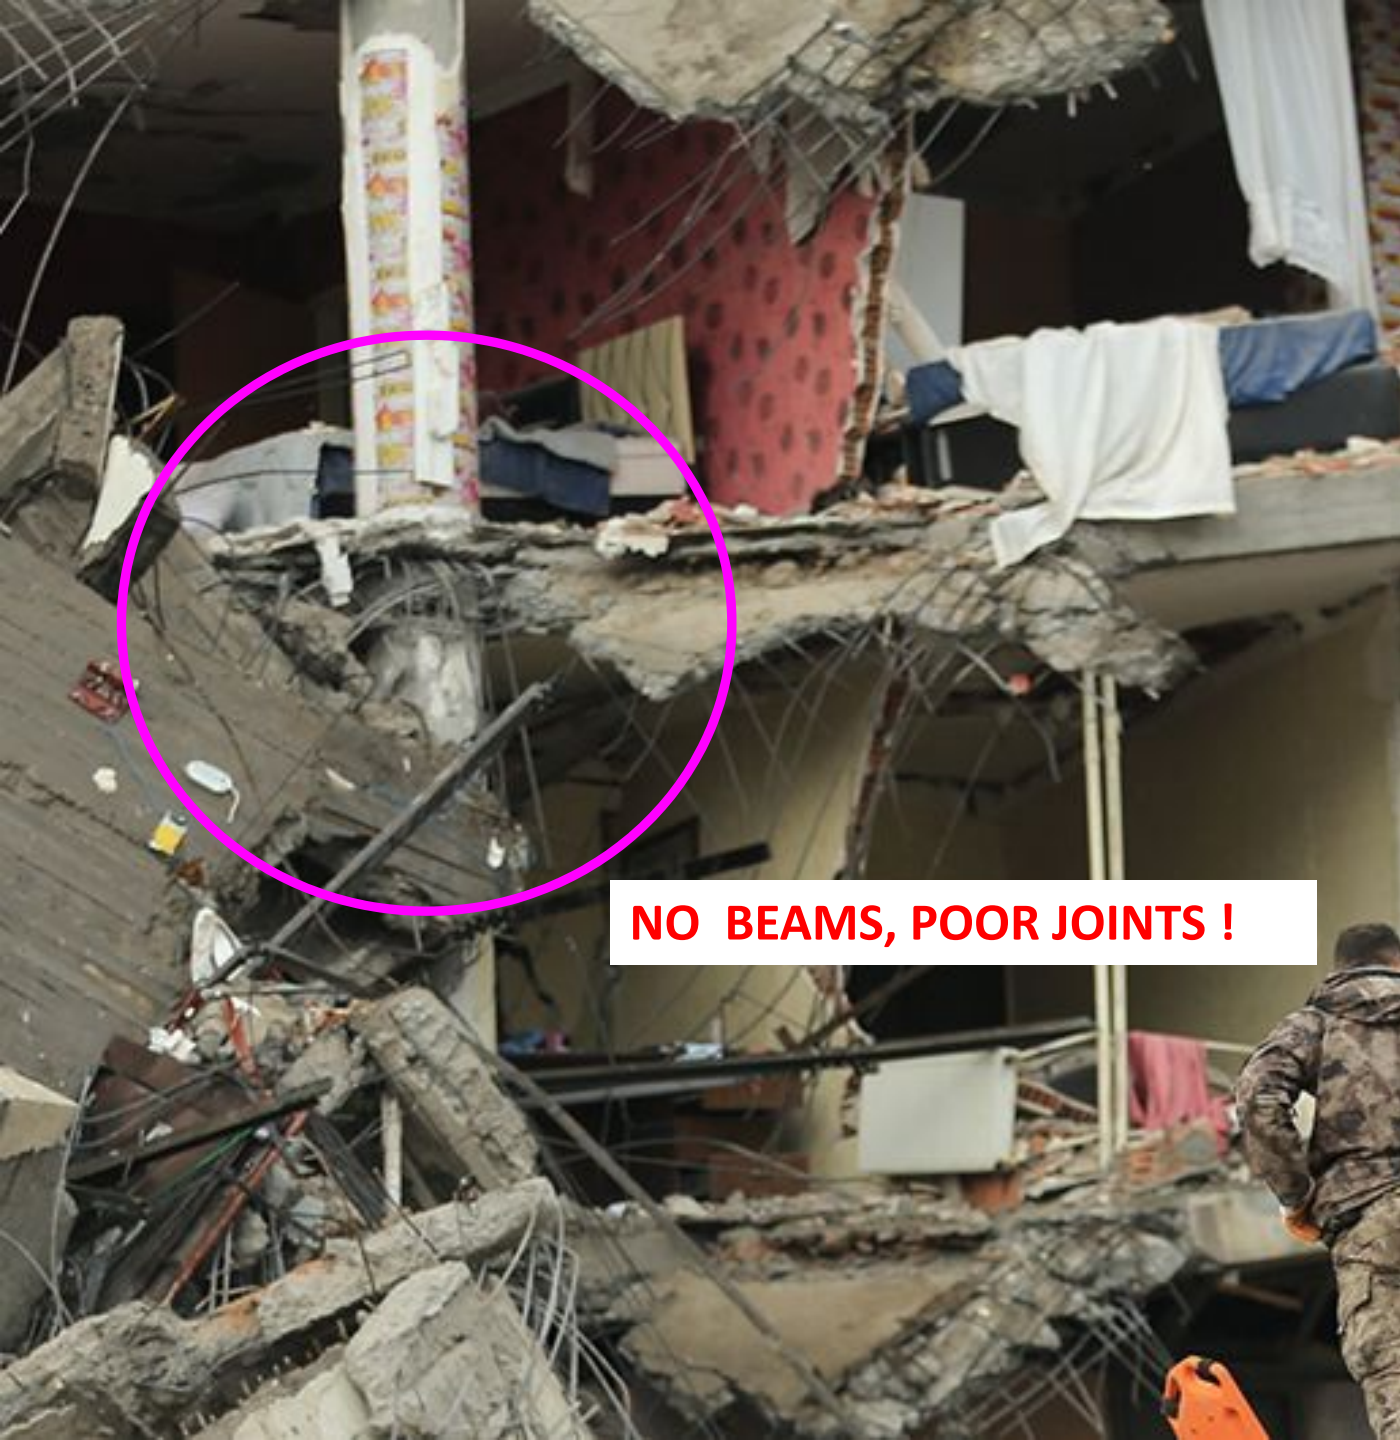
NO BEAMS, POOR JOINTS !

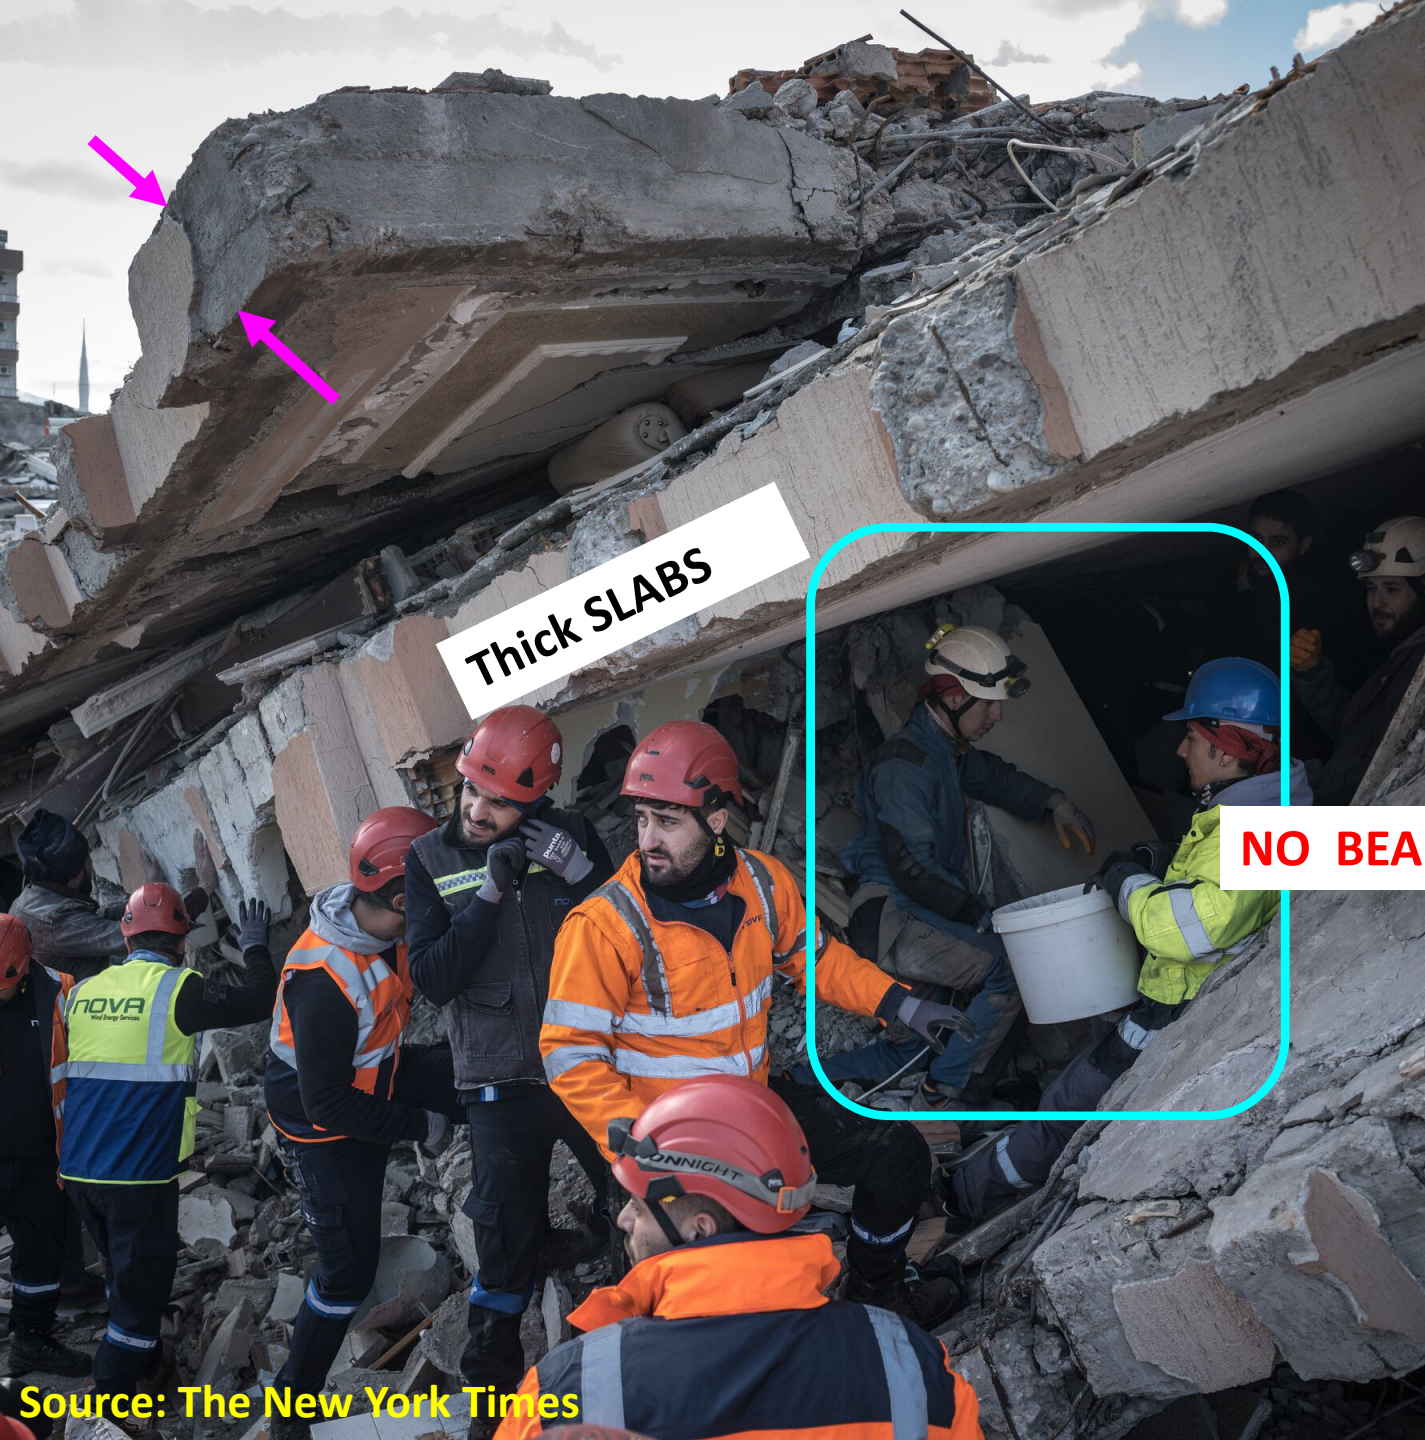
Thick SLABS

NO BEAMS, POOR JOINTS !

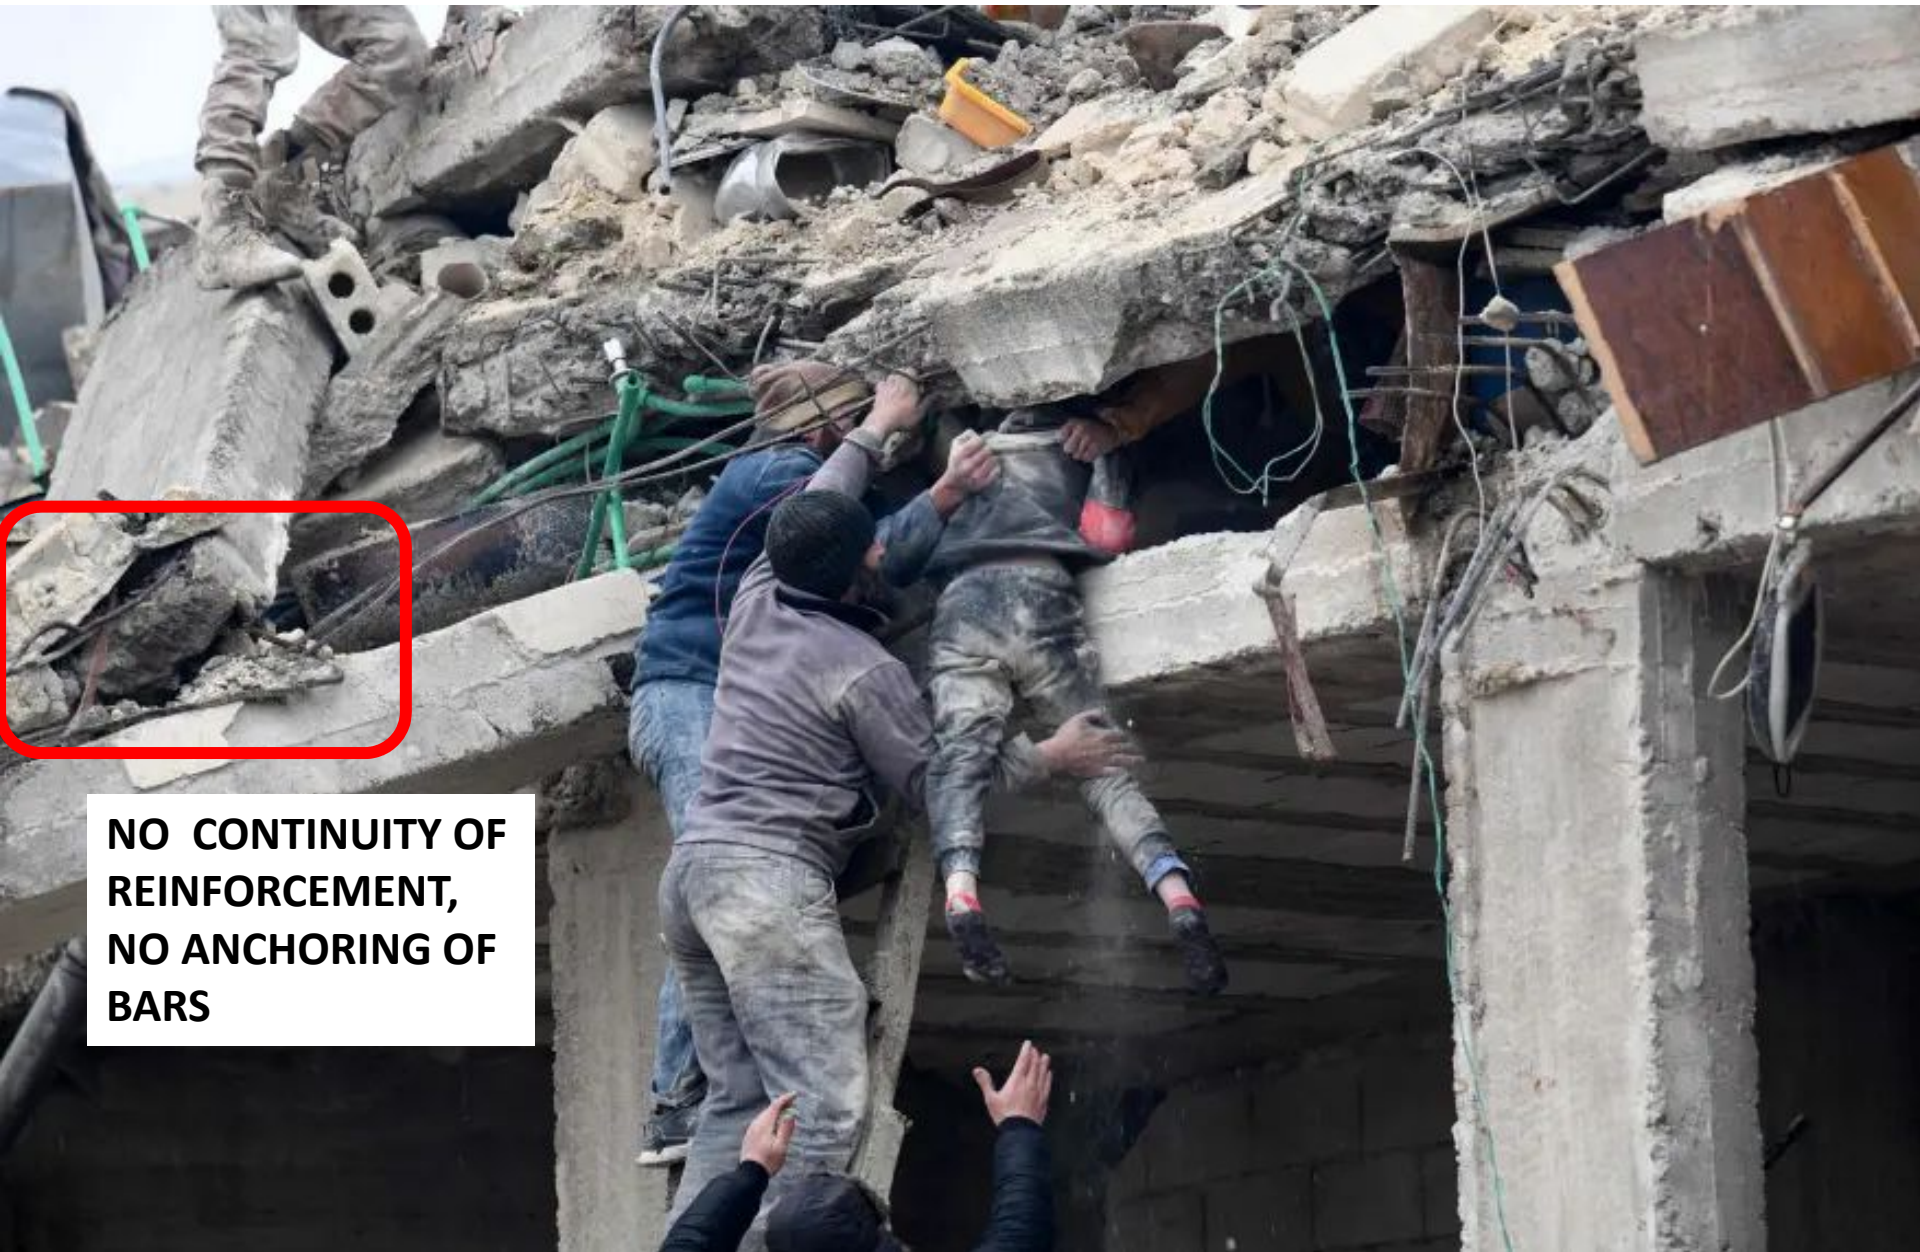
**NO CONTINUITY OF
REINFORCEMENT,
NO ANCHORING OF
BARS**

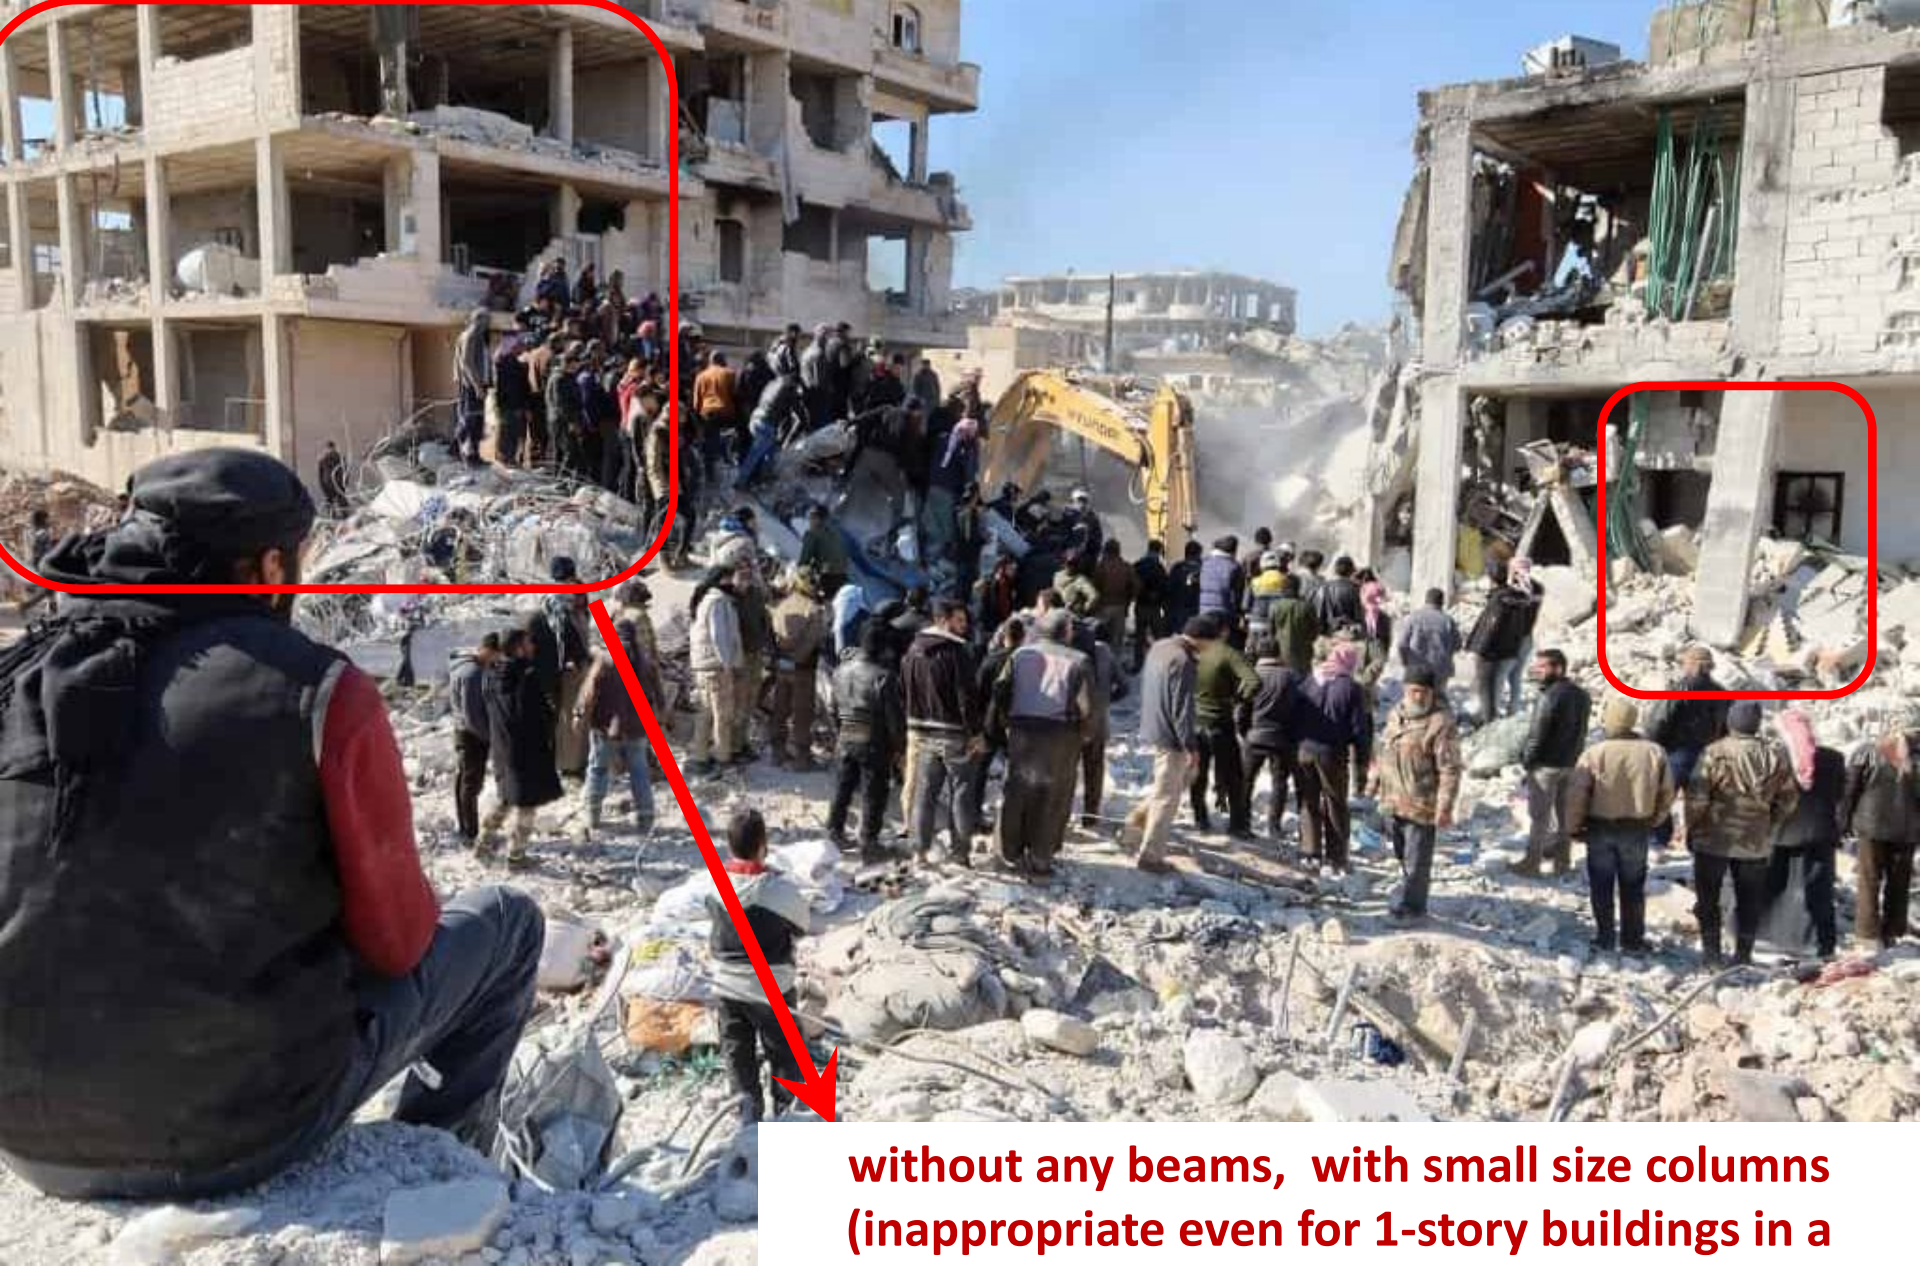
without any beams, with small size columns (inappropriate even for 1-story buildings in a region of moderate seismicity). It is a miracle that it did not fully collapsed.

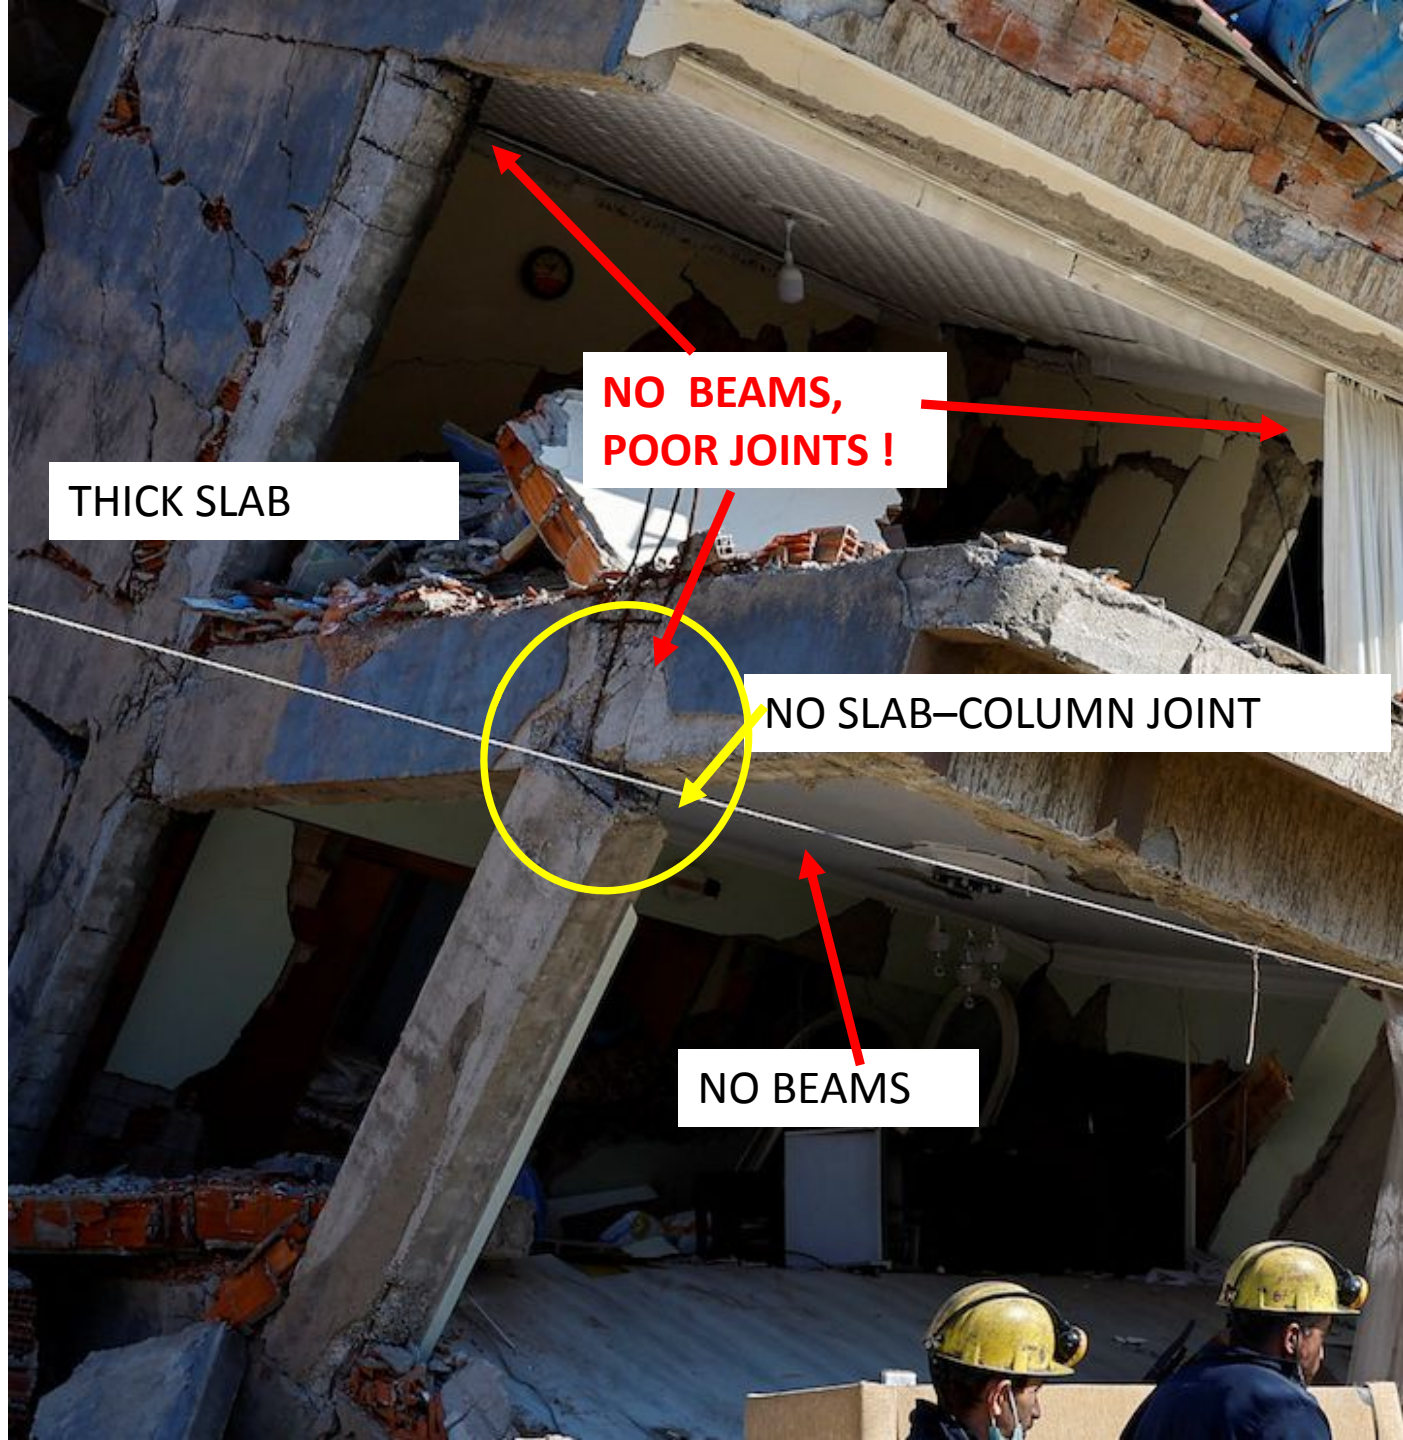
THICK SLAB

NO BEAMS,
POOR JOINTS !

NO SLAB-COLUMN JOINT

NO BEAMS

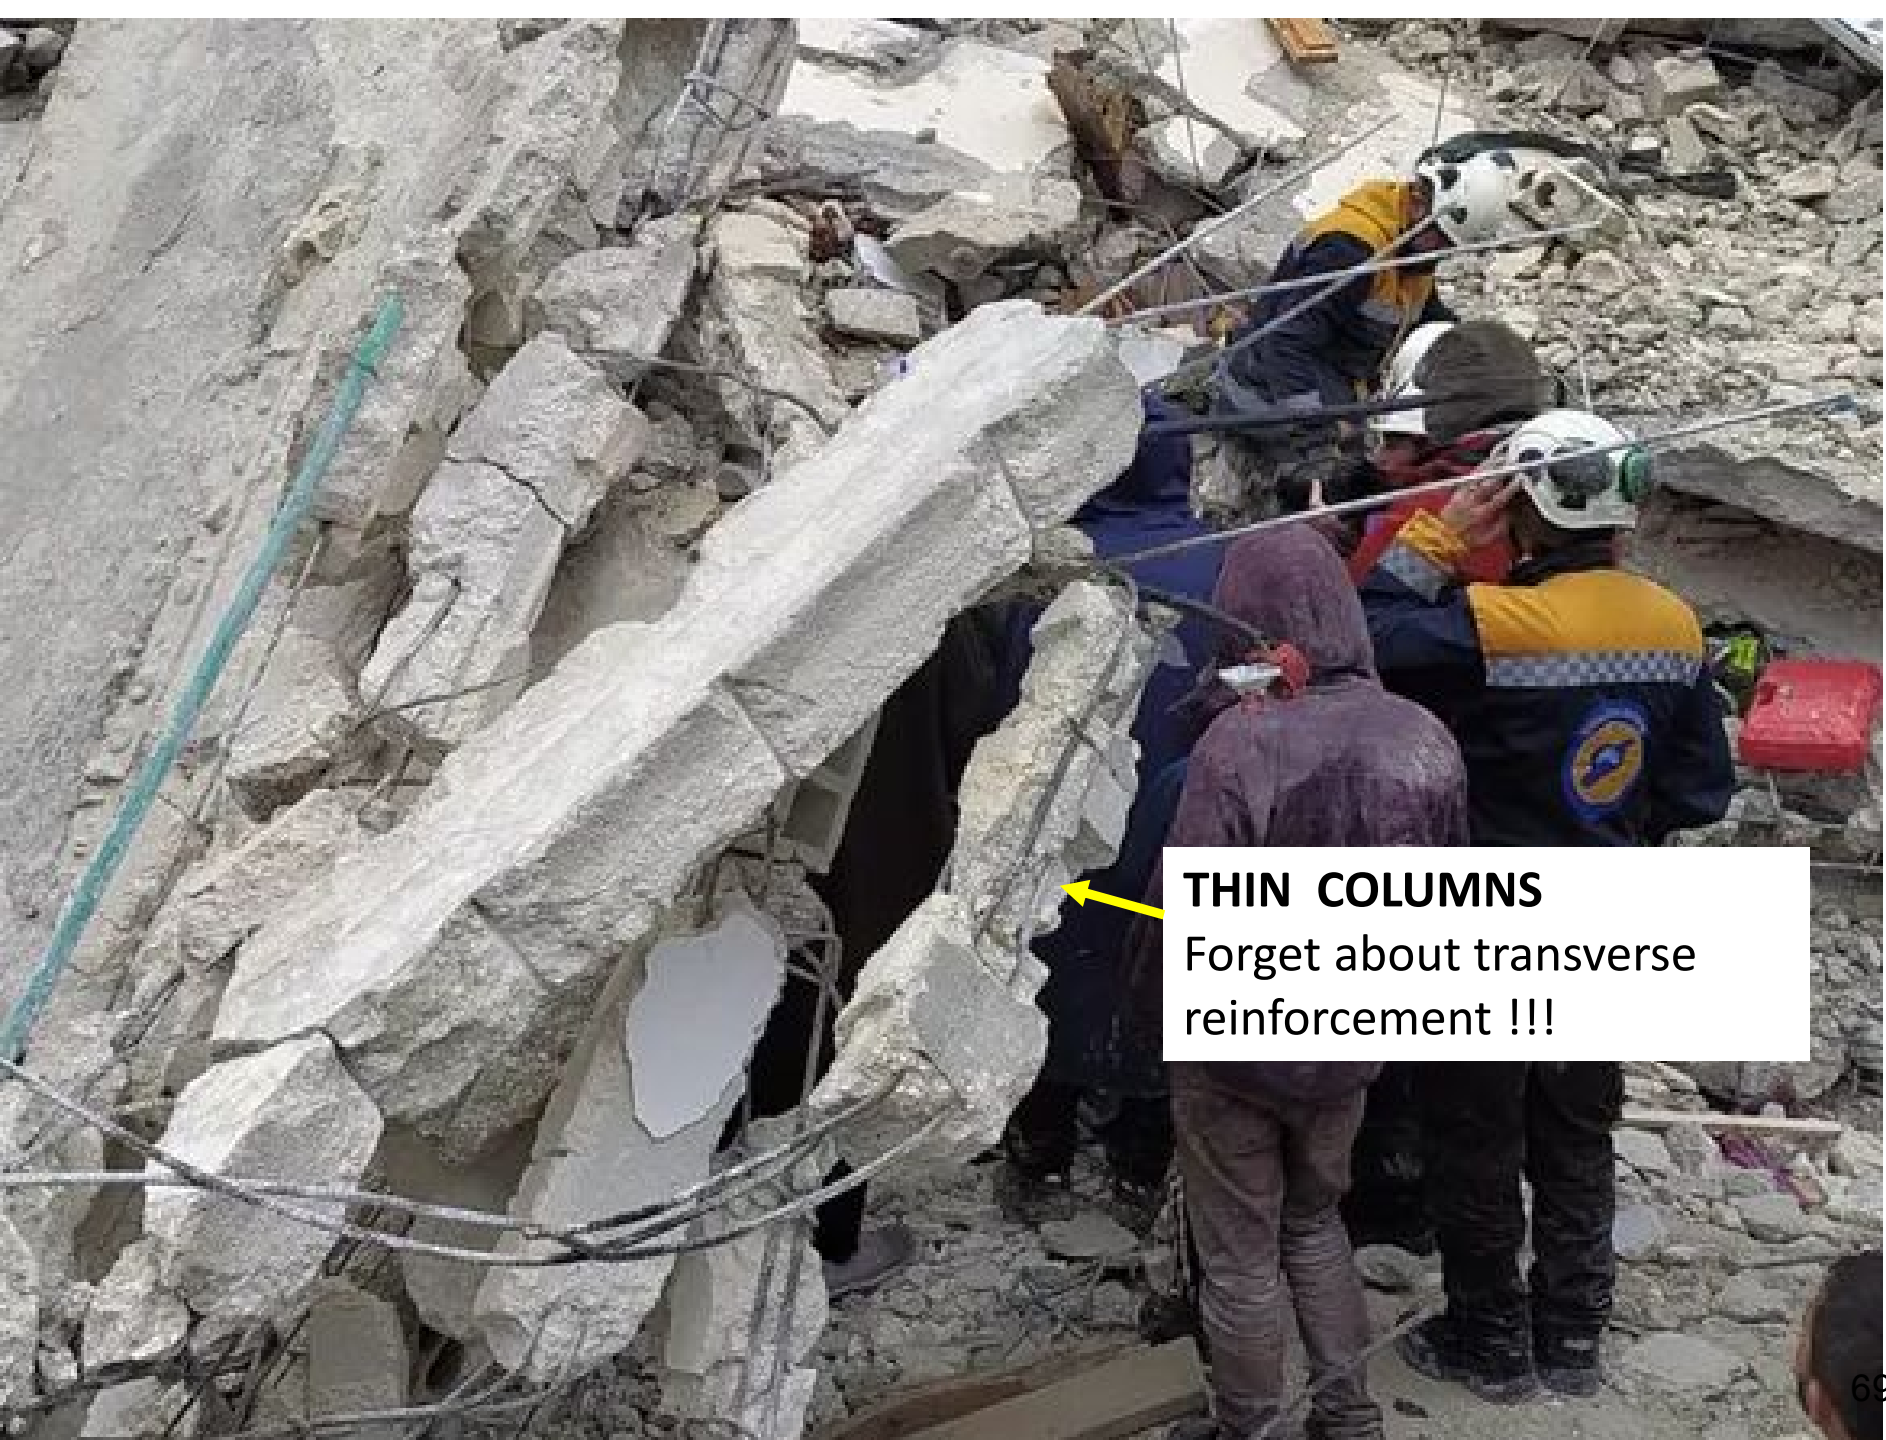
THIN COLUMNS

Forget about transverse reinforcement !!!

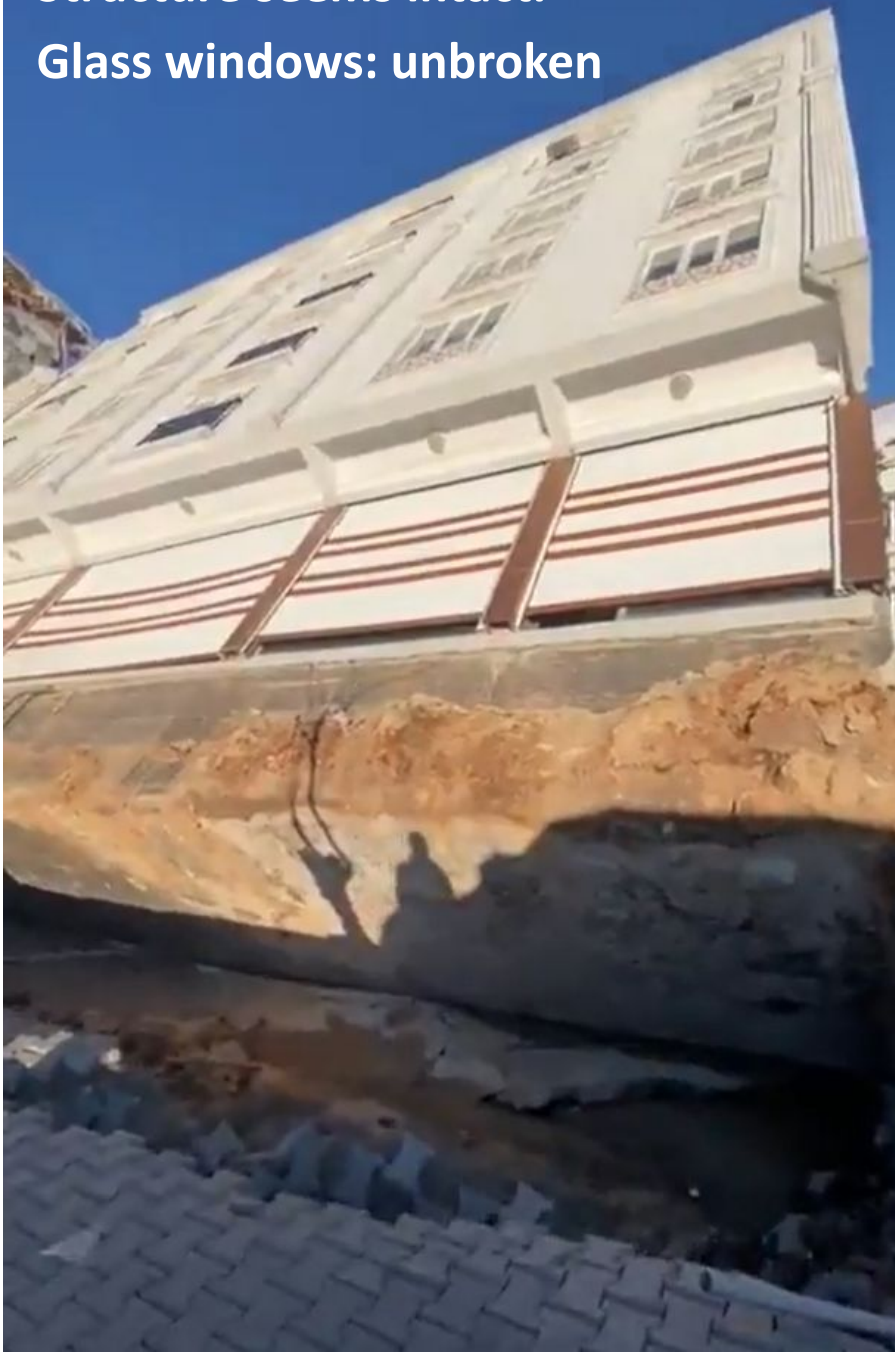
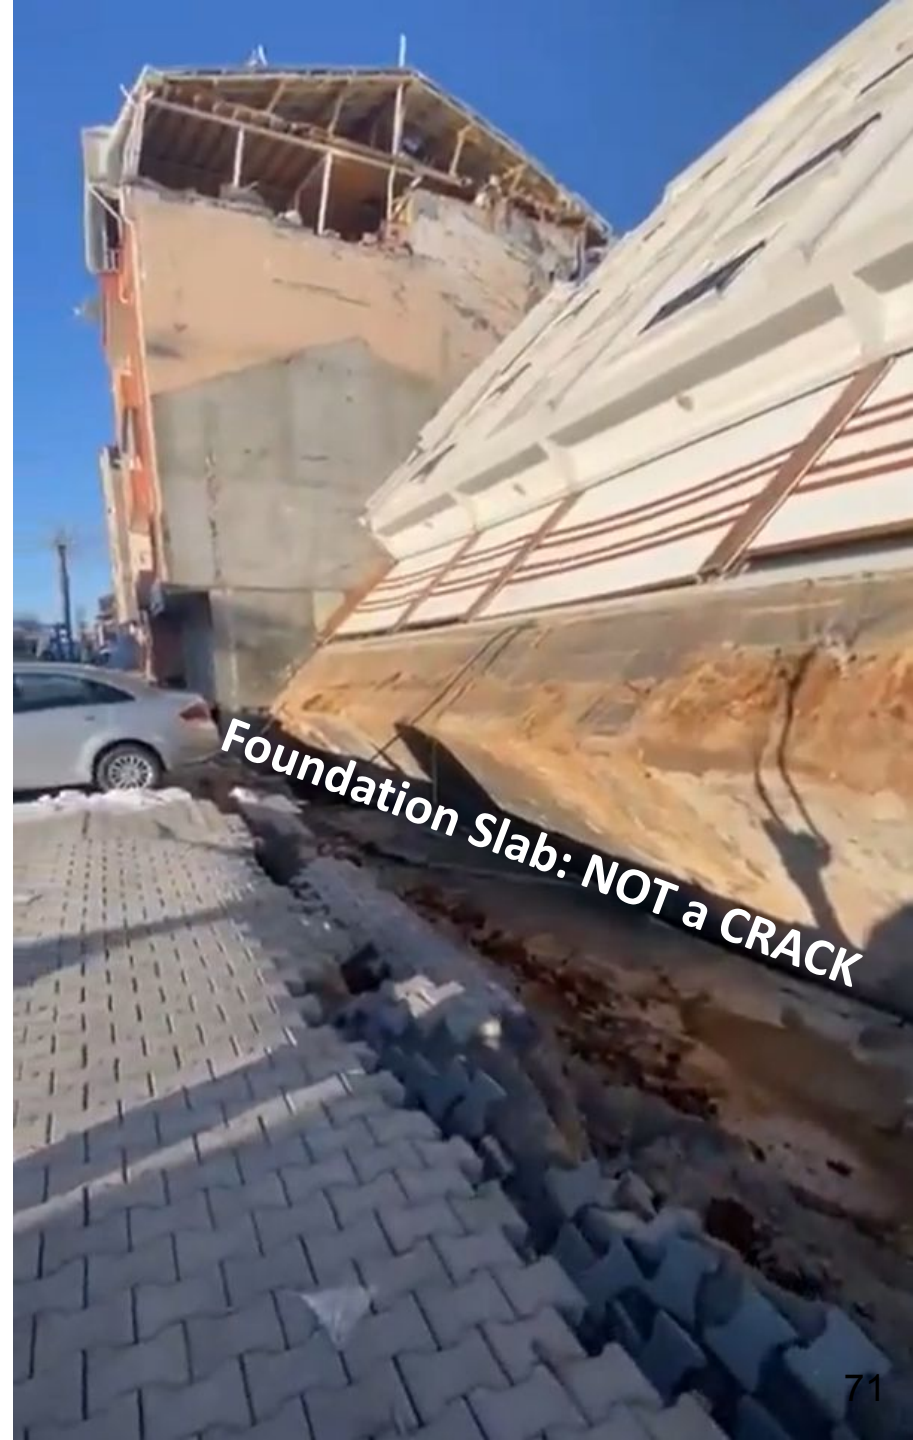
Overturning of a building apparently due to bearing-capacity failure on soft soil (perhaps with a high water table) under strong seismic moment. No evident damage in the structure. The glass windows remain unscathed ! Similarly intact appears to be the foundation slab.

This is reminiscent of ADAPAZARI in the 1999 Kocaeli (Izmit) Earthquake !!!

Structure seems intact.
Glass windows: unbroken

Foundation Slab: NOT a CRACK

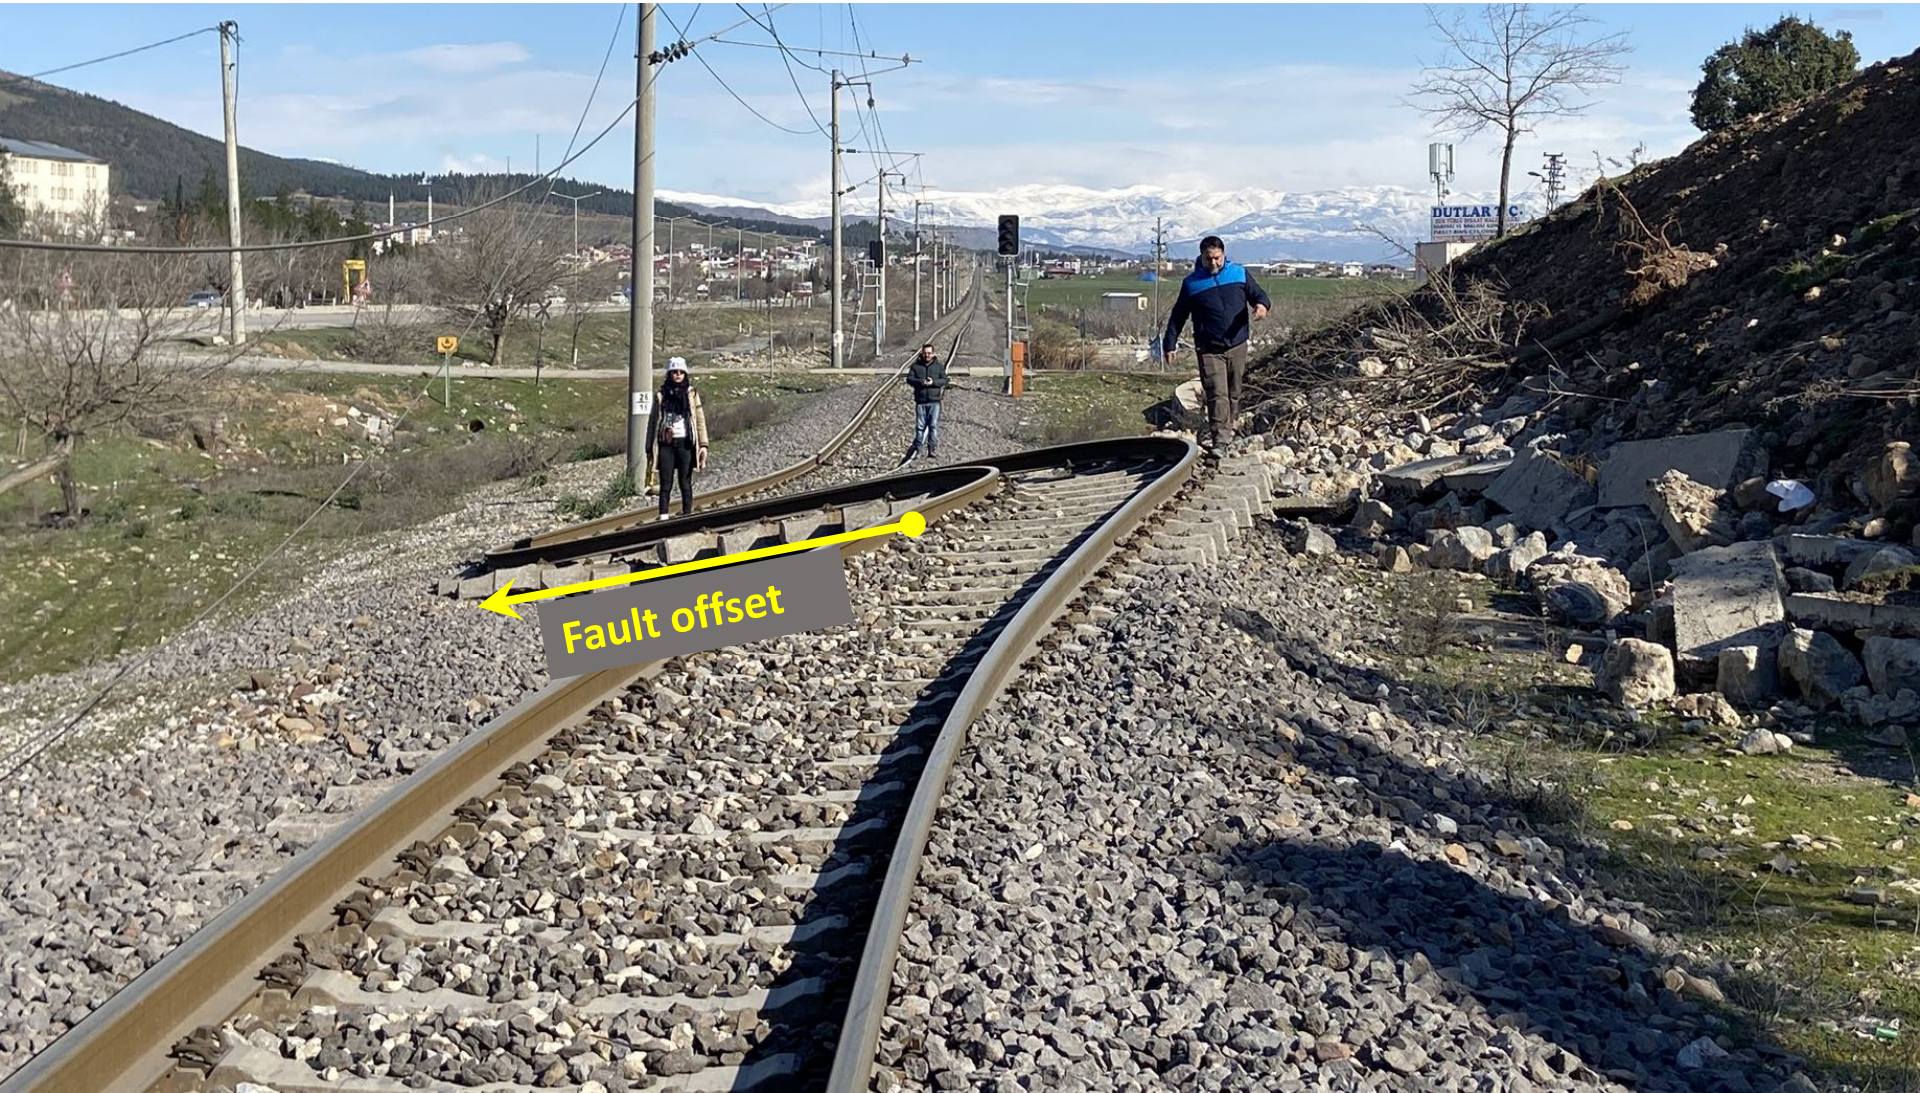
The strike slip fault as emerges at surface
