The 2 earthquakes of February 6th 2023 in Turkey

Preliminary Report

Failures of Multistorey Buildings in Turkey and Syria Due to the M 7.8 and M 7.5 Earthquakes

PART B: Structural Collapse and Interpretation

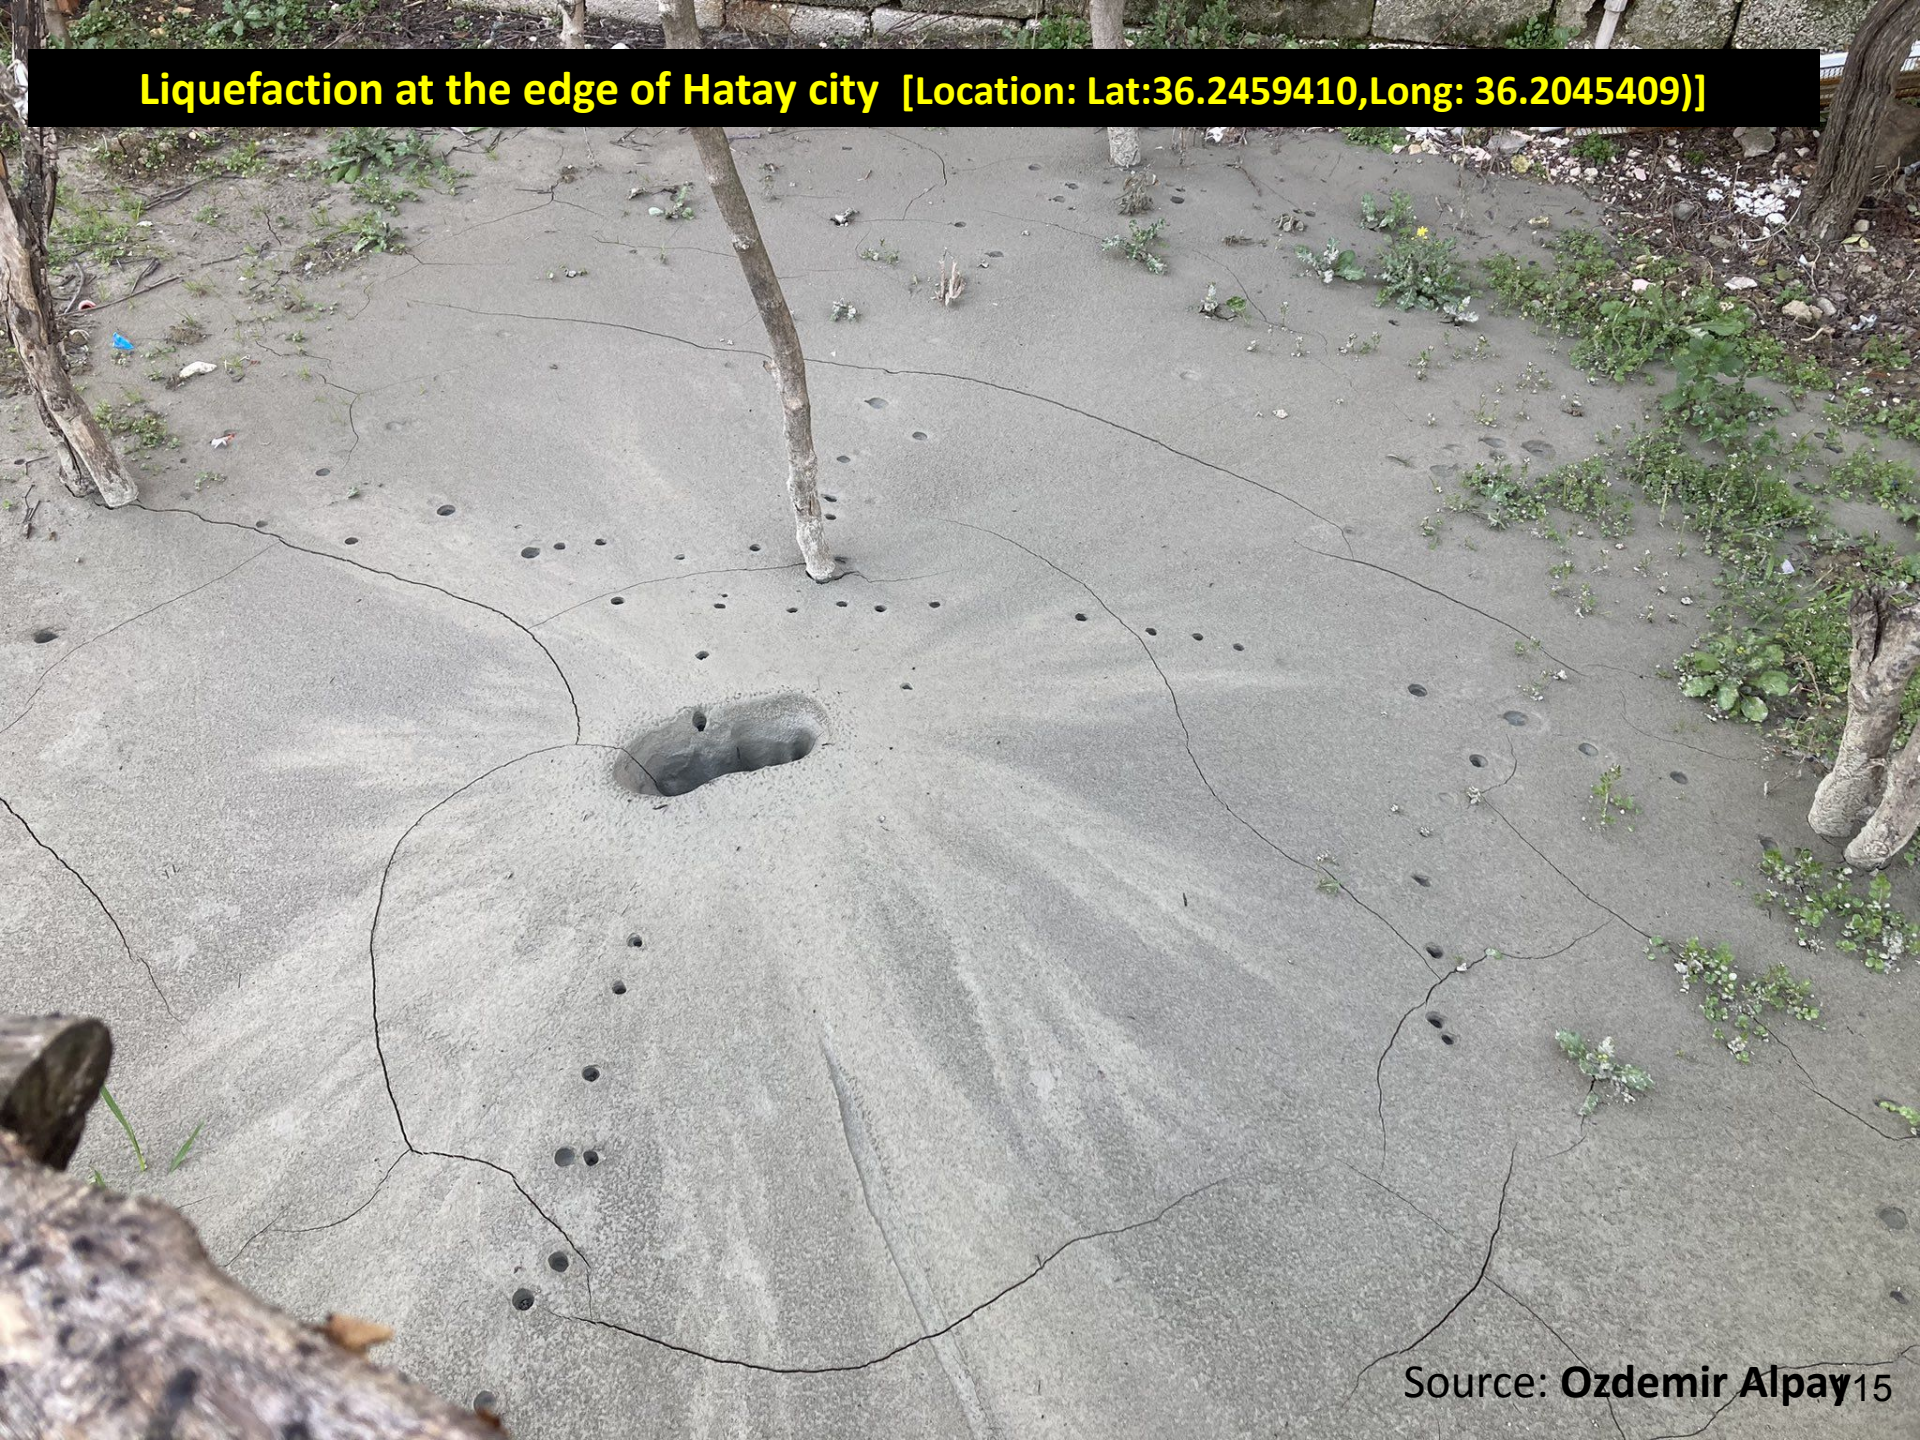
Liquefaction at the edge of Hatay city [Location: Lat:36.2459410,Long: 36.2045409)]

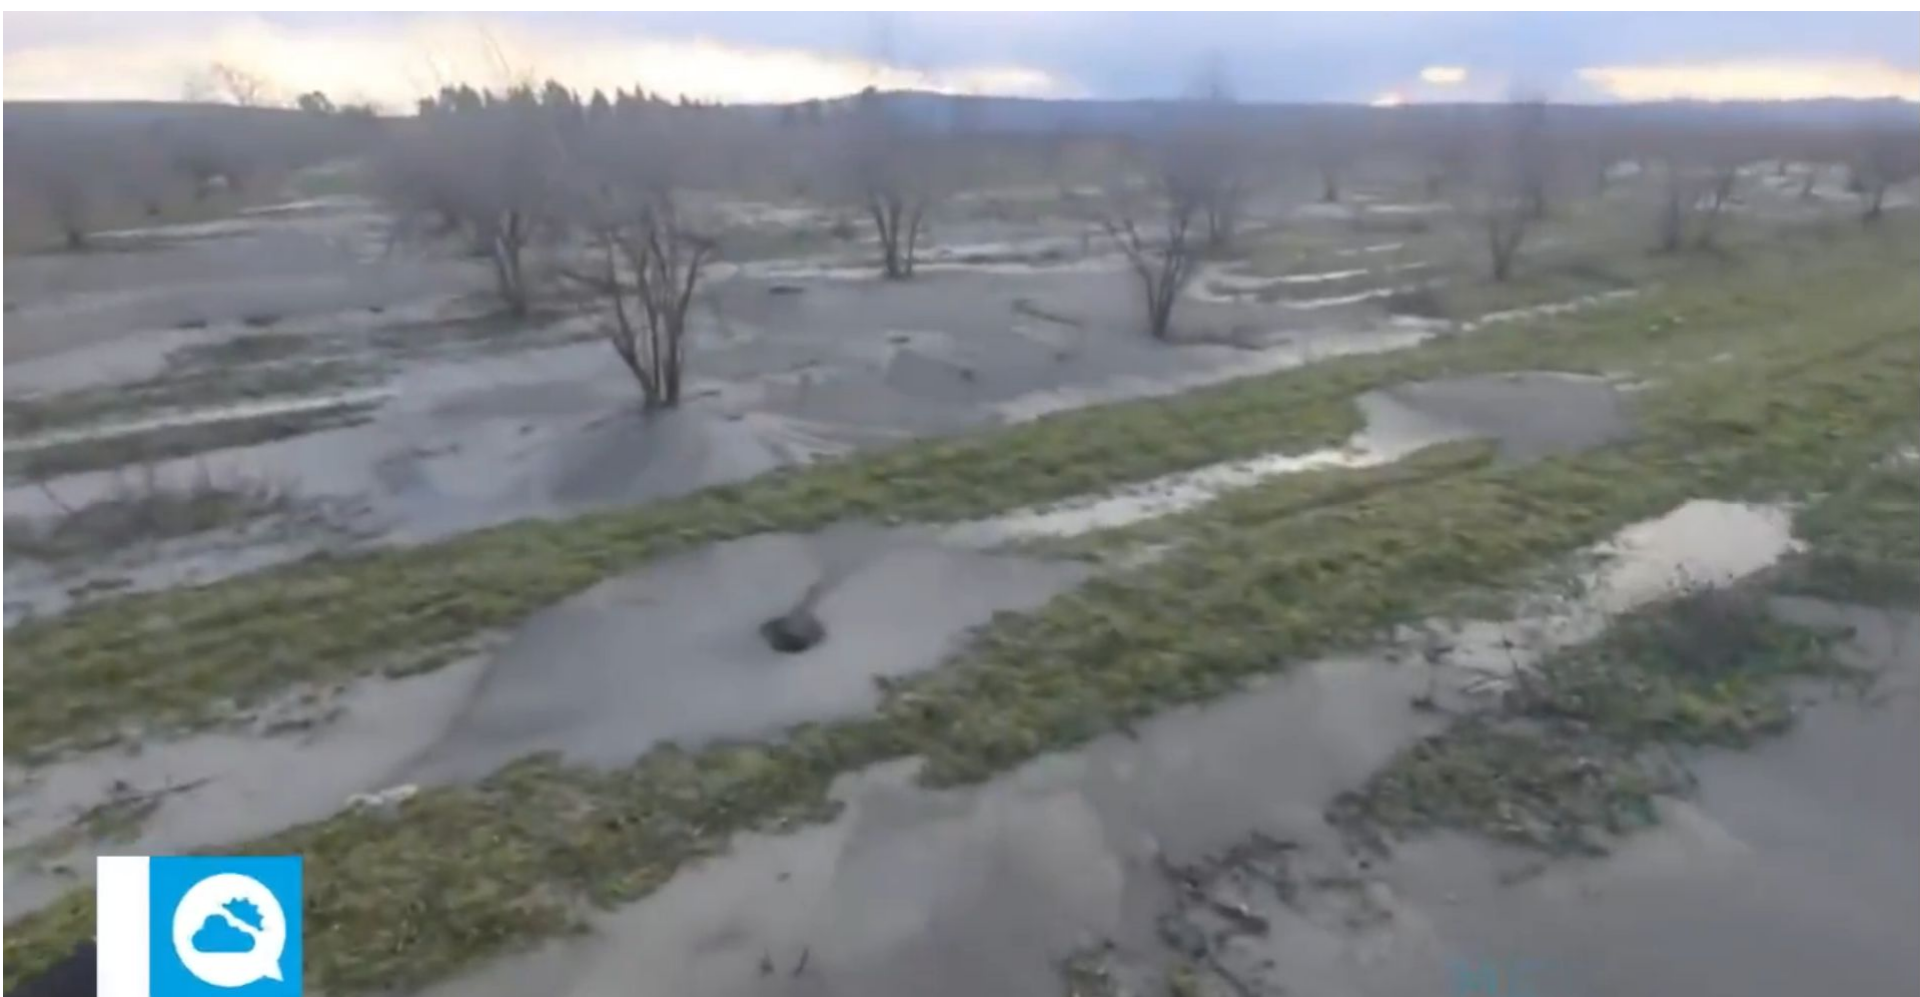
Soil liquefaction in northern Syria after the M7.8 earthquake

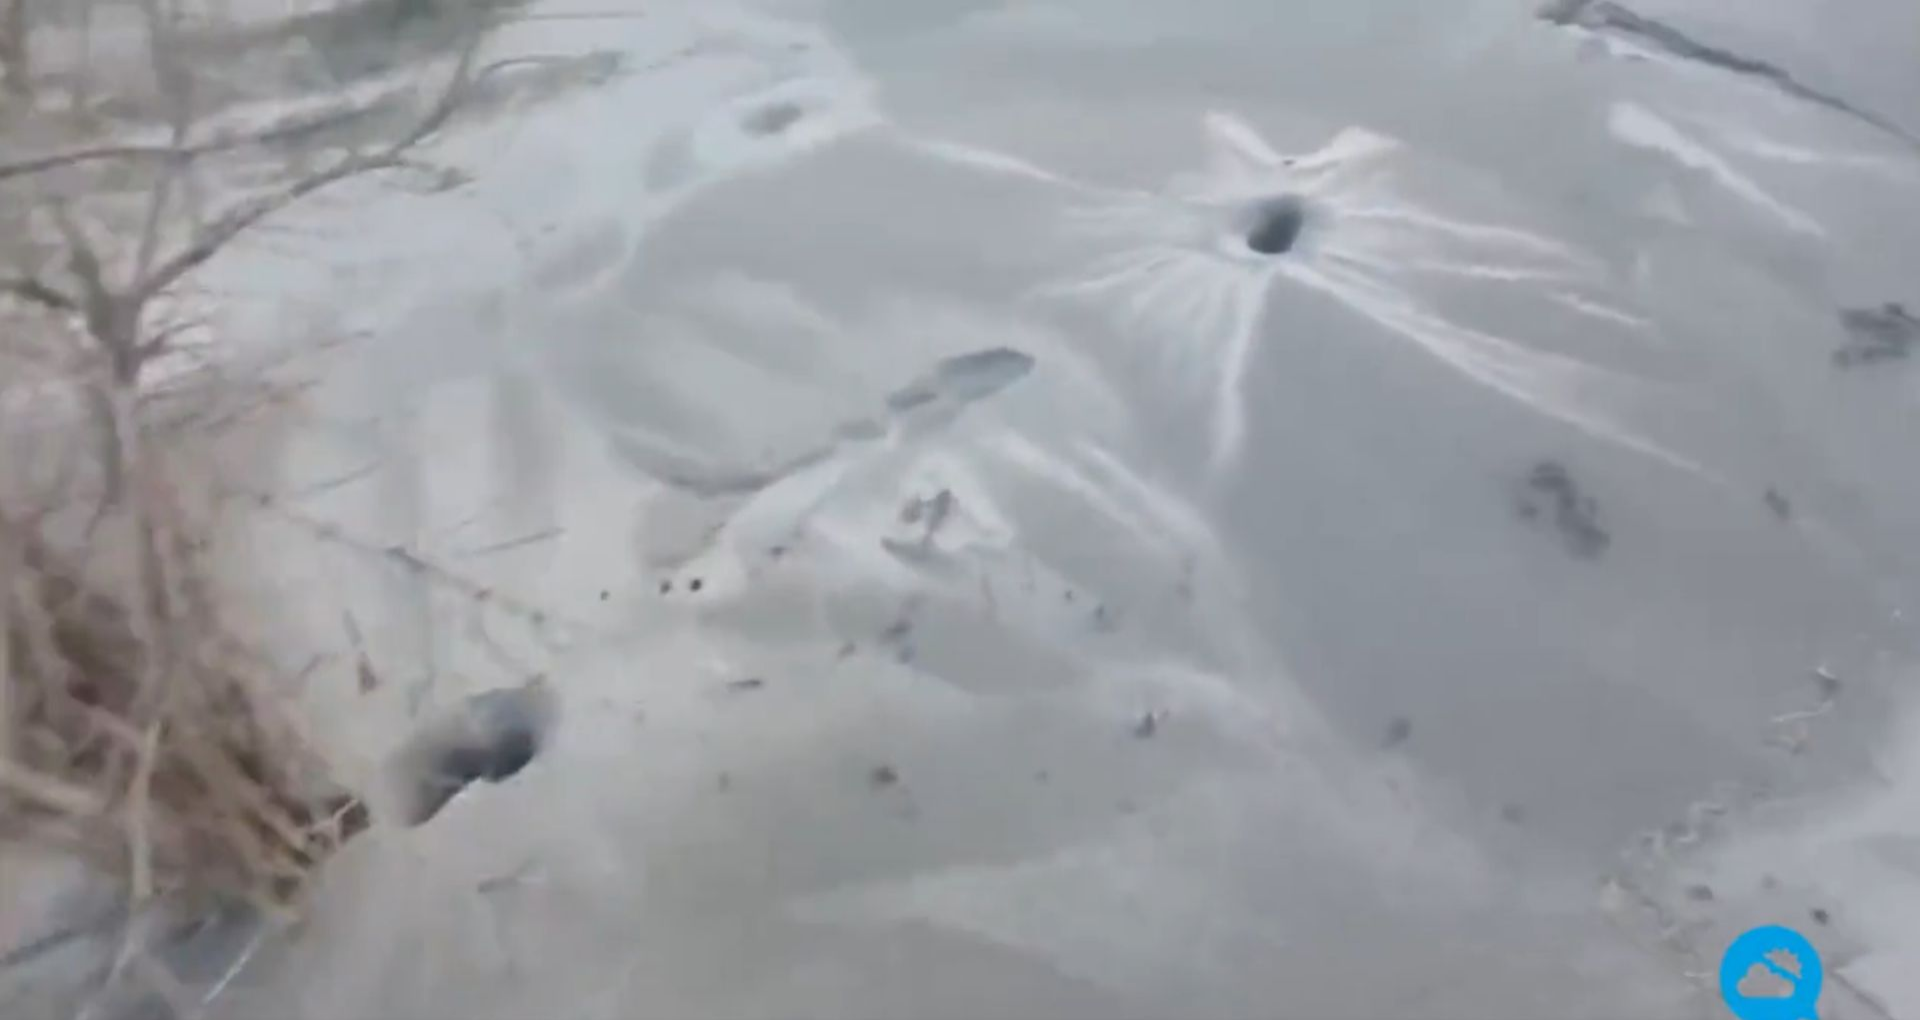
Soil liquefaction in northern Syria after the M7.8 earthquake

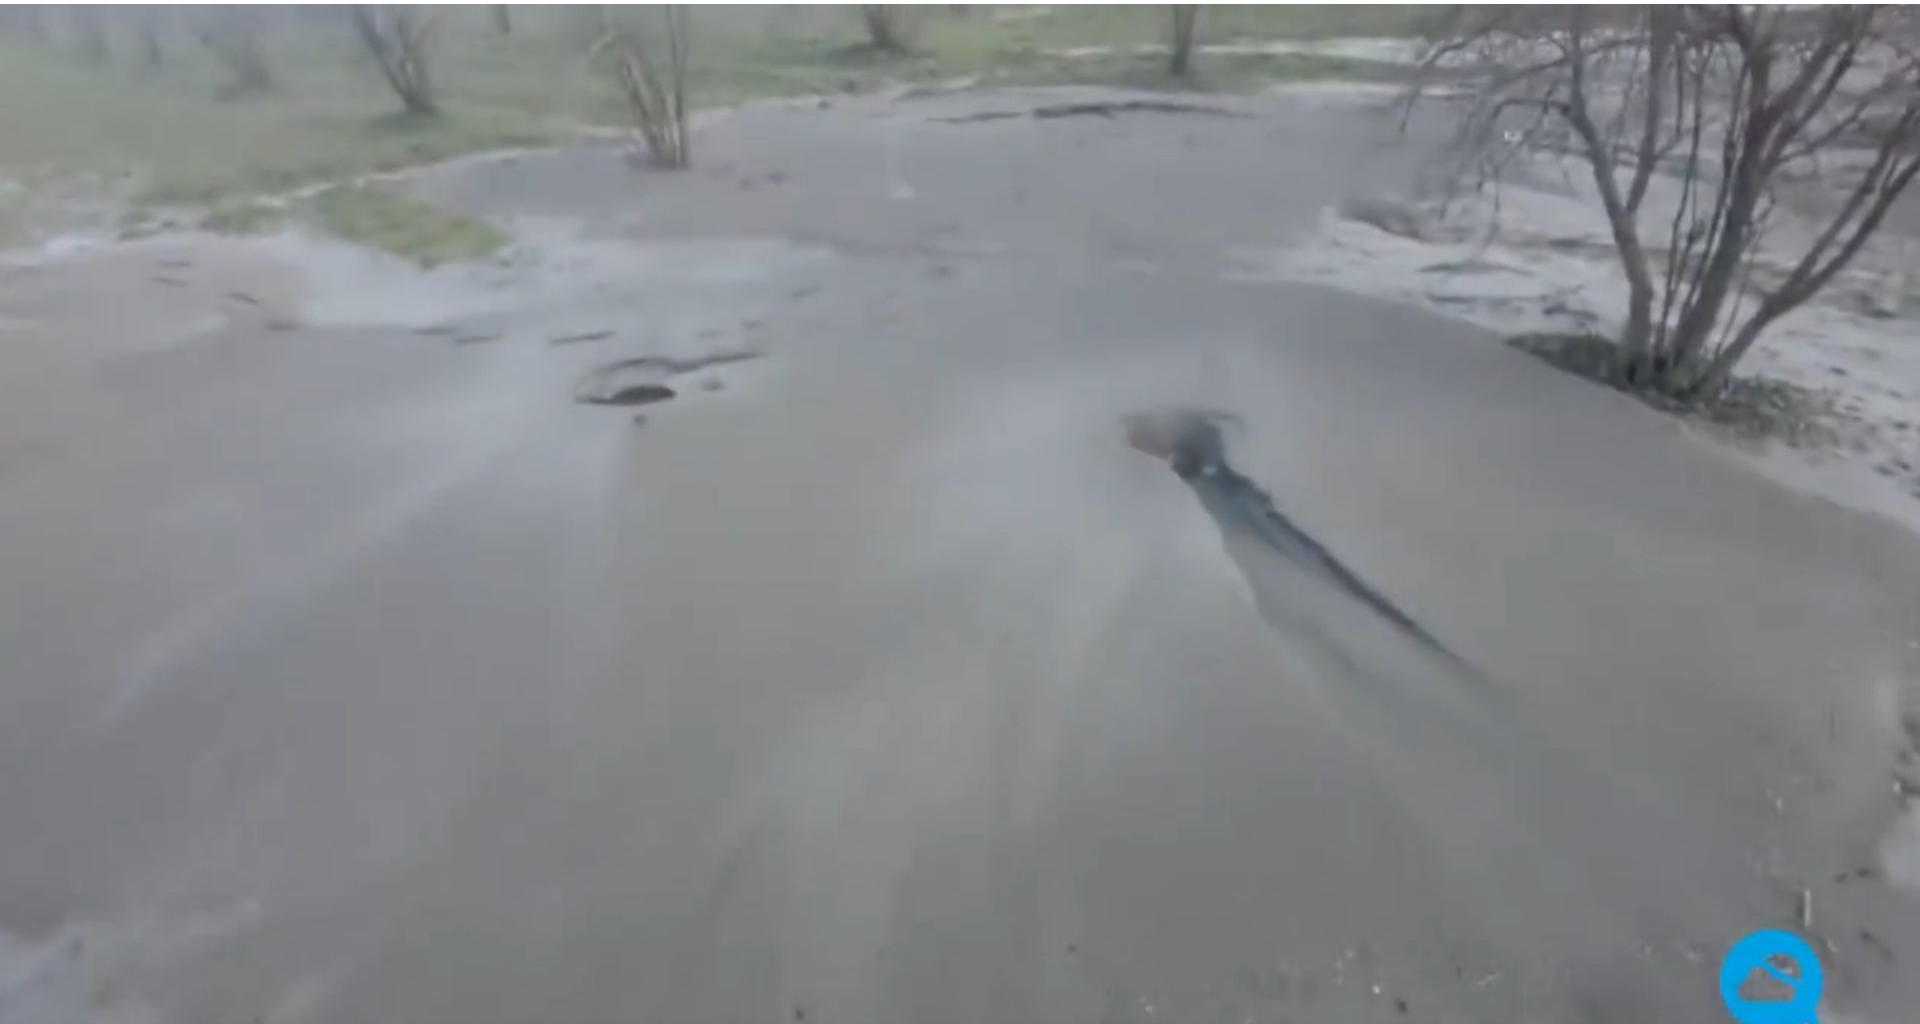
Soil liquefaction in northern Syria after the M7.8 earthquake
