The 2 earthquakes of February 6th 2023 in Turkey

Preliminary Report

Failures of Multistorey Buildings in Turkey and Syria Due to the M 7.8 and M 7.5 Earthquakes

PART B: Structural Collapse and Interpretation

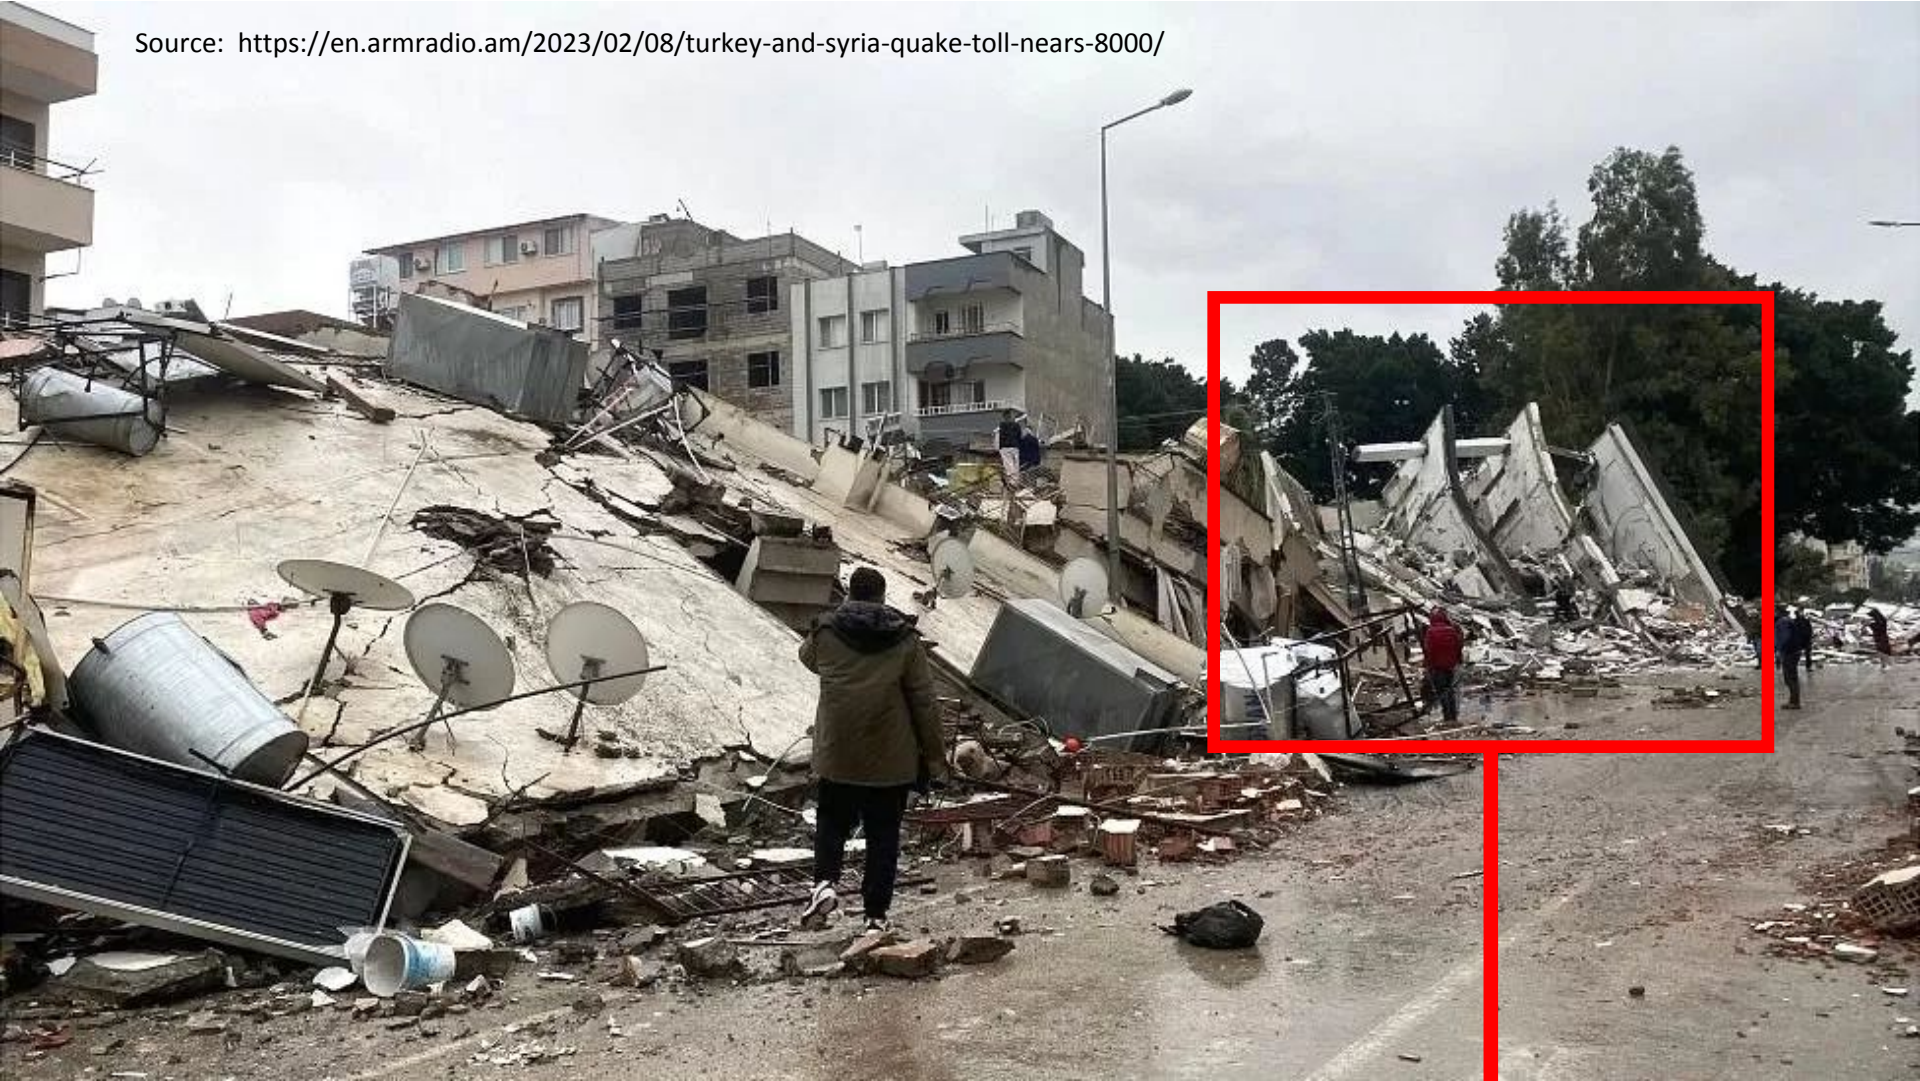
(For comparison, a typical 2-story building in Cephalonia, Greece, is shown — from an area of similar seismicity as the region inflicted by the 7.8 earthquake.)

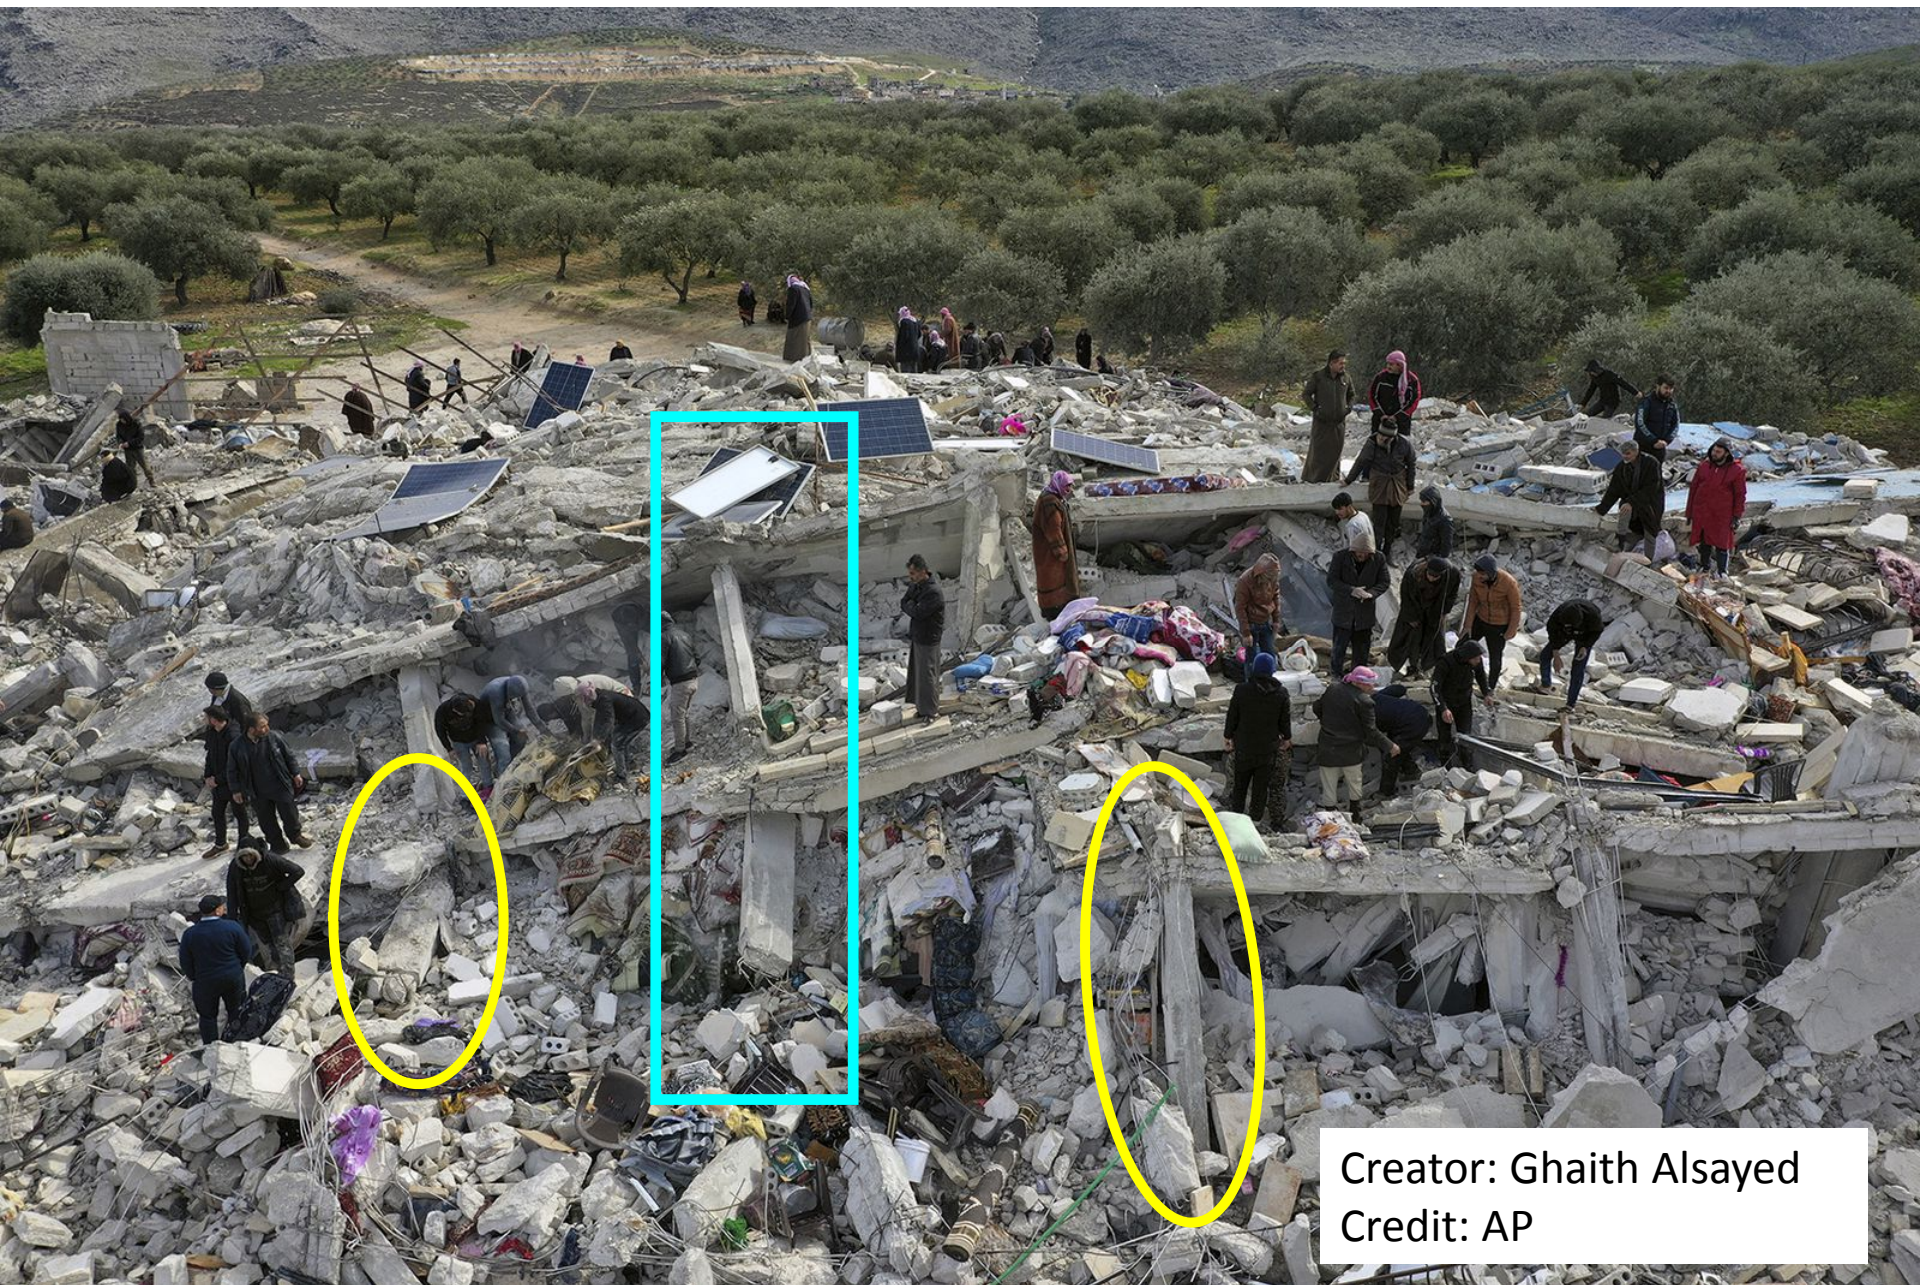
Numerous buildings without any beam, with small size columns (inappropriate even for 1-story buildings in a region of moderate seismicity).²⁴

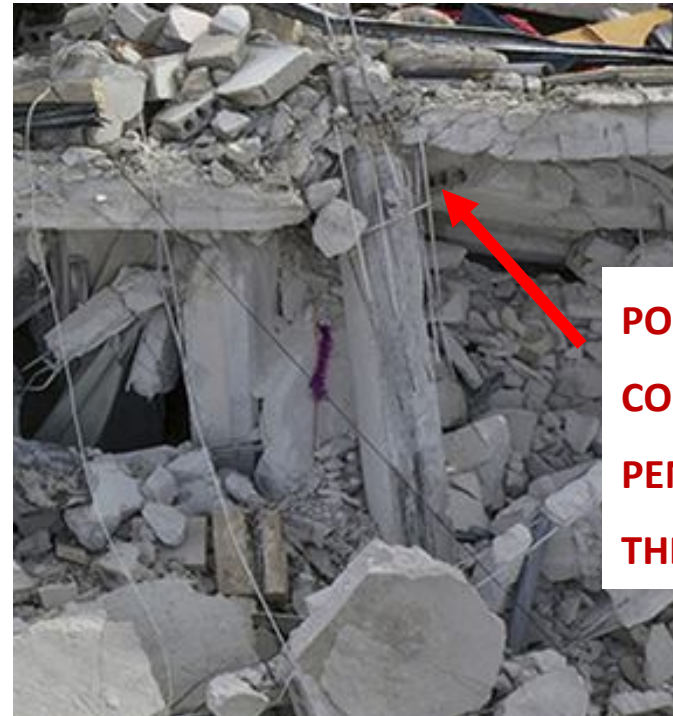
NO BEAMS
NO SHEAR WALLS

**POOR JOINT,
COLUMN
PENETRATES
THE SLAB**

**VERY FEW
REBARS, OF
VERY SMALL
DIAMETER**

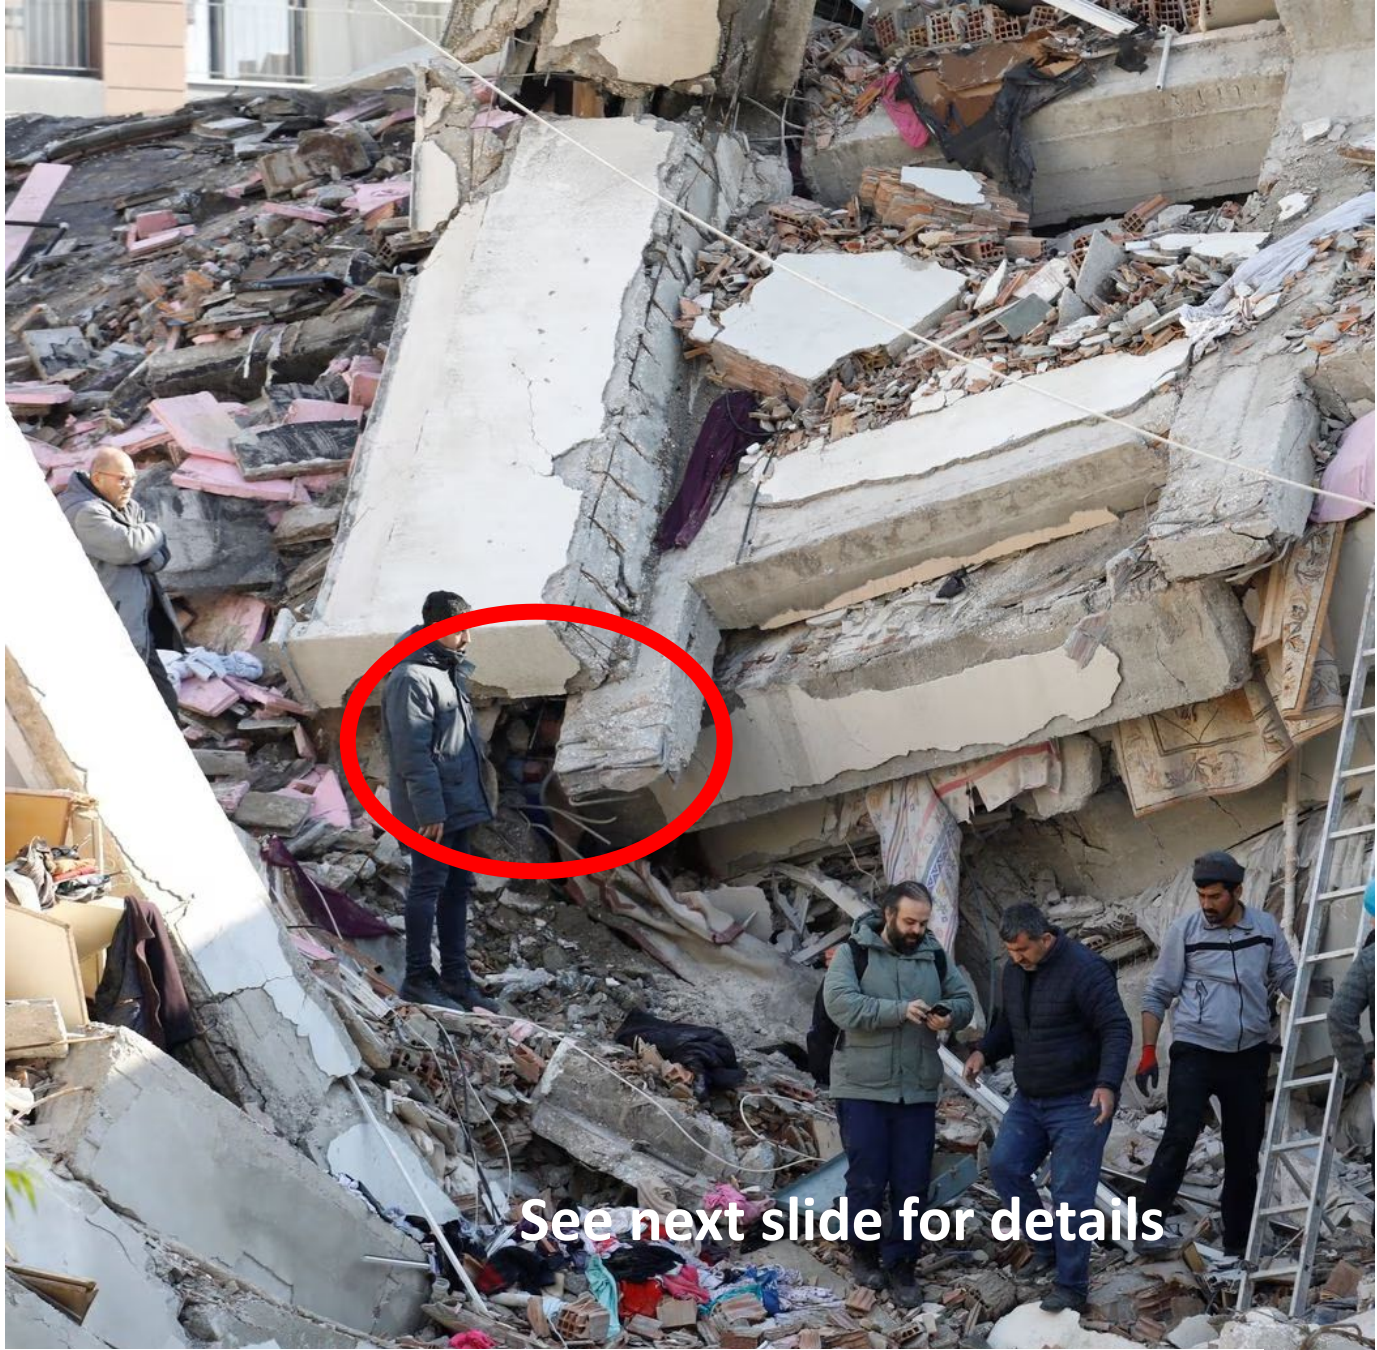
Joints fail, as if there is no continuity of the longitudinal reinforcement (REBARS).

Essentially, NO Slab–Column JOINT

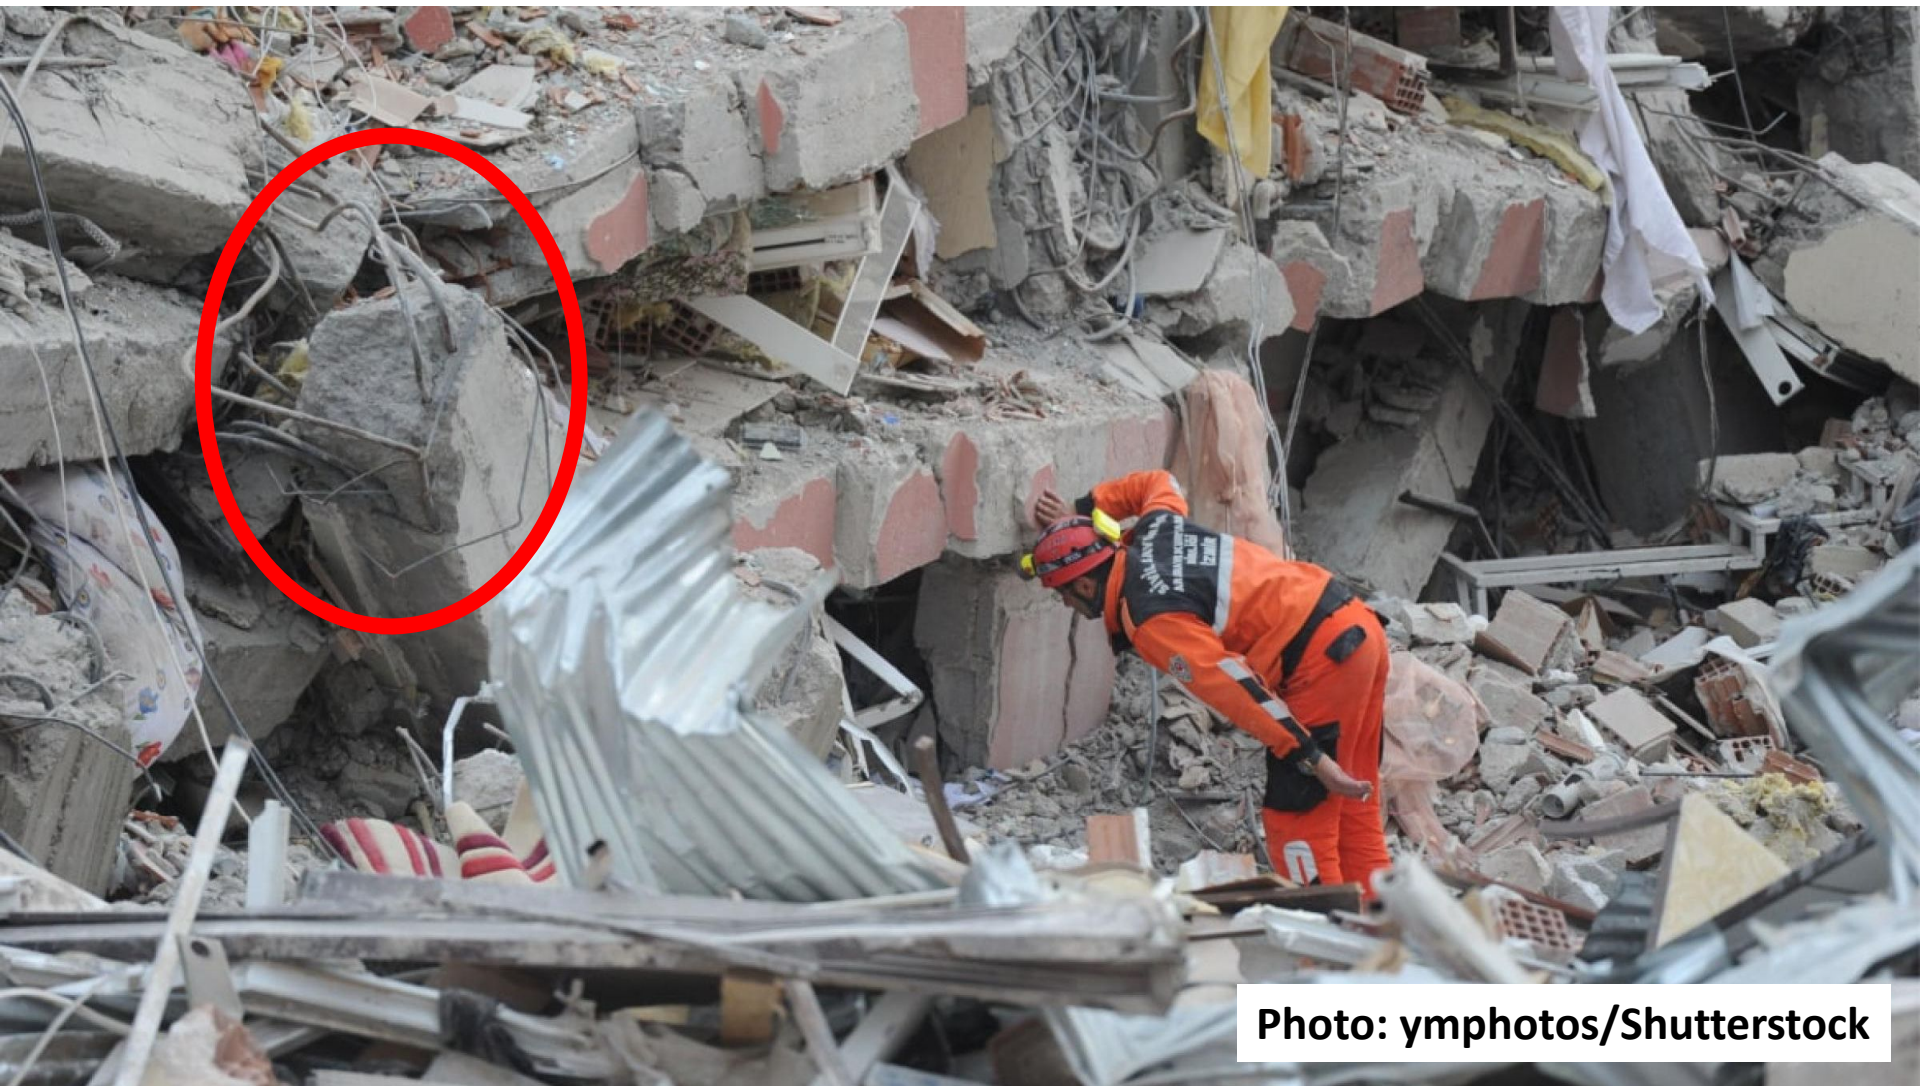
**VERY FEW REBARS,
OF VERY SMALL
DIAMETER**

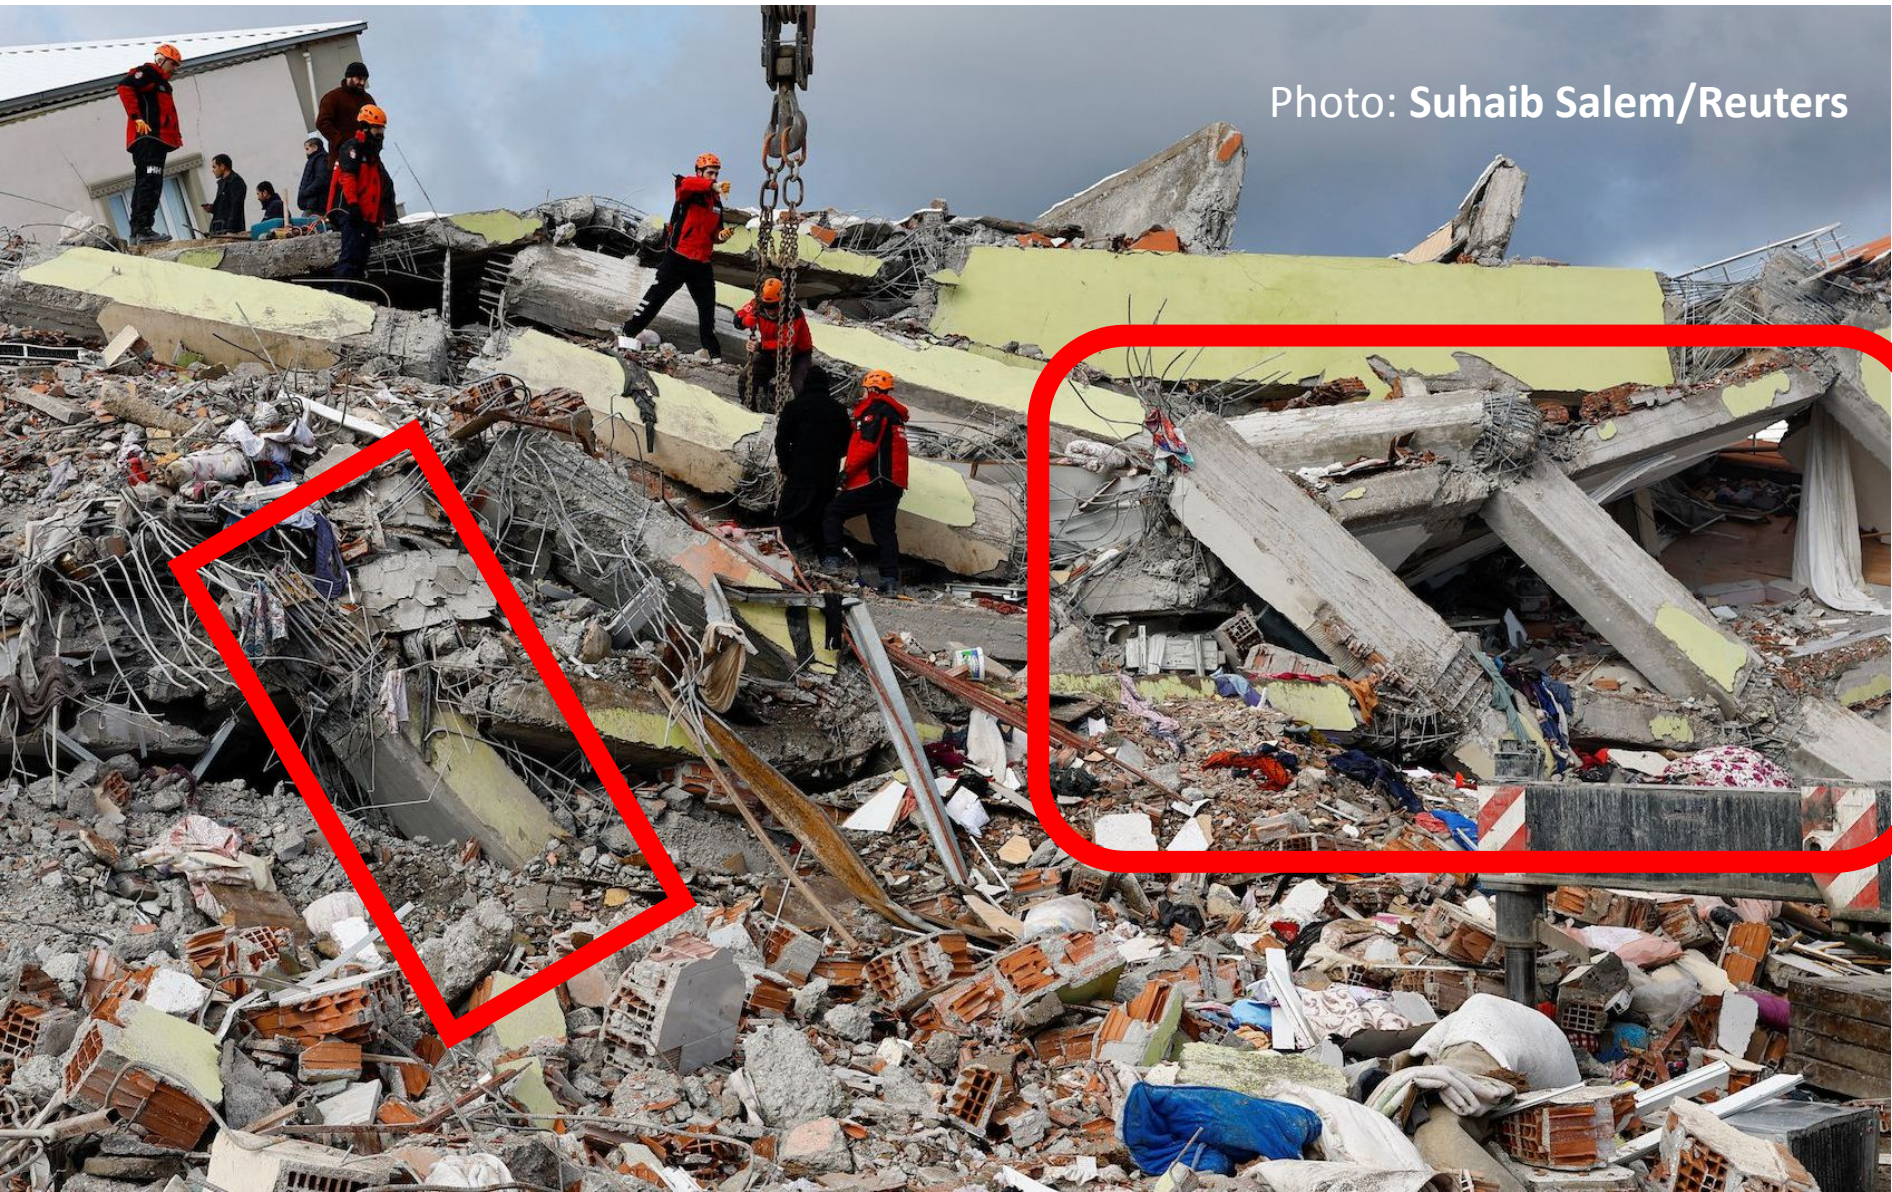
Transverse reinforcement almost effectively non-existing... it was untied, leading the inadequate longitudinal rebars to buckle.

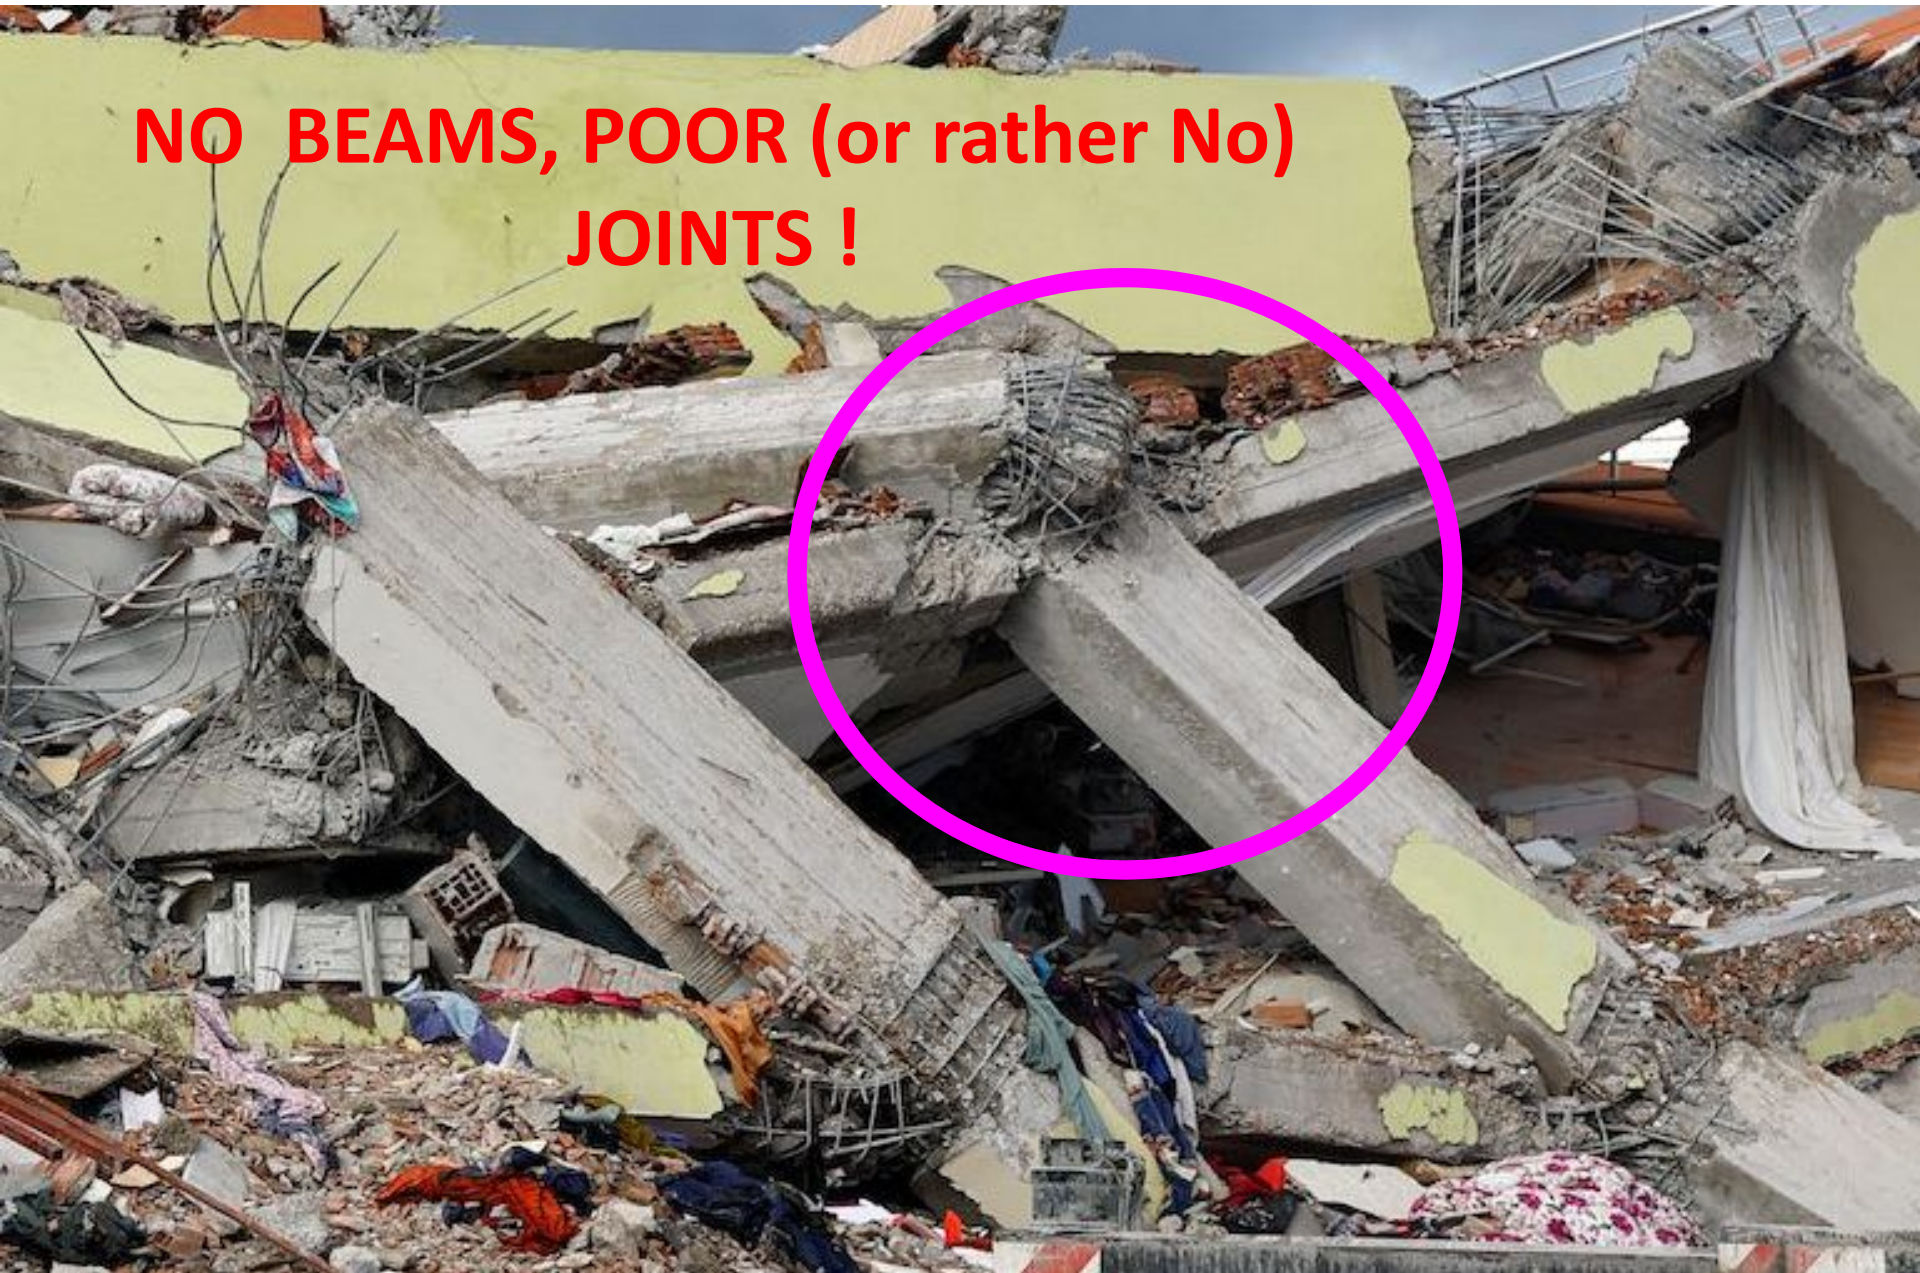
**Transverse bars
were un-tied.**

**Longitudinal
REBARS are of
VERY SMALL
DIAMETER**

**NO BEAMS, POOR (or rather No)
JOINTS !**

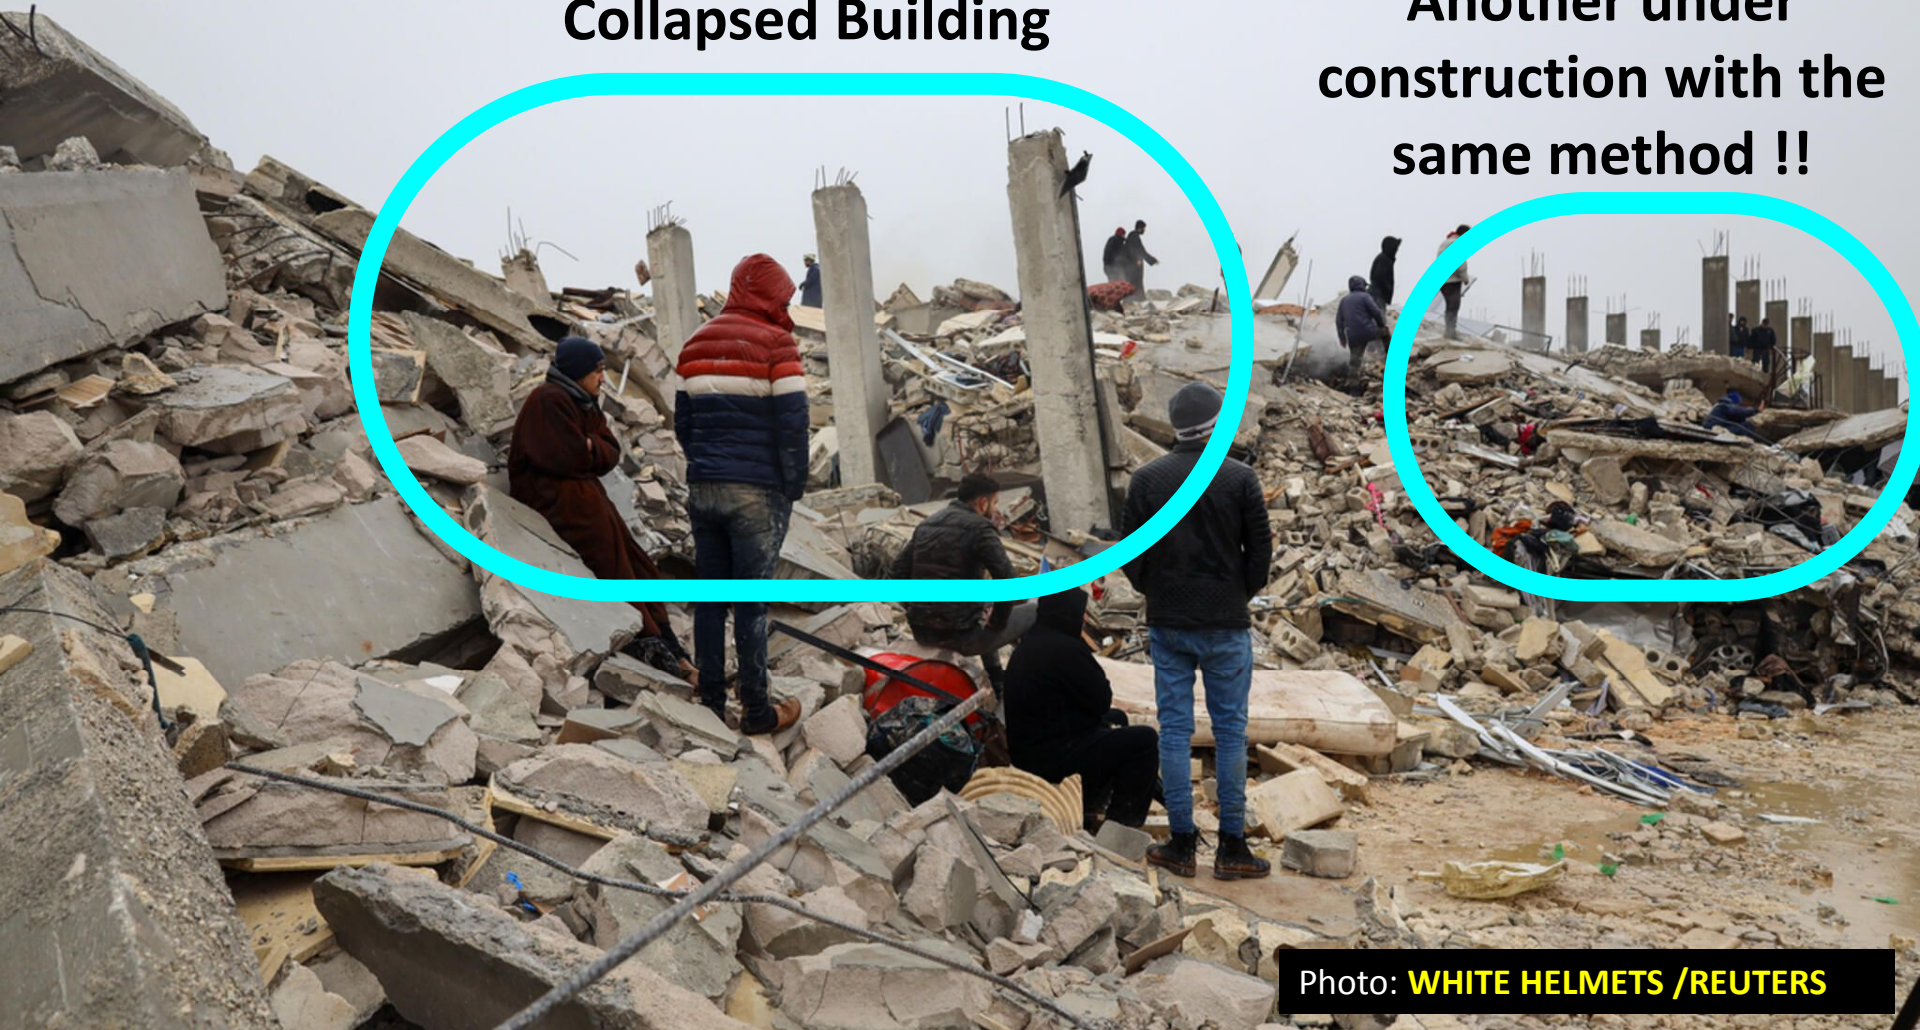
The next one

Collapsed Building

**Another under
construction with the
same method !!**

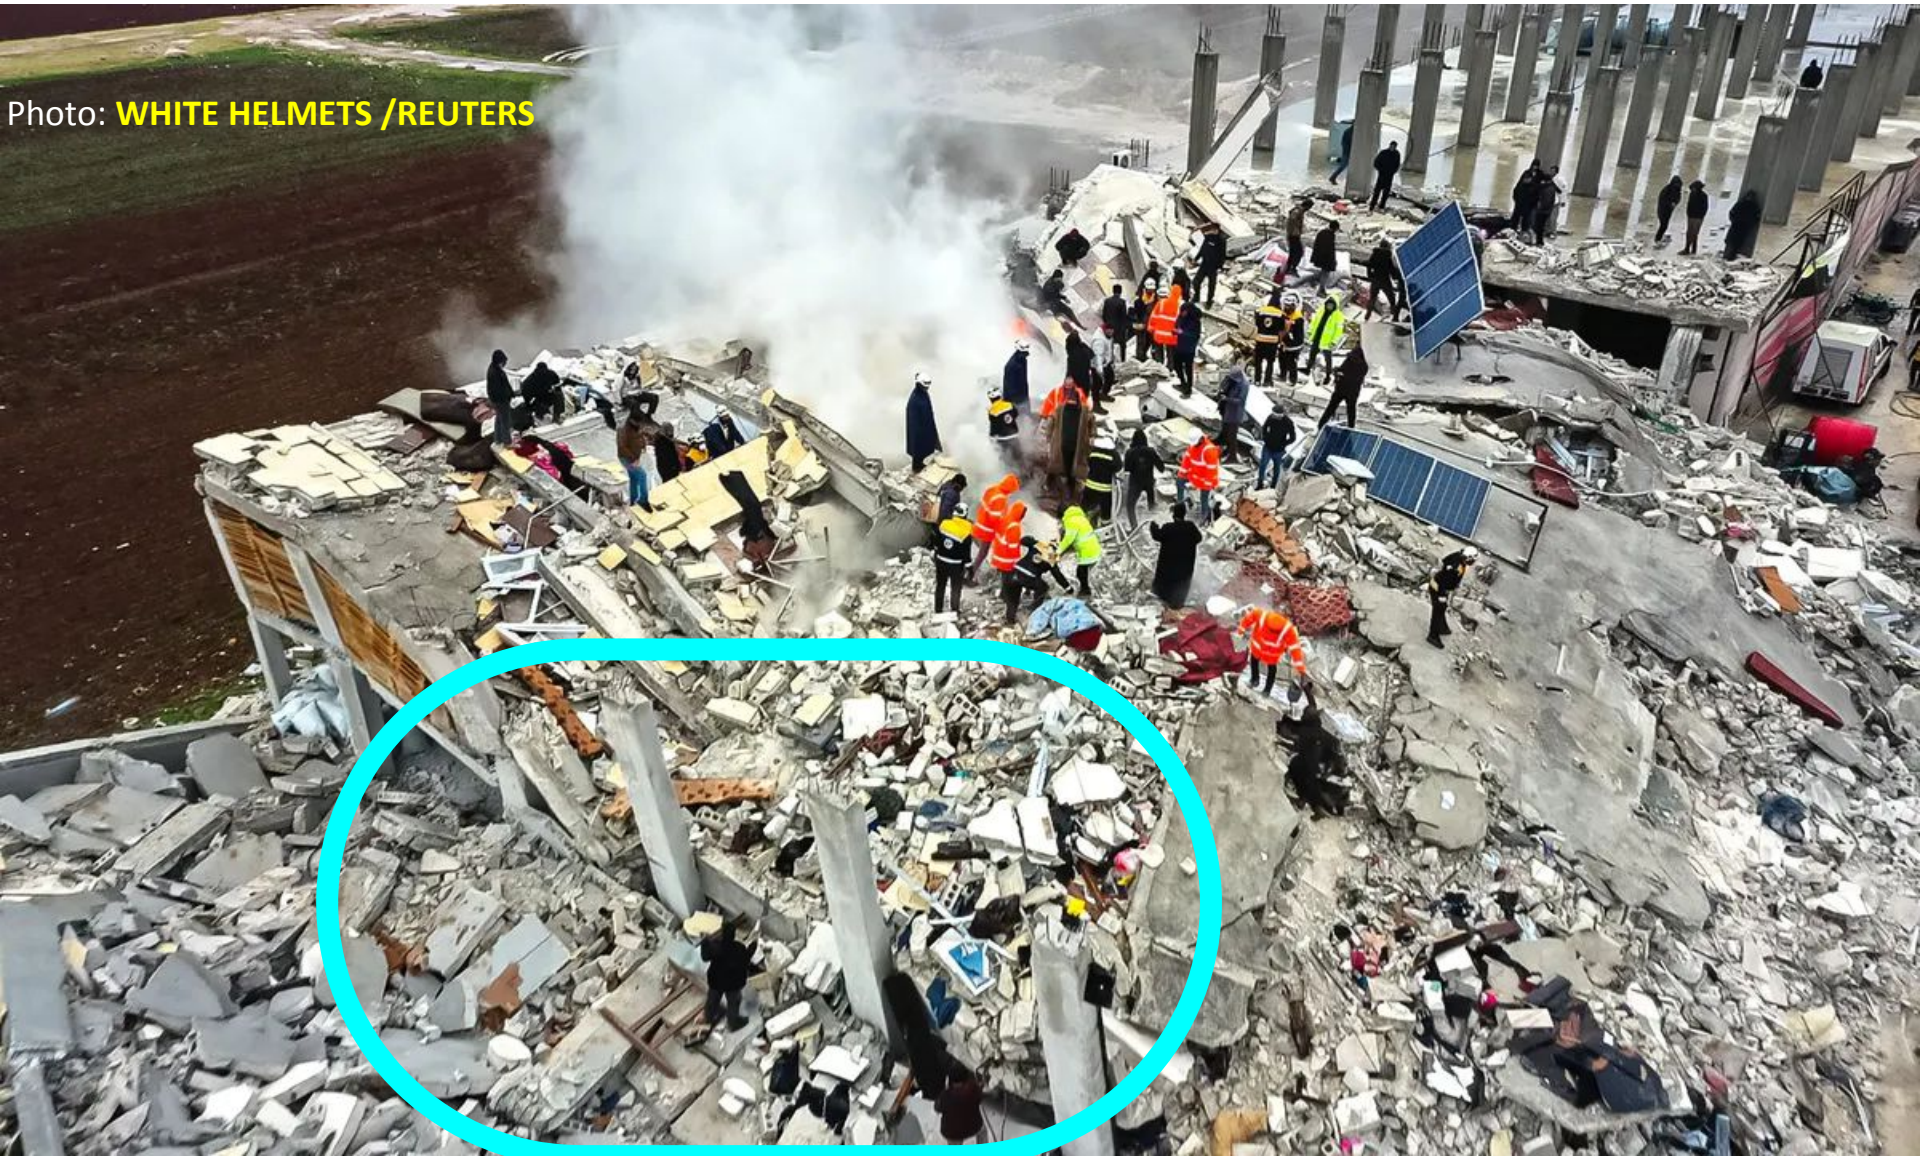
Same building seen from a different angle

NO BEAMS, POOR JOINTS !

**VERY FEW
REBARS OF
VERY SMALL
DIAMETER**

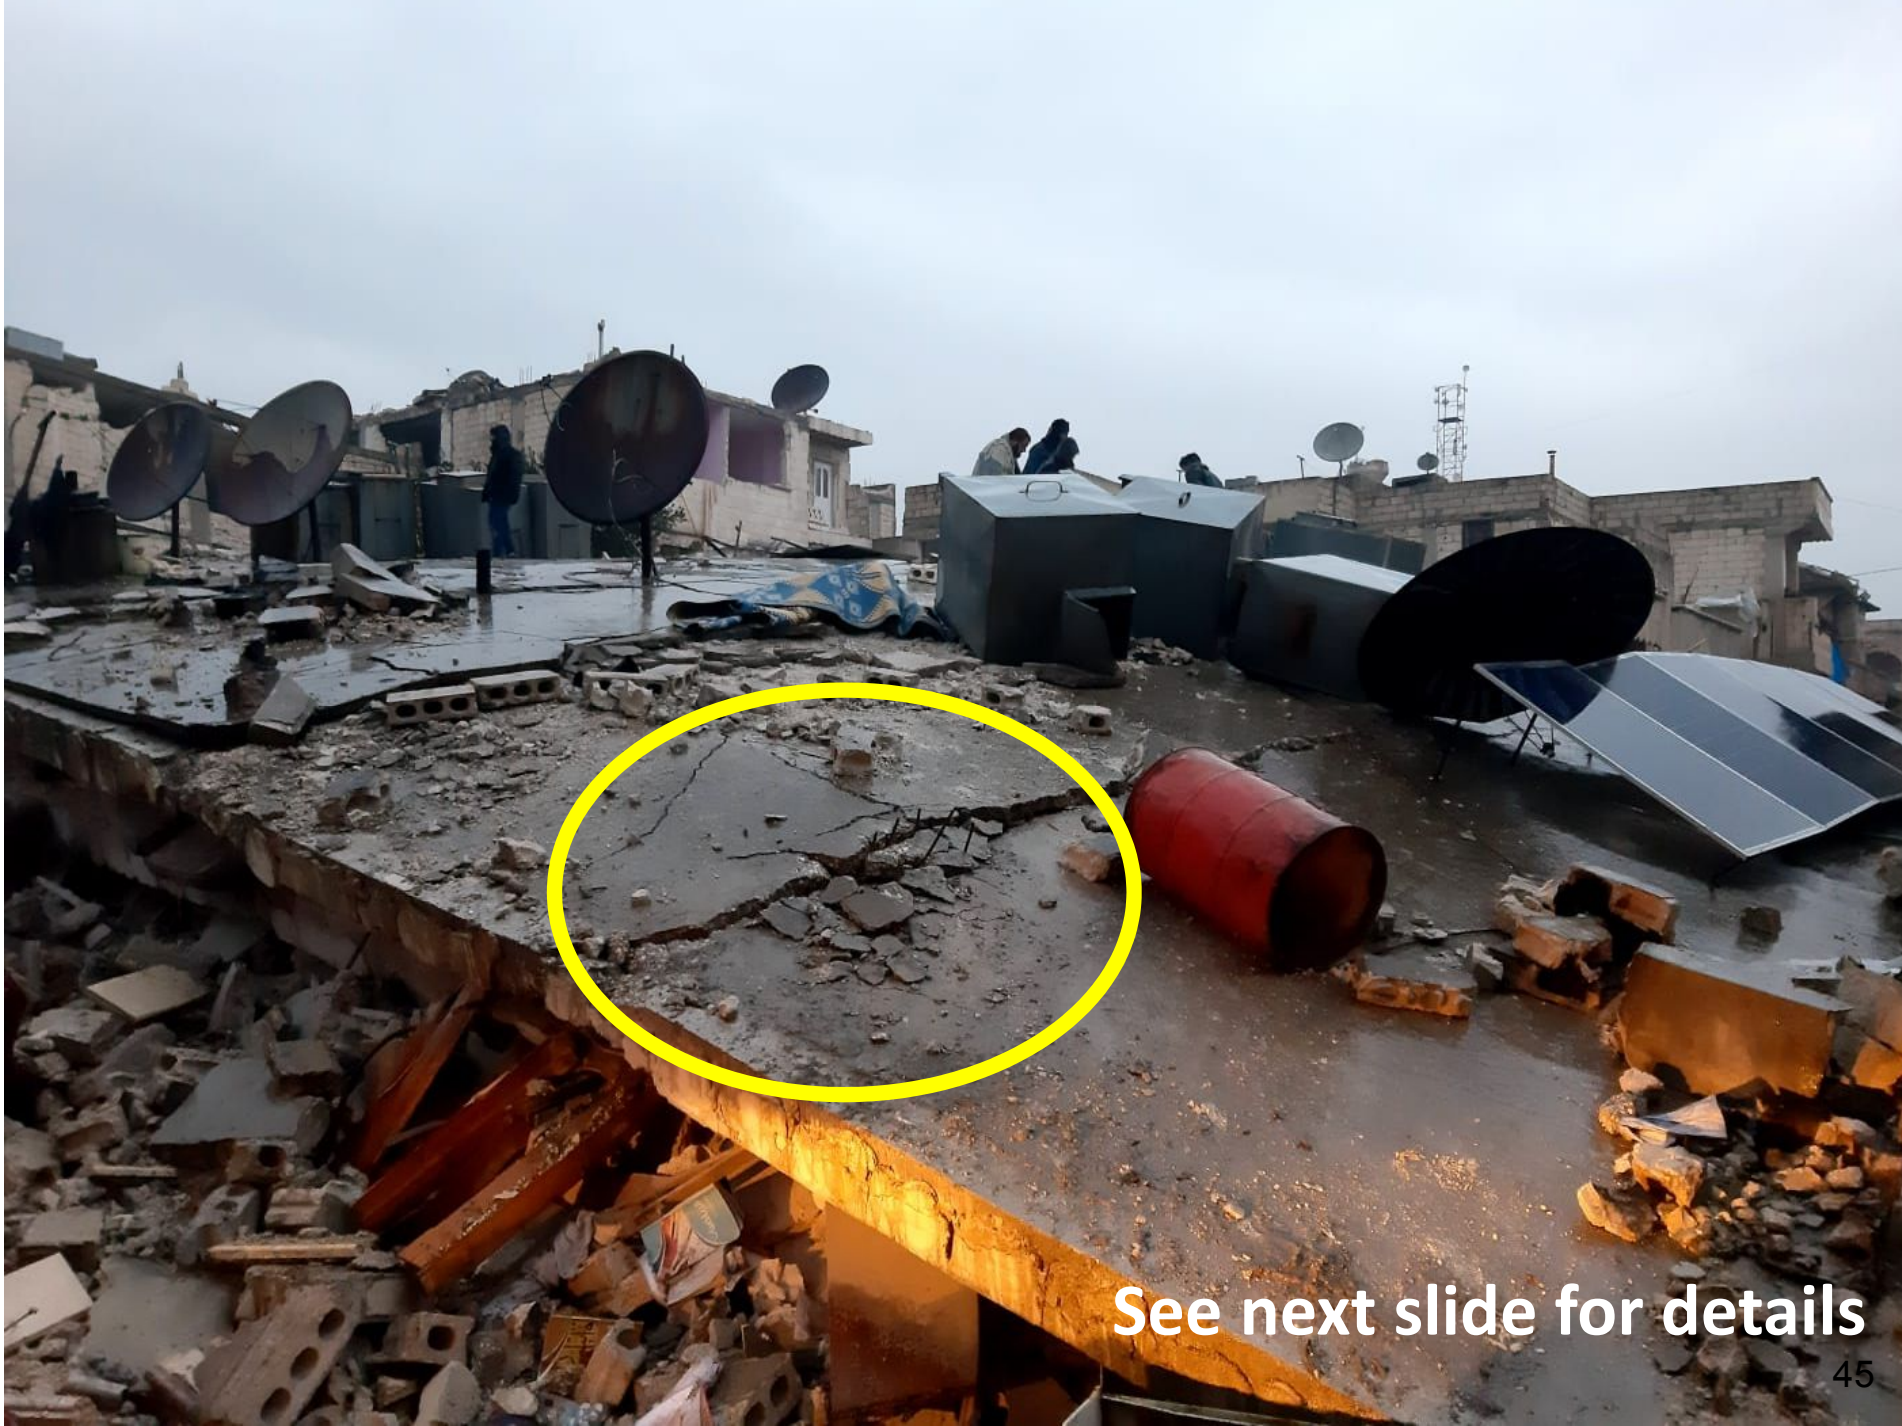
**VERY THIN COLUMNS
NO BEAMS
POOR JOINTS**

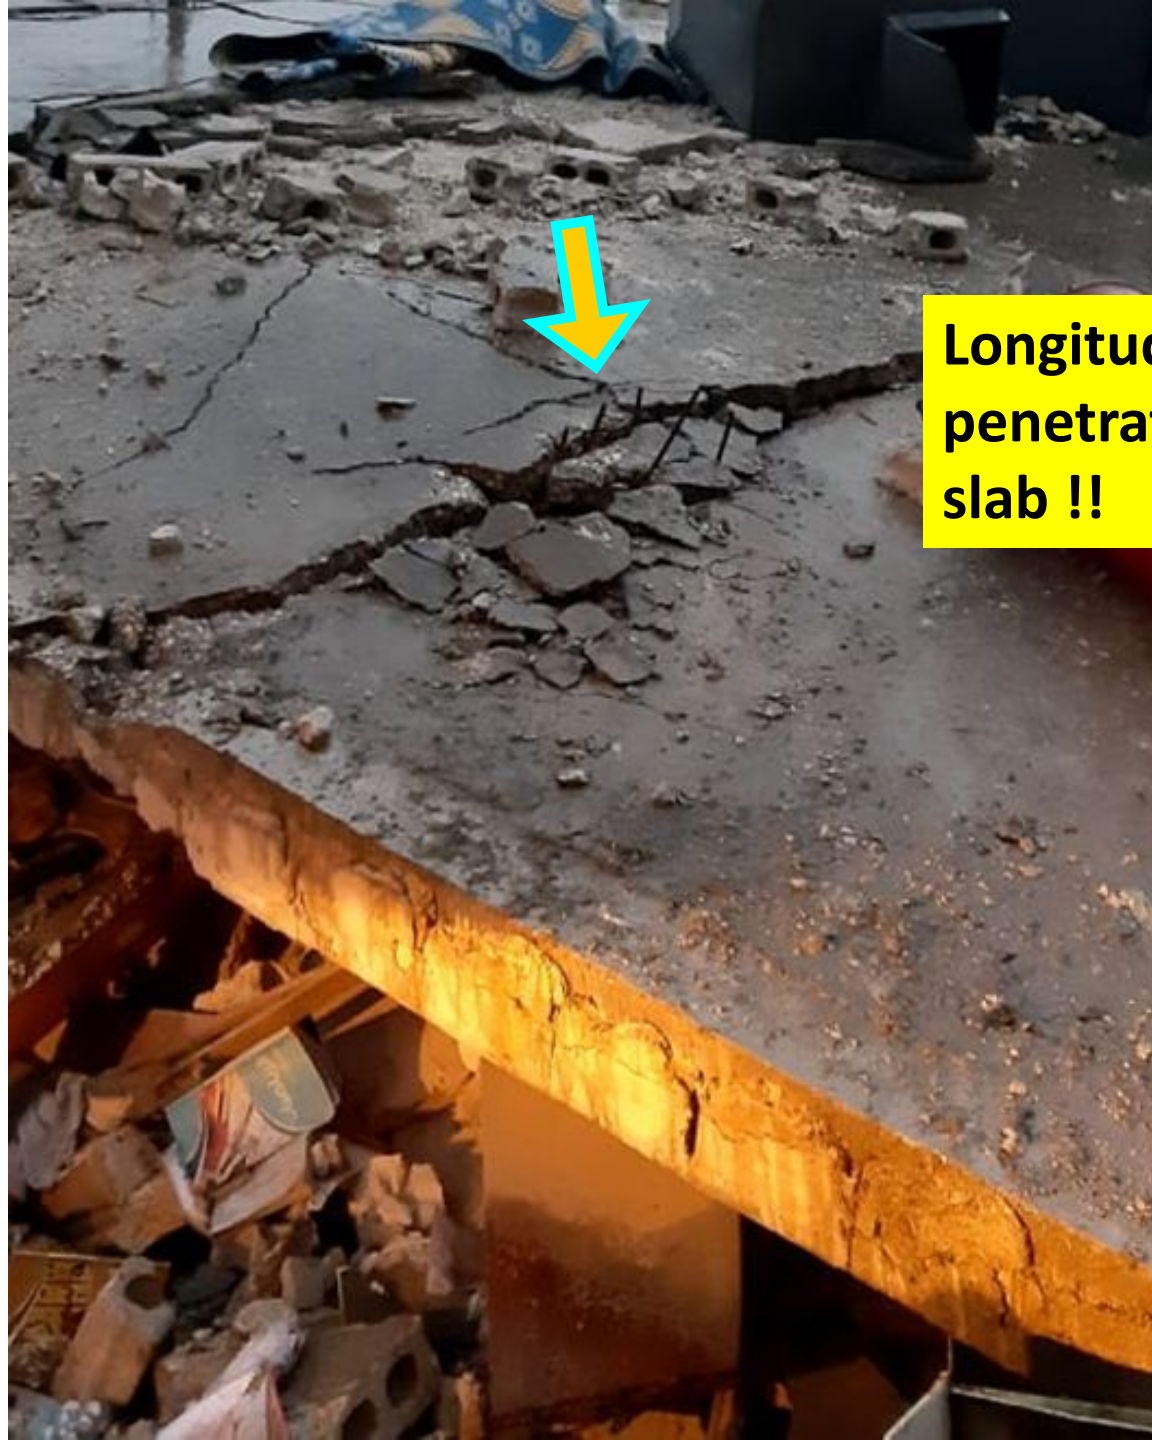
**Longitudinal REBARS have
penetrated the supported
slab !!**
