The 2 earthquakes of February 6th 2023 in Turkey

Preliminary Report

Failures of Multistorey Buildings in Turkey and Syria Due to the M 7.8 and M 7.5 Earthquakes

PART B: Structural Collapse and Interpretation

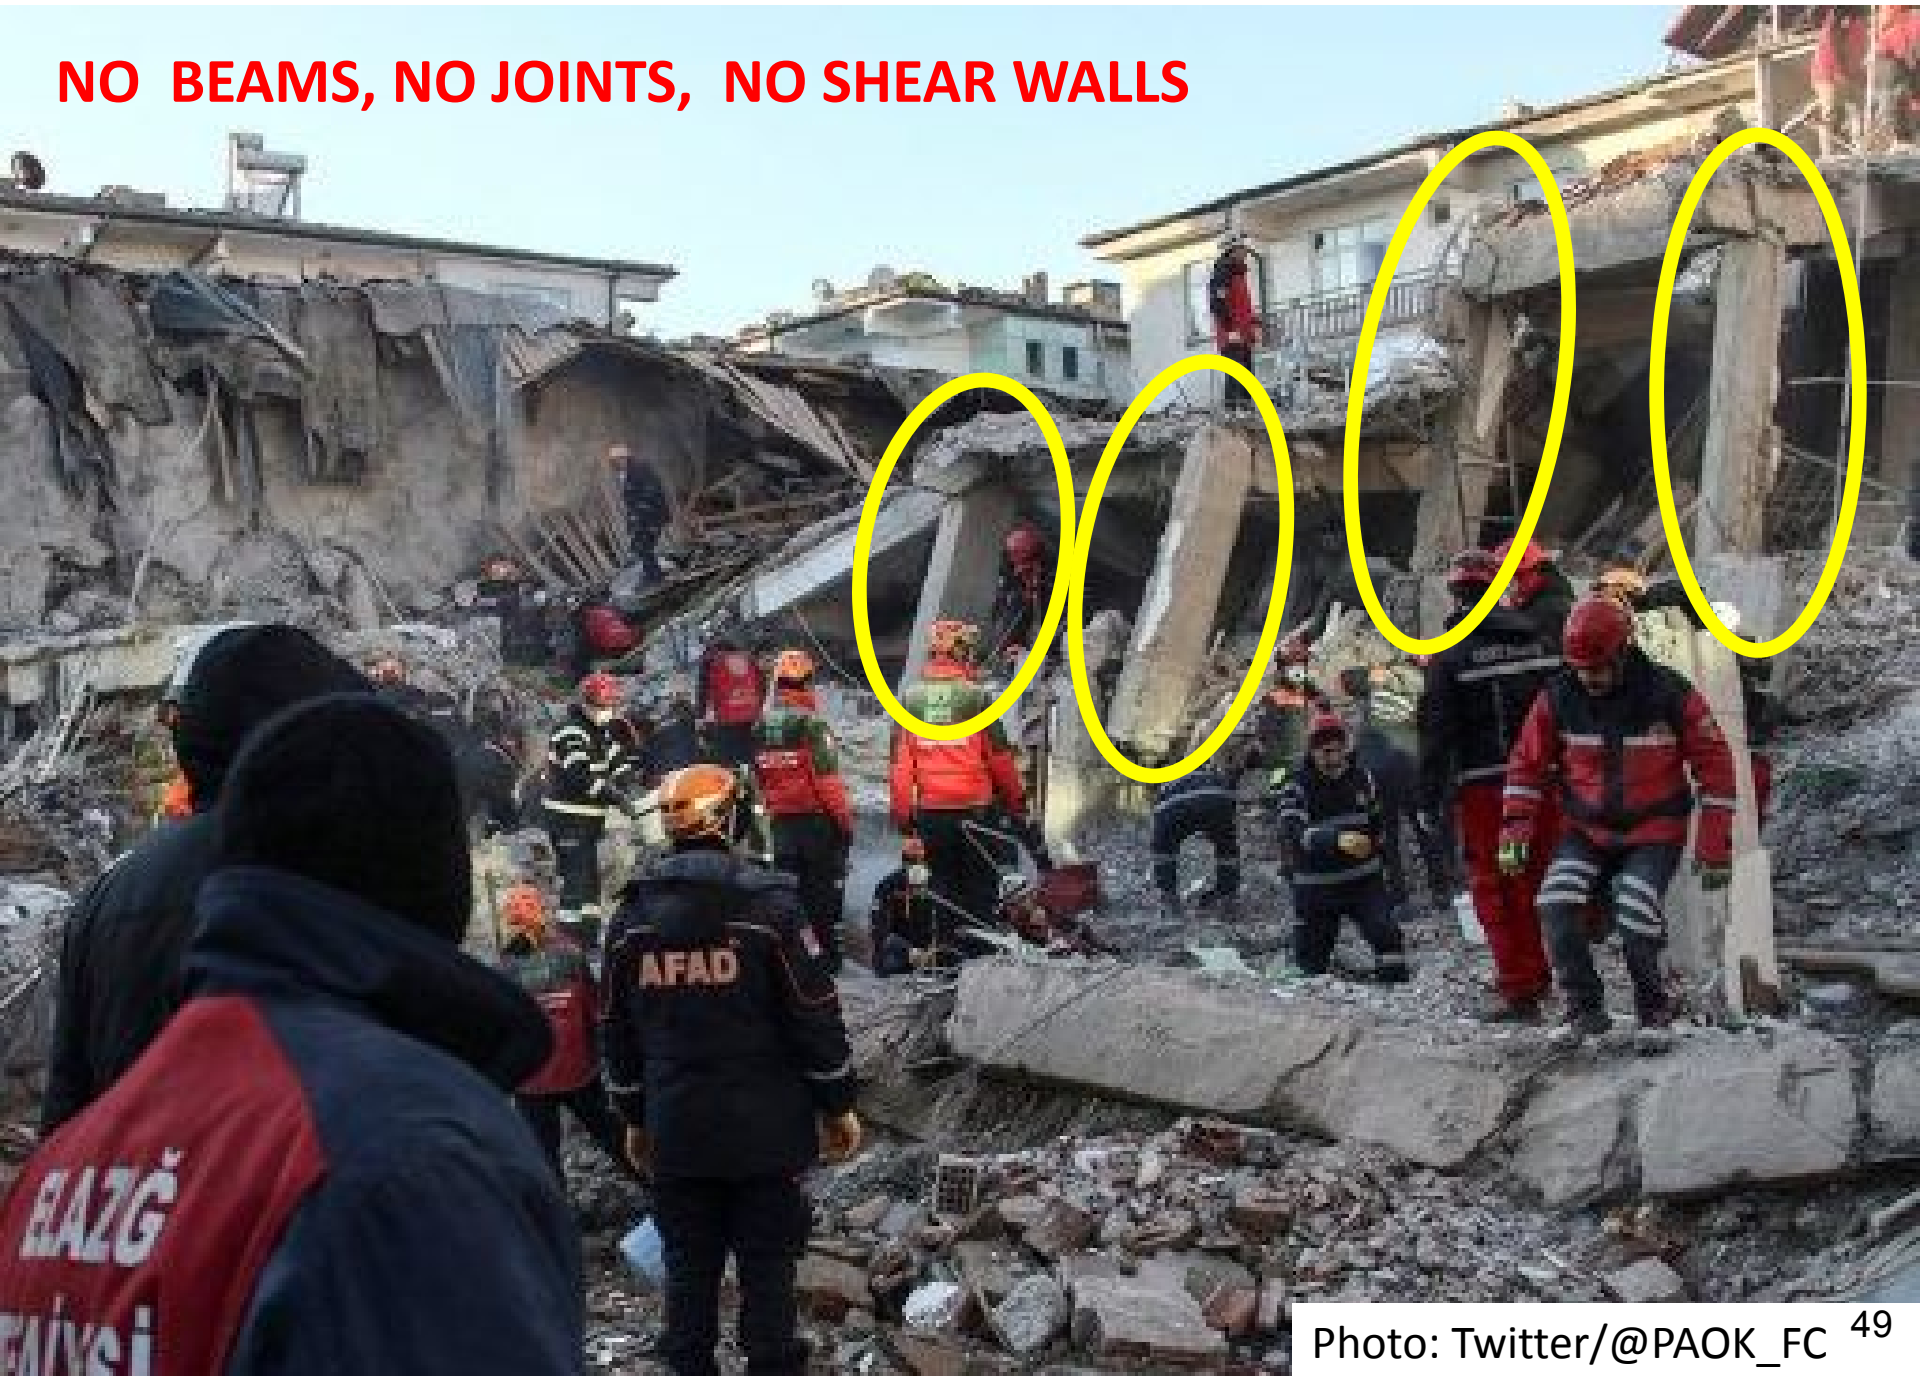
NO BEAMS, NO JOINTS, NO SHEAR WALLS

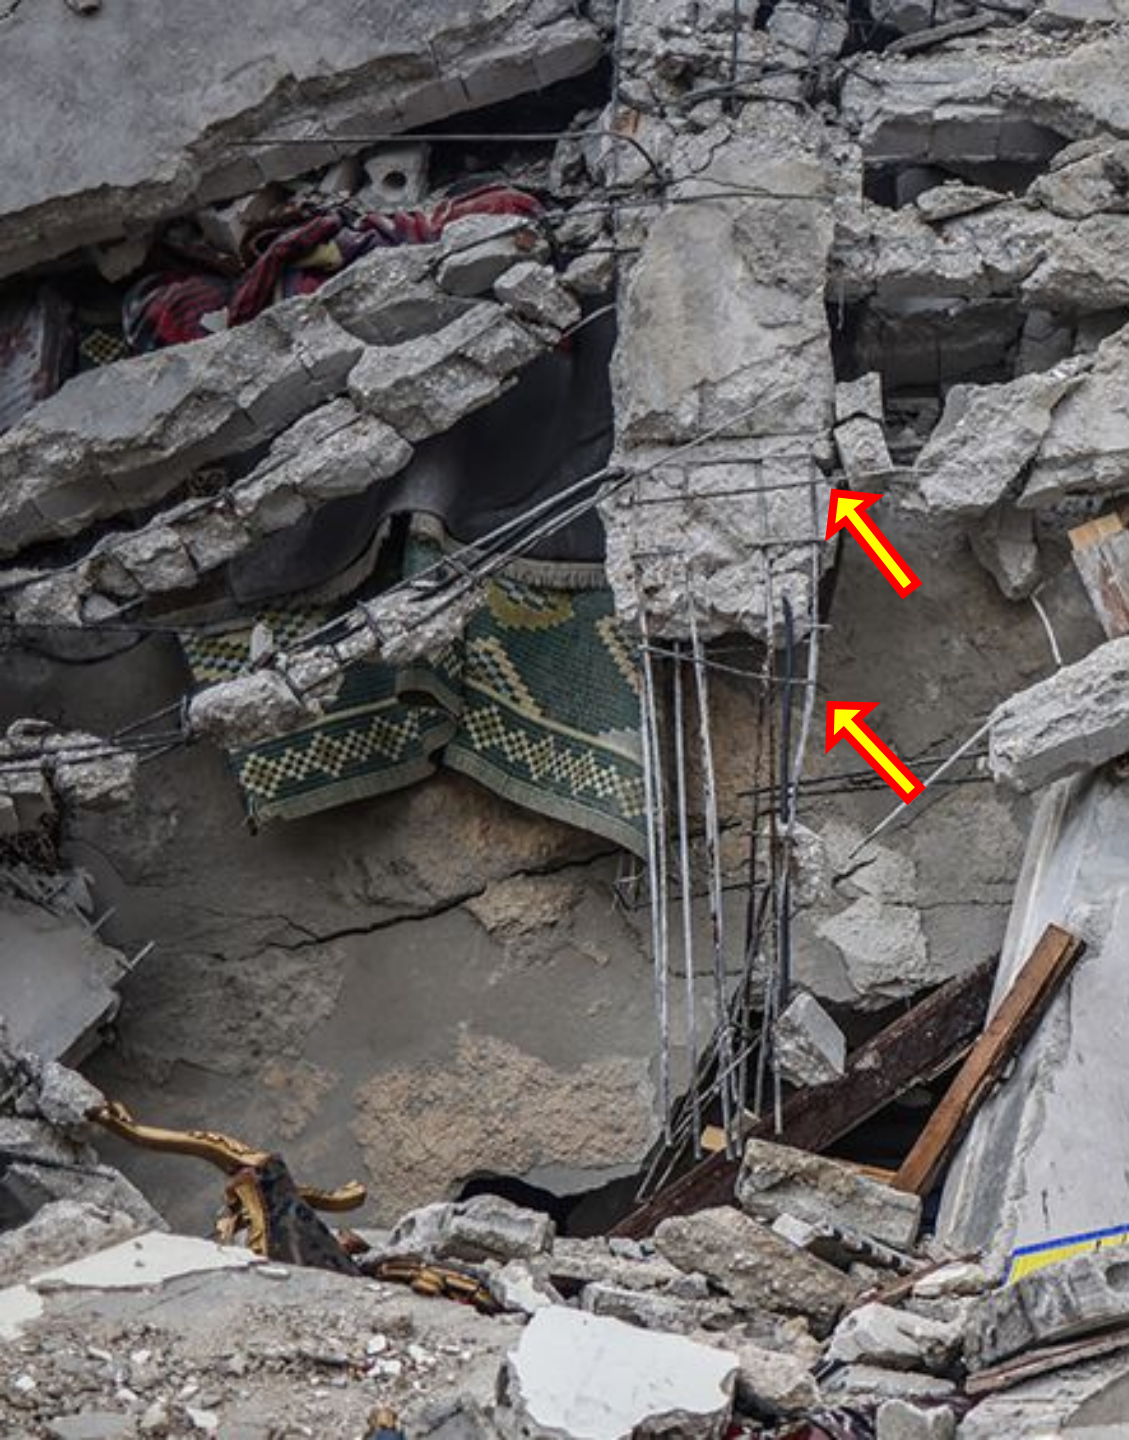
**FEW LONGITUDINAL REBARS,
OF VERY SMALL DIAMETER**

Transverse reinforcement ??

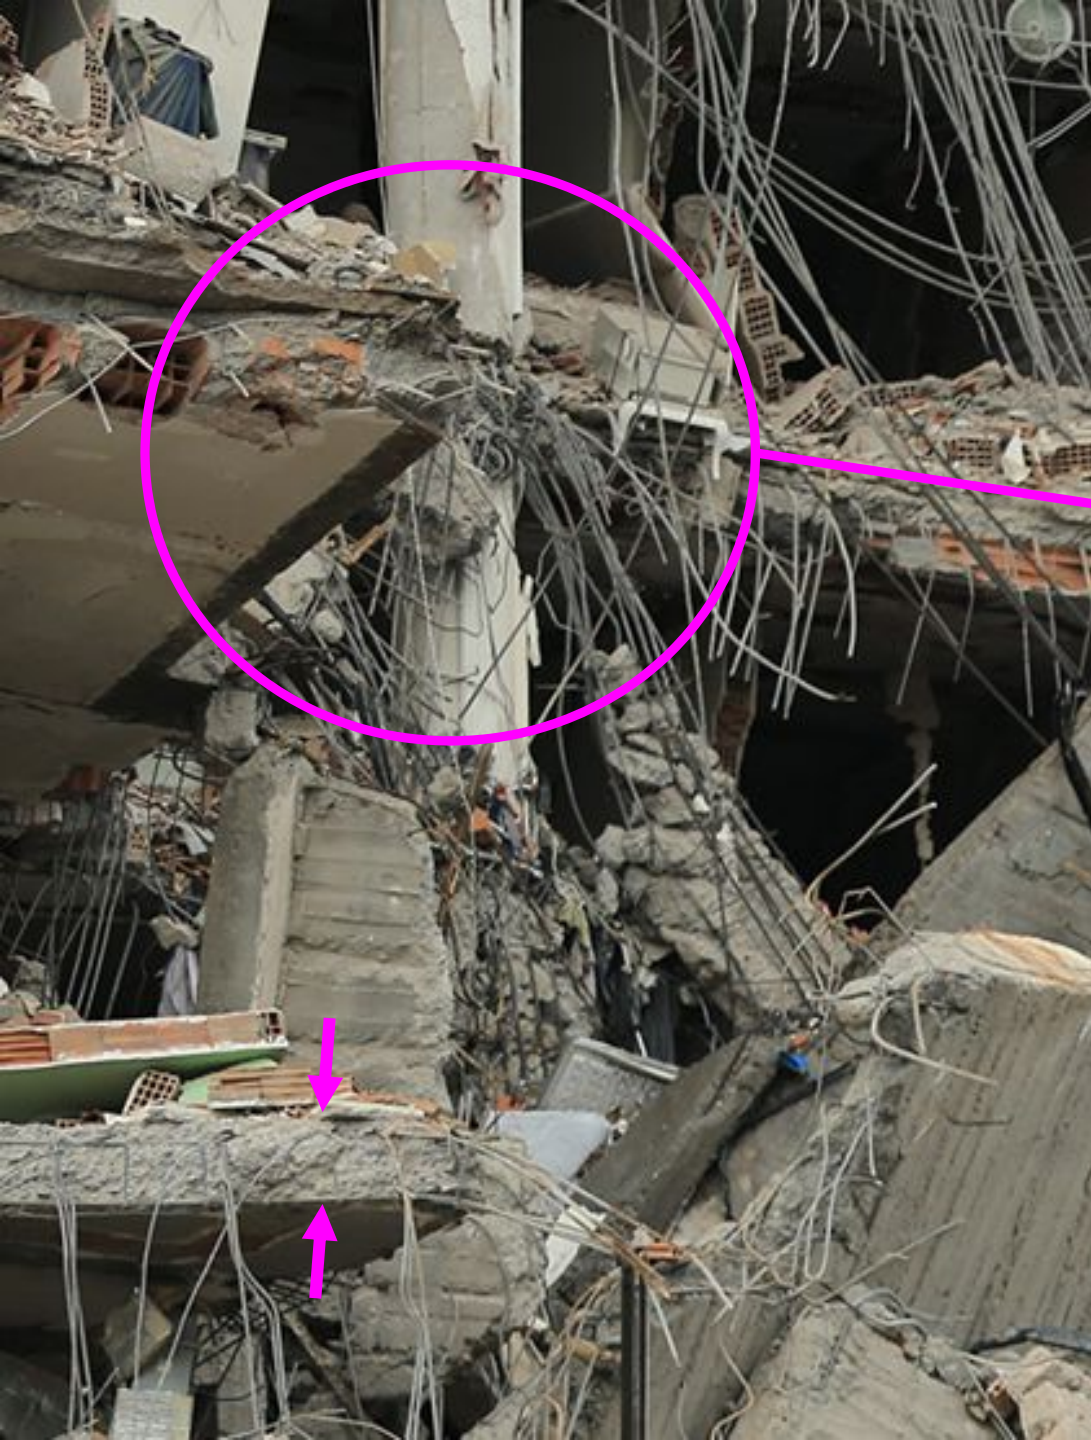
NO BEAMS, POOR JOINTS !

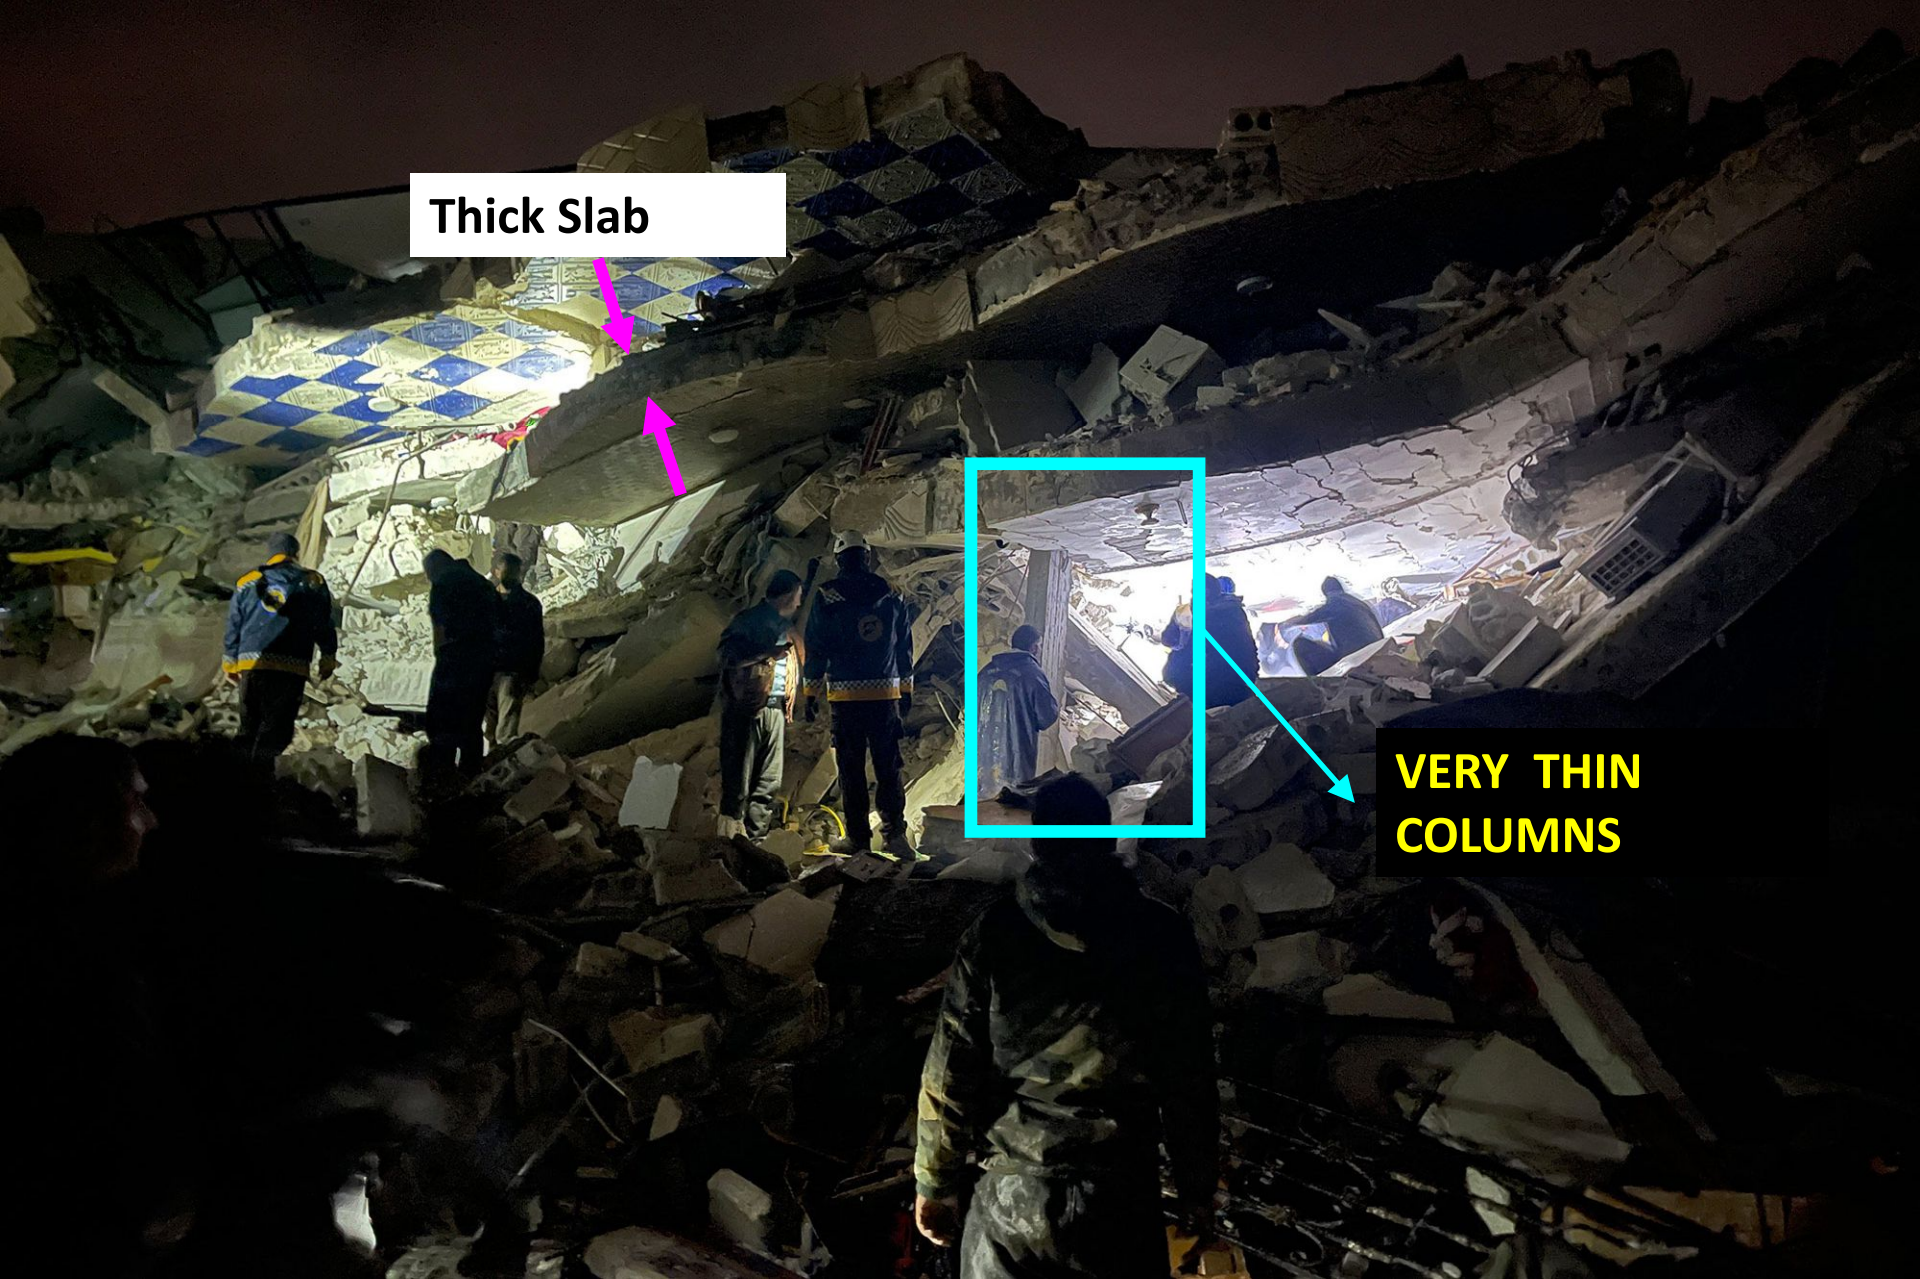
NO BEAMS, POOR JOINTS !

Rubbles of a collapsed building in Idlib, Syria, on February 6. (Aaref Watad/AFP/Getty Images)

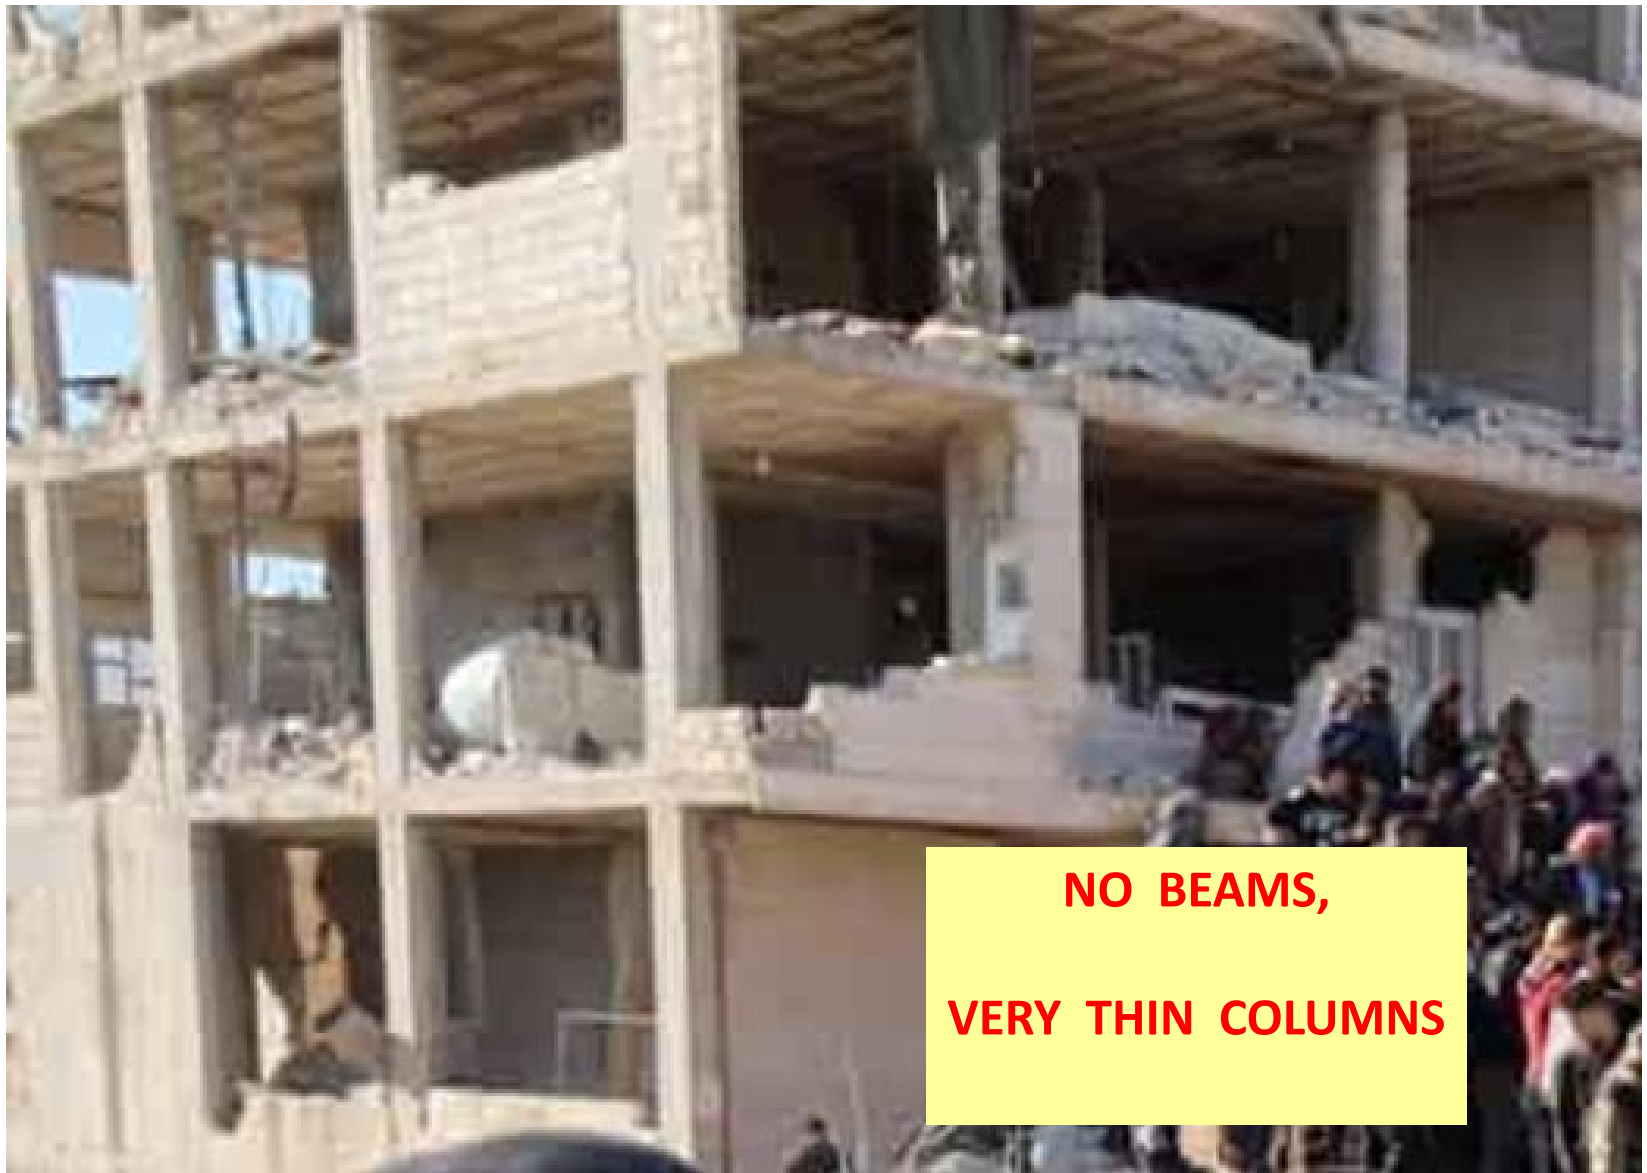
without any beams, with small size columns (inappropriate even for 1-story buildings in a region of moderate seismicity). It is a miracle that it did not fully collapsed.

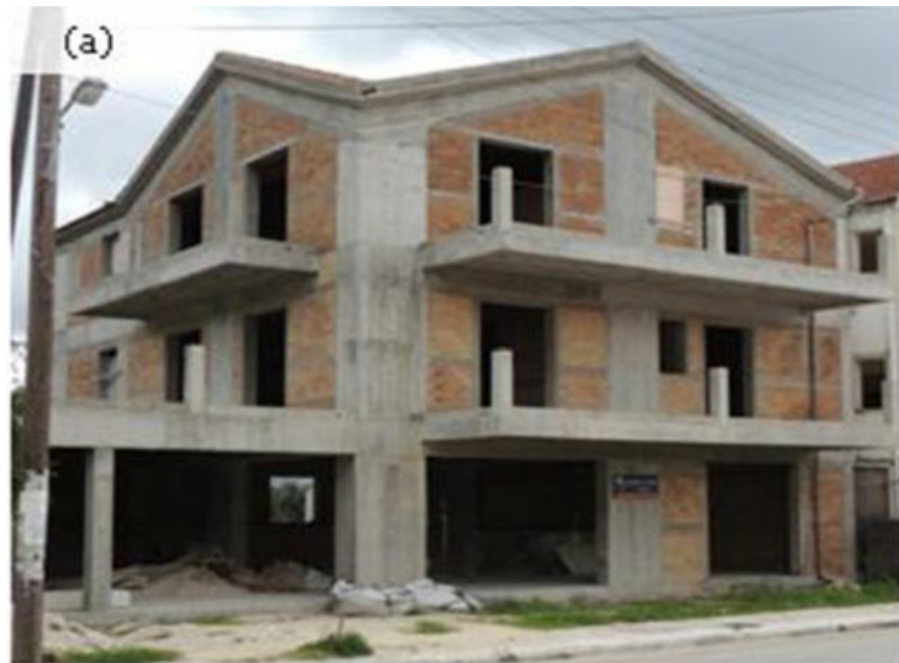
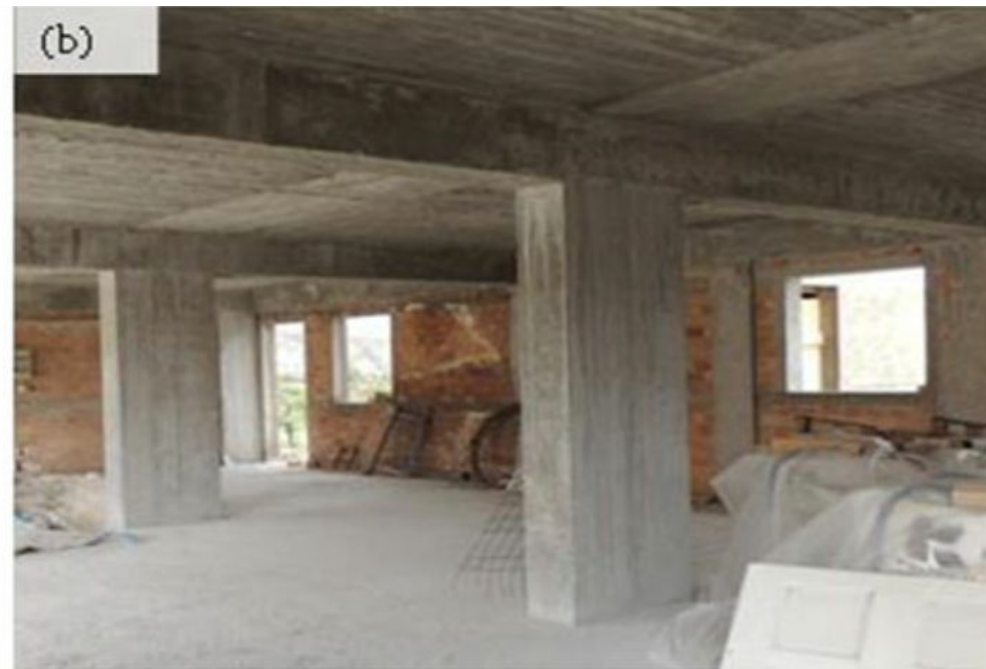
VISUAL COMPARISON with an UNDER-CONSTRUCTION 2-STORY BUILDING in CEPHALONIA, after two Earthquakes in 2014

Large shear walls, strong beams, brick masonry well-confined (with RC ties around openings and at mid-height).

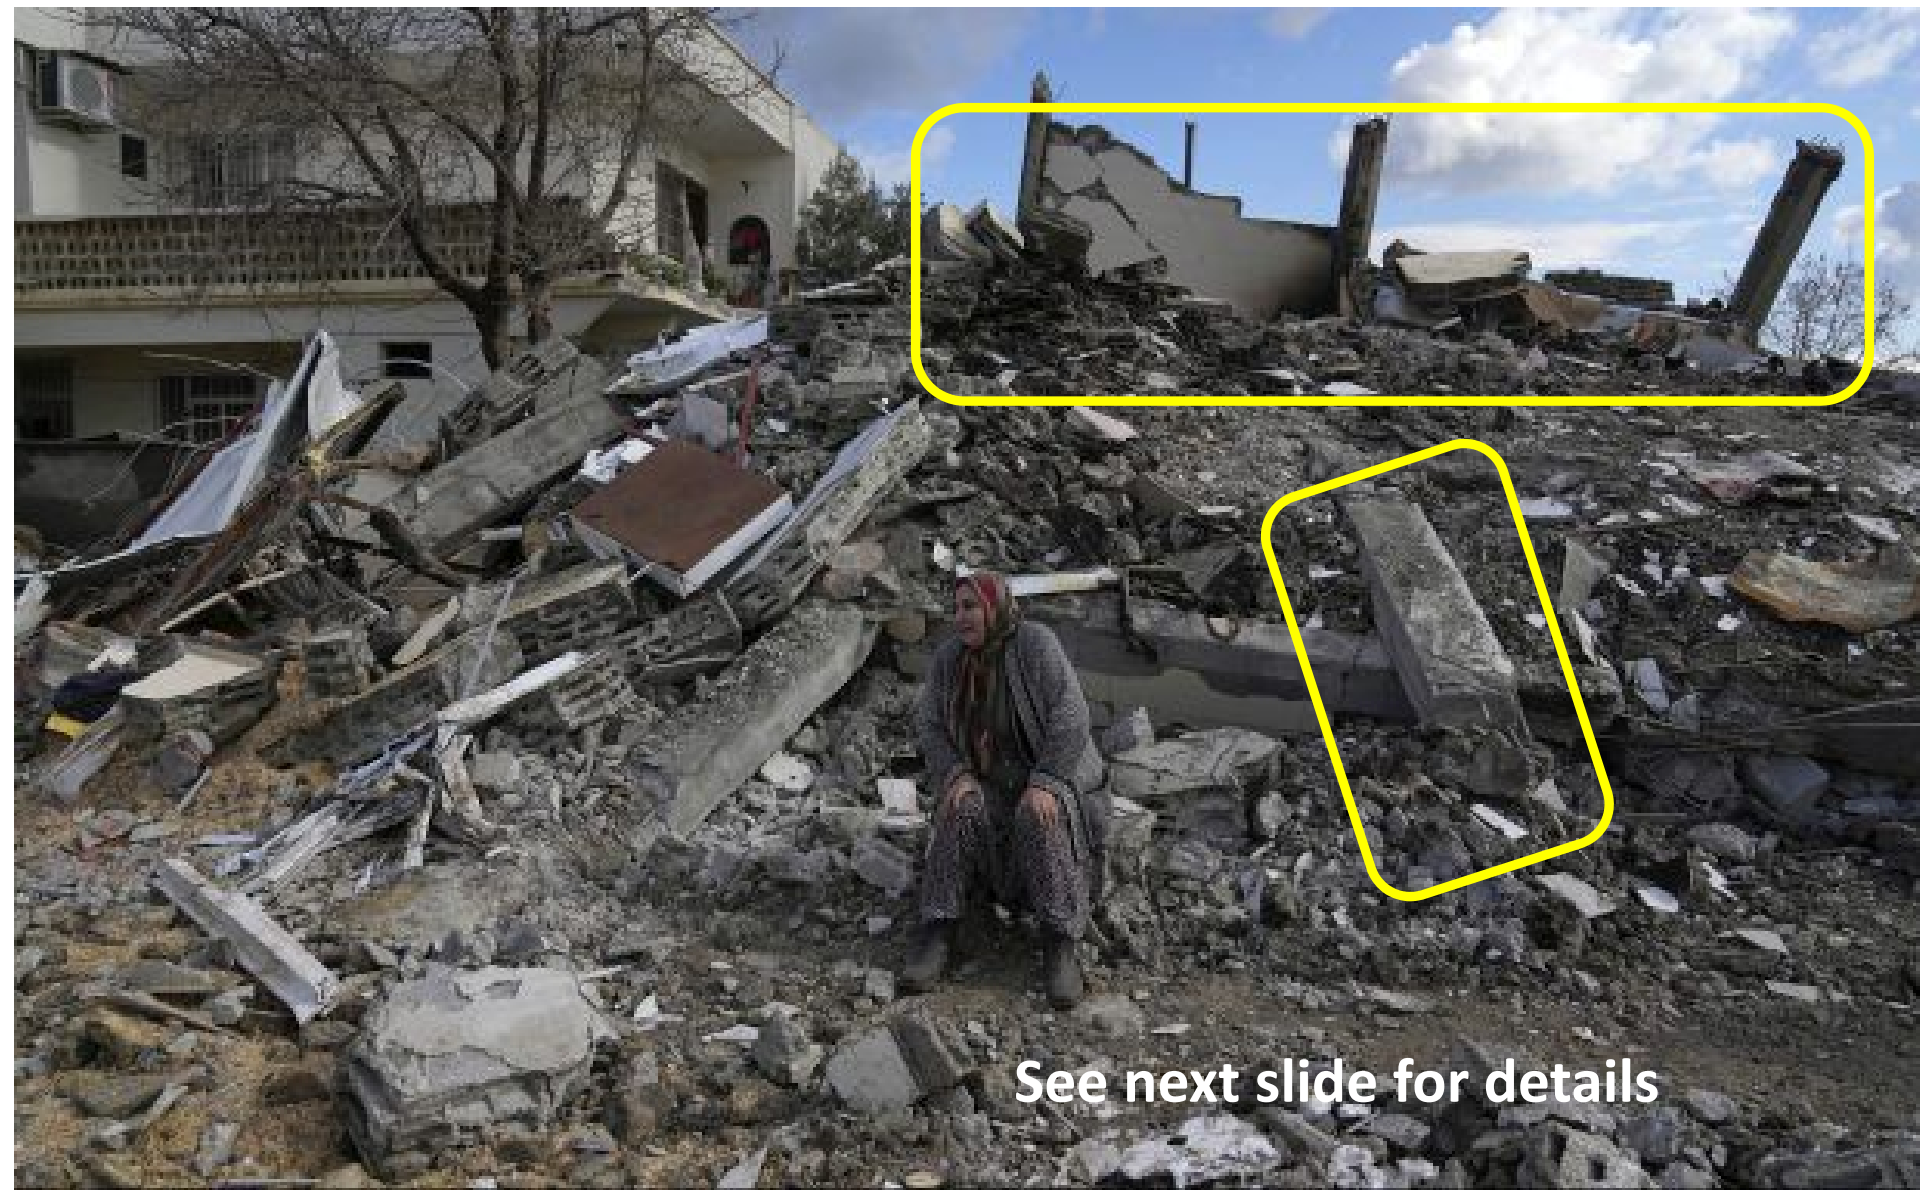
A woman sits on the rubble of a destroyed building in Nurdagi town on the outskirts of Osmaniye city southern Turkey, Tuesday, Feb. 7, 2023. **(AP Photo/Khalil Hamra)**

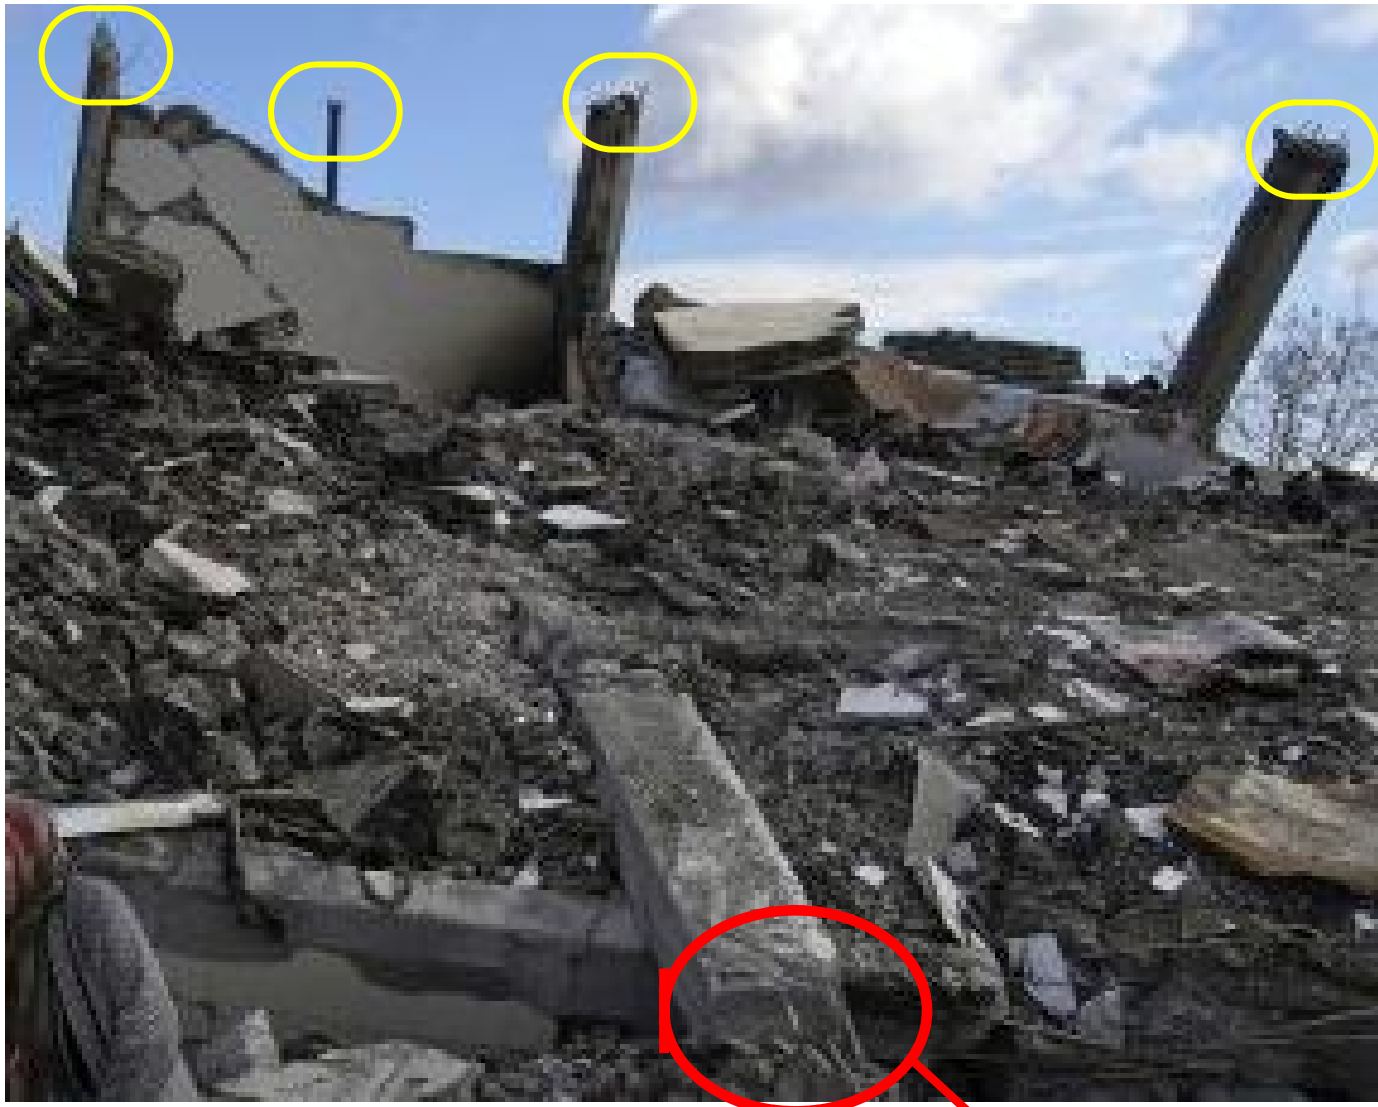
VERY FEW REBARS OF VERY SMALL DIAMETER

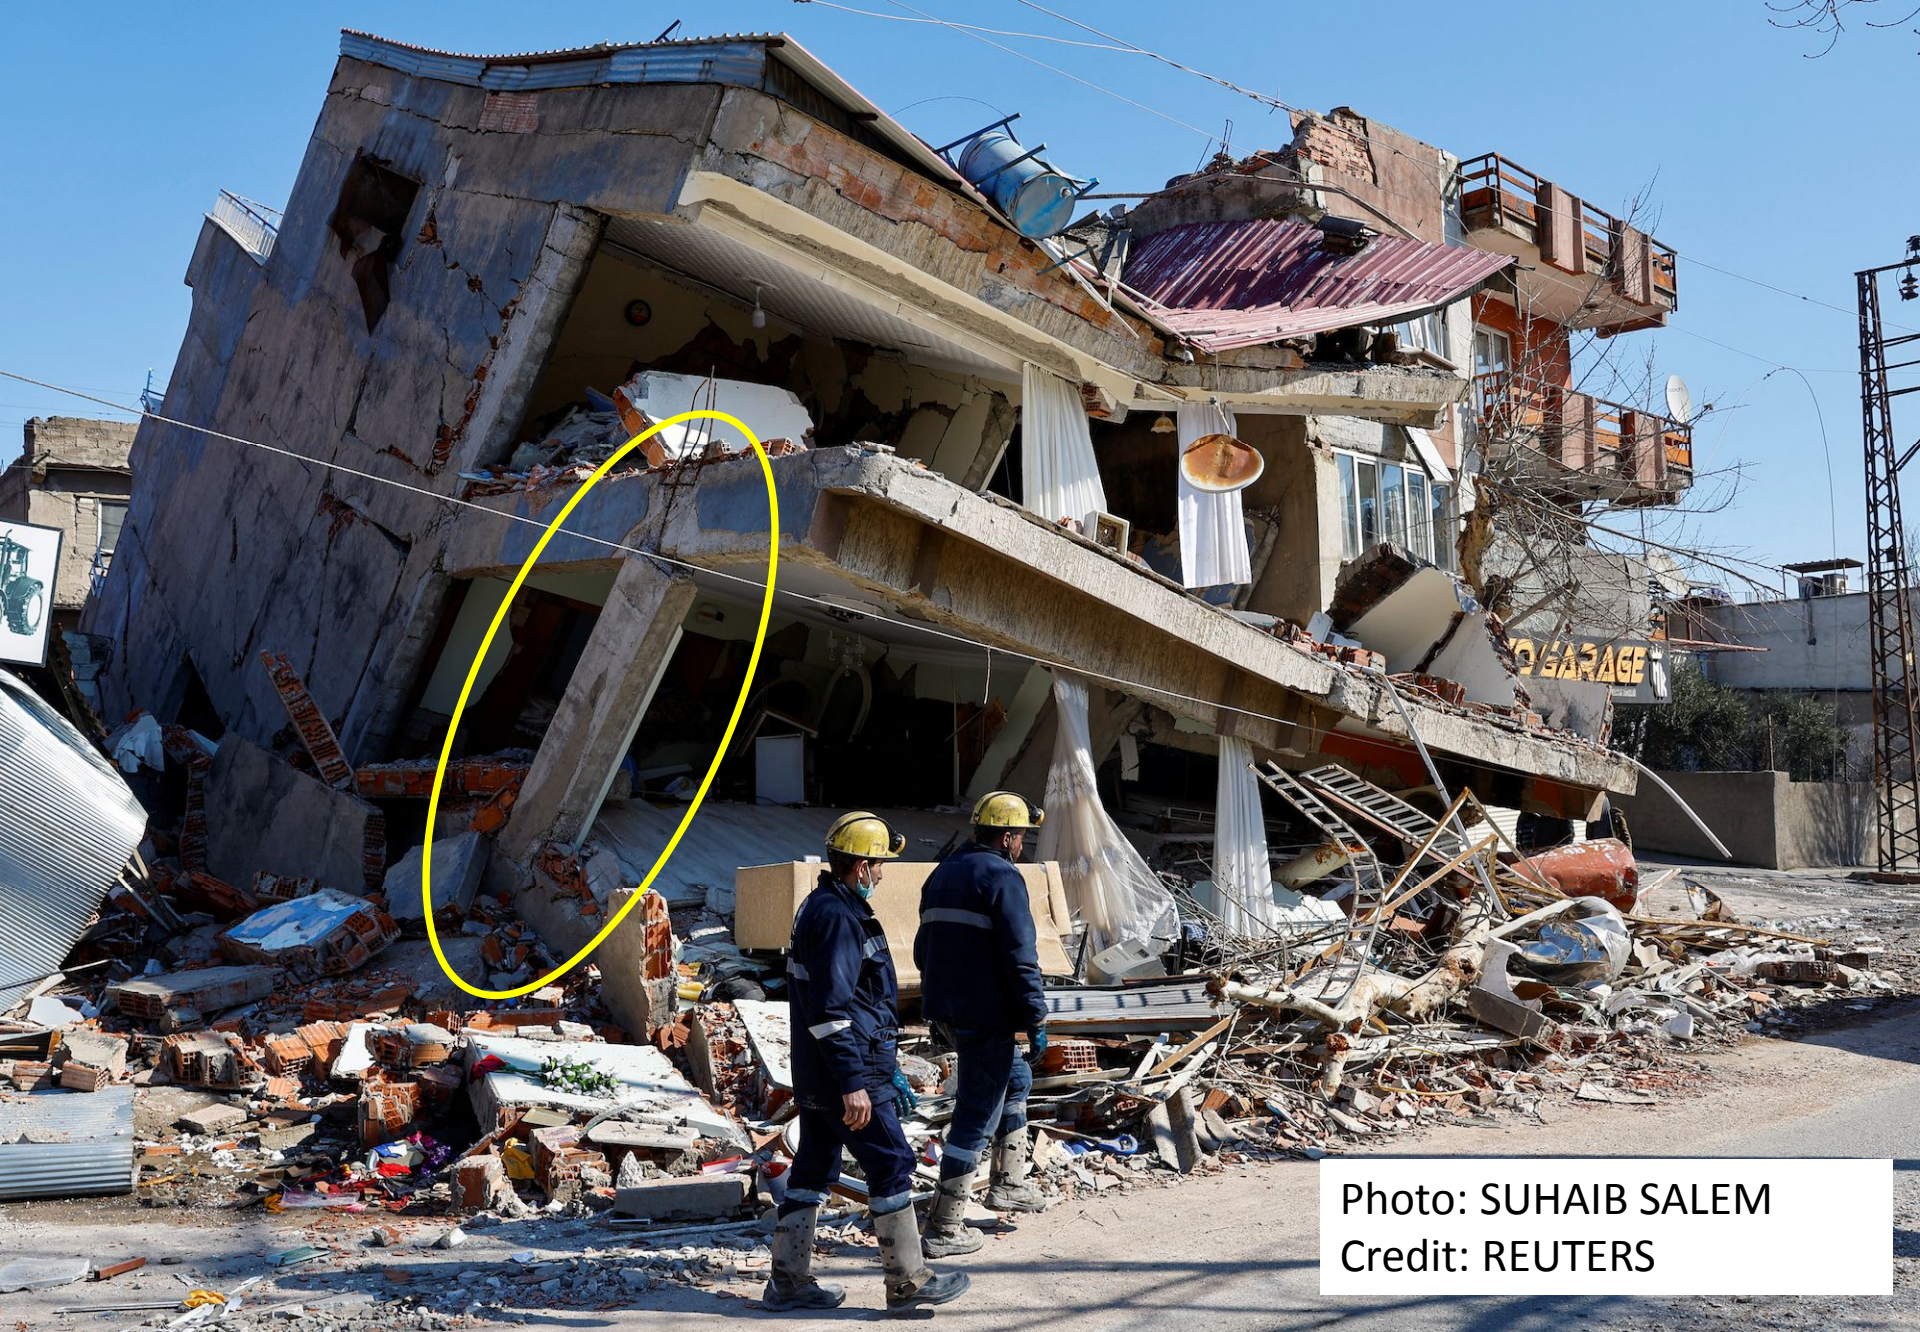
THICK SLAB

NO BEAMS,
POOR JOINTS !

NO SLAB-COLUMN JOINT

NO BEAMS

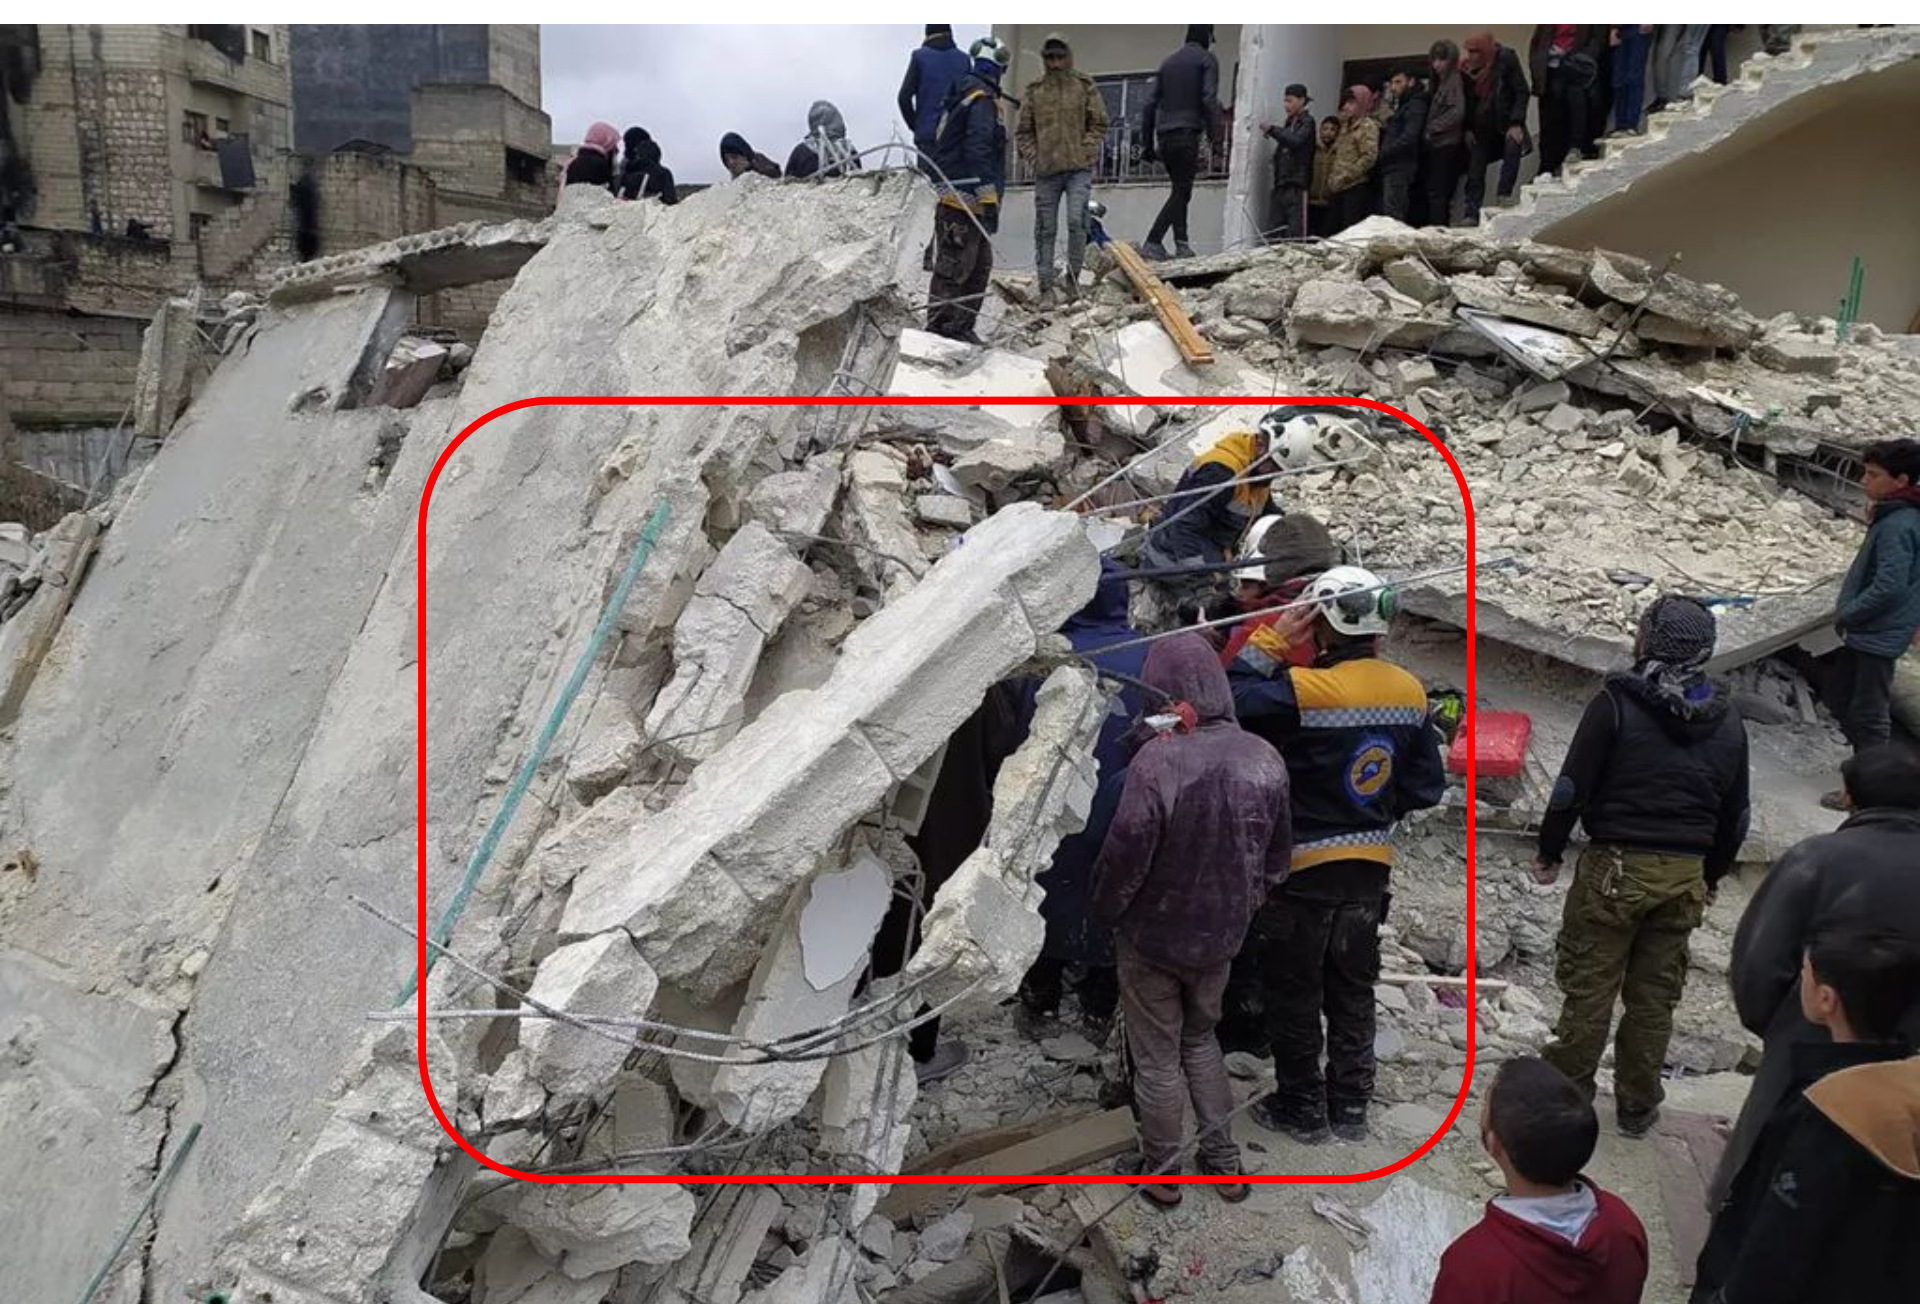
THIN COLUMNS

Forget about transverse reinforcement !!!

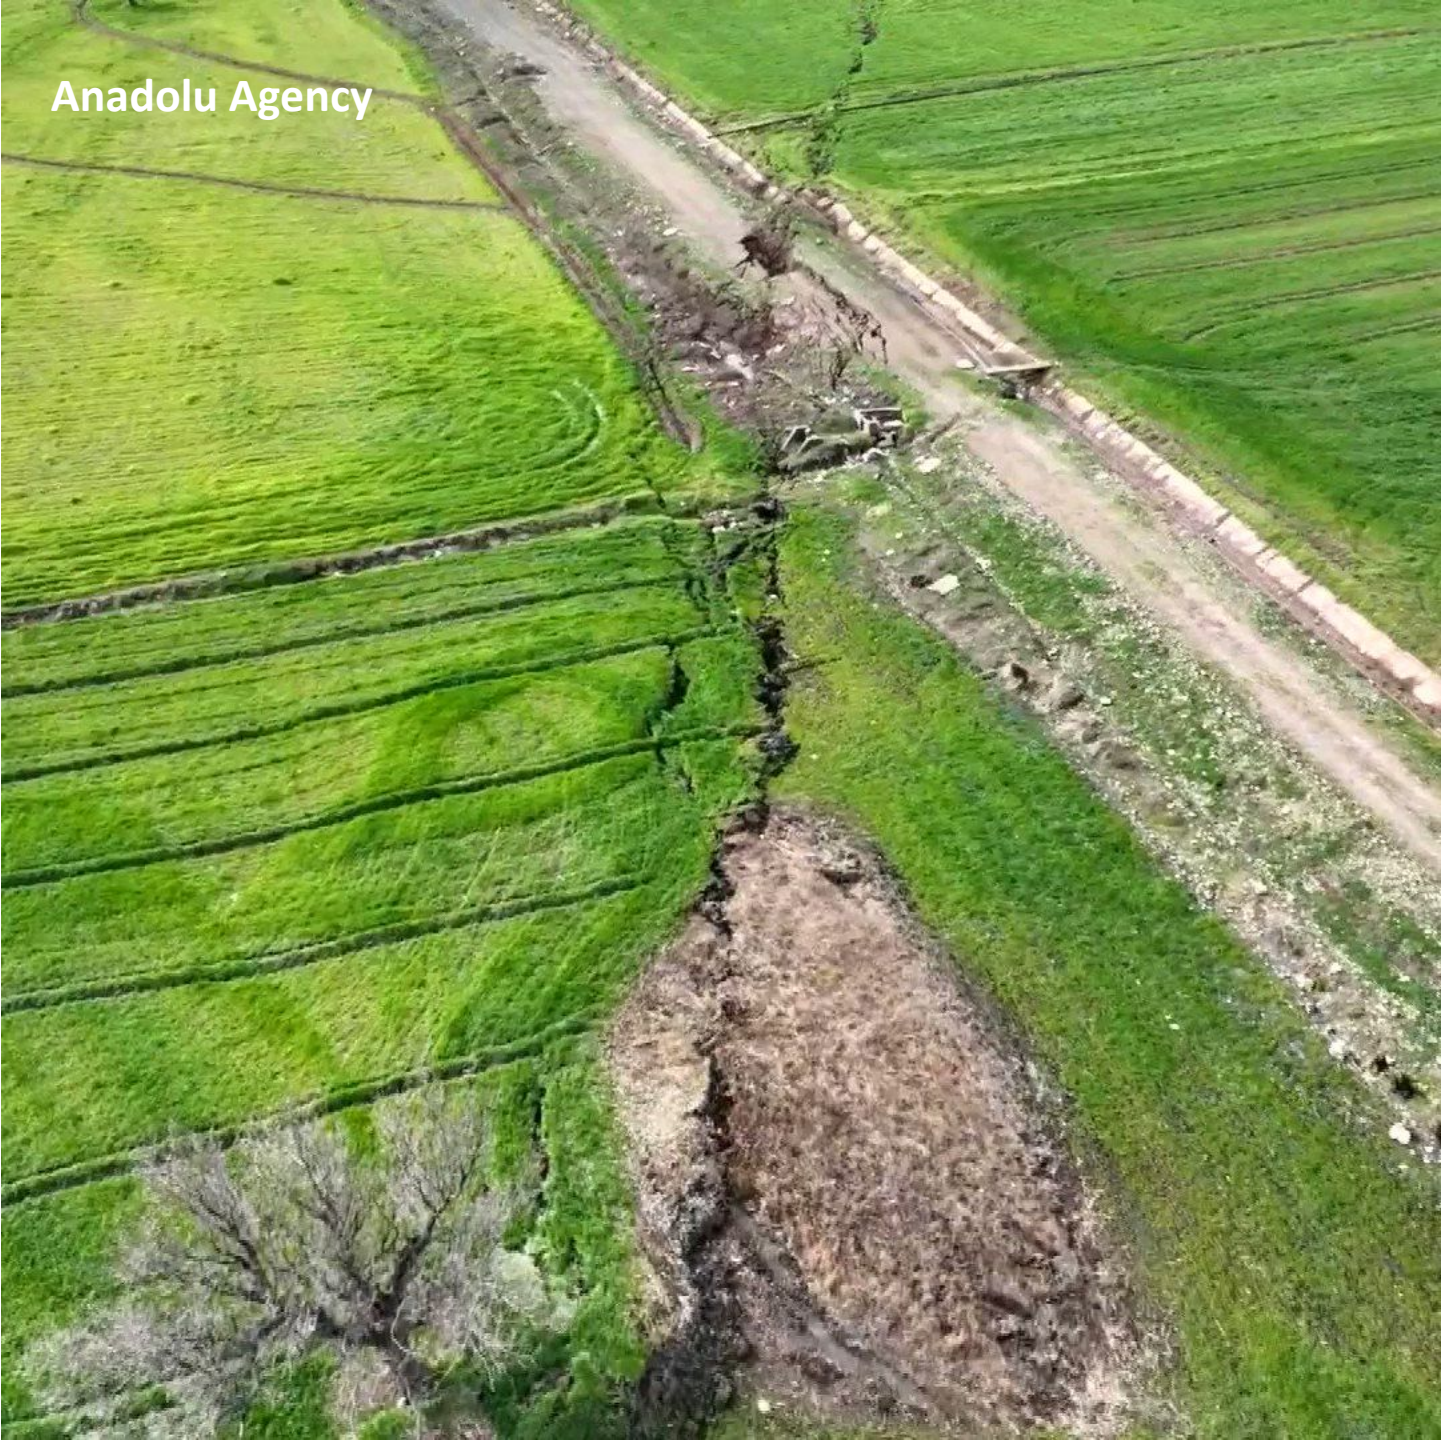
Ground movement measured closer to or further away from passing satellite
