The 2 earthquakes of February 6th 2023 in Turkey

Preliminary Report

Failures of Multistorey Buildings in Turkey and Syria Due to the M 7.8 and M 7.5 Earthquakes

PART B: Structural Collapse and Interpretation

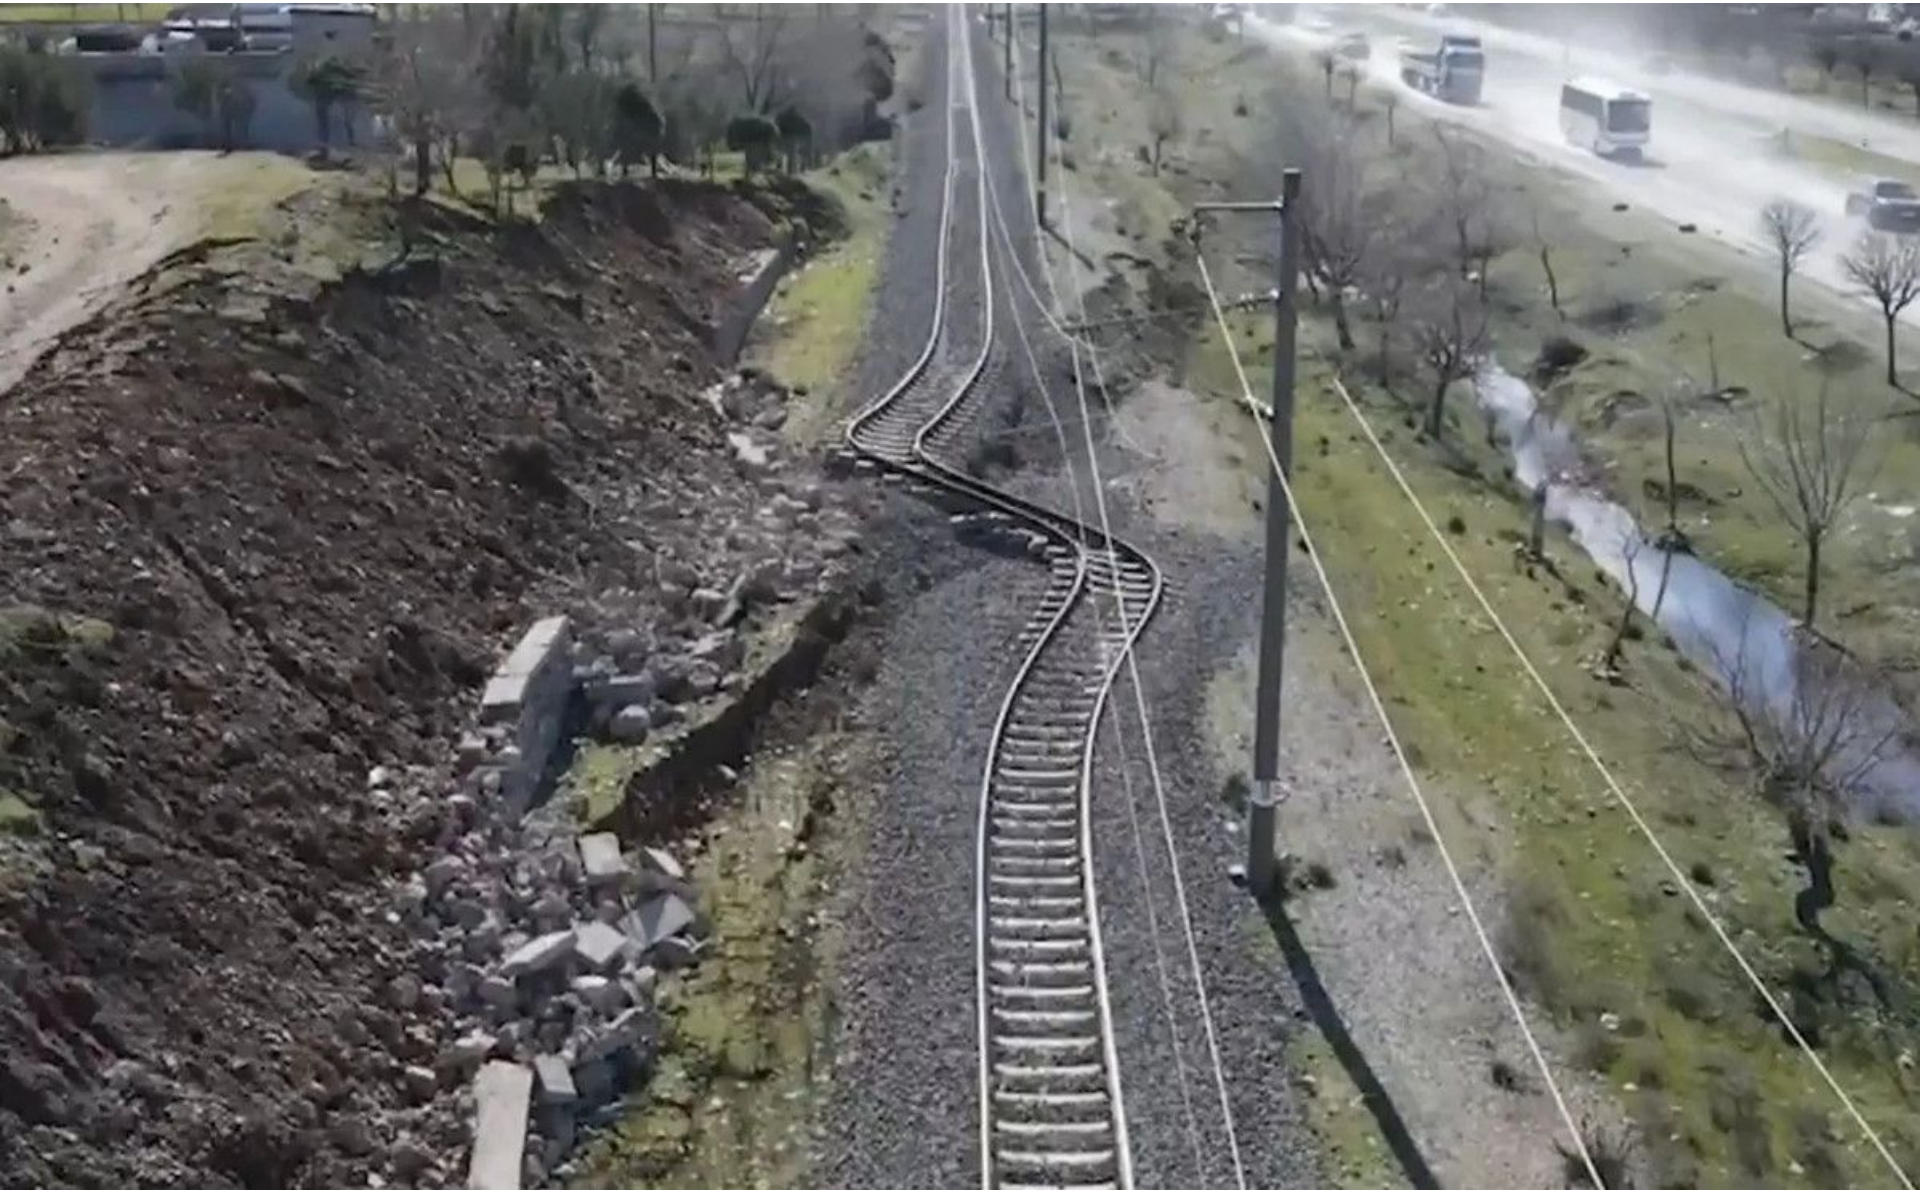
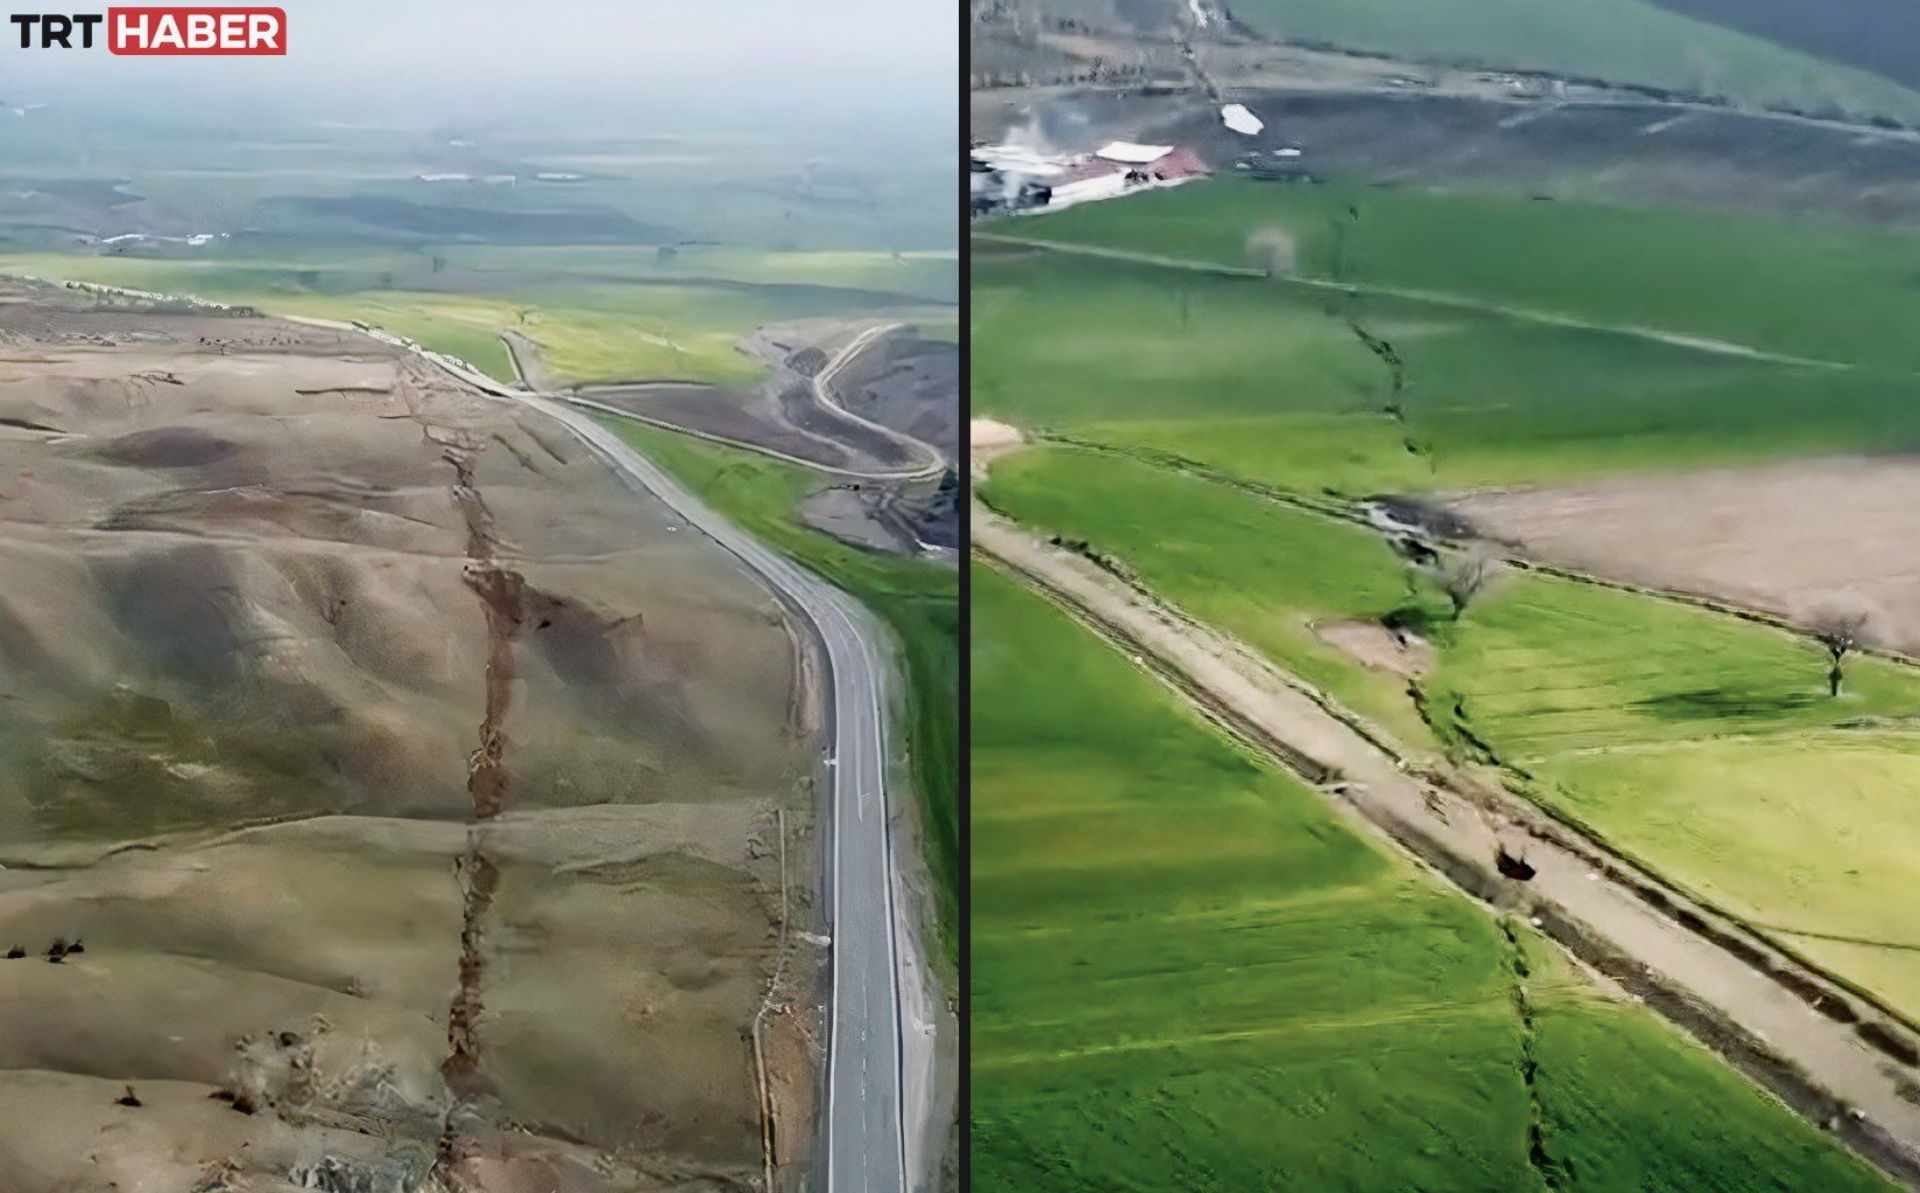
The strike slip fault as emerges at surface

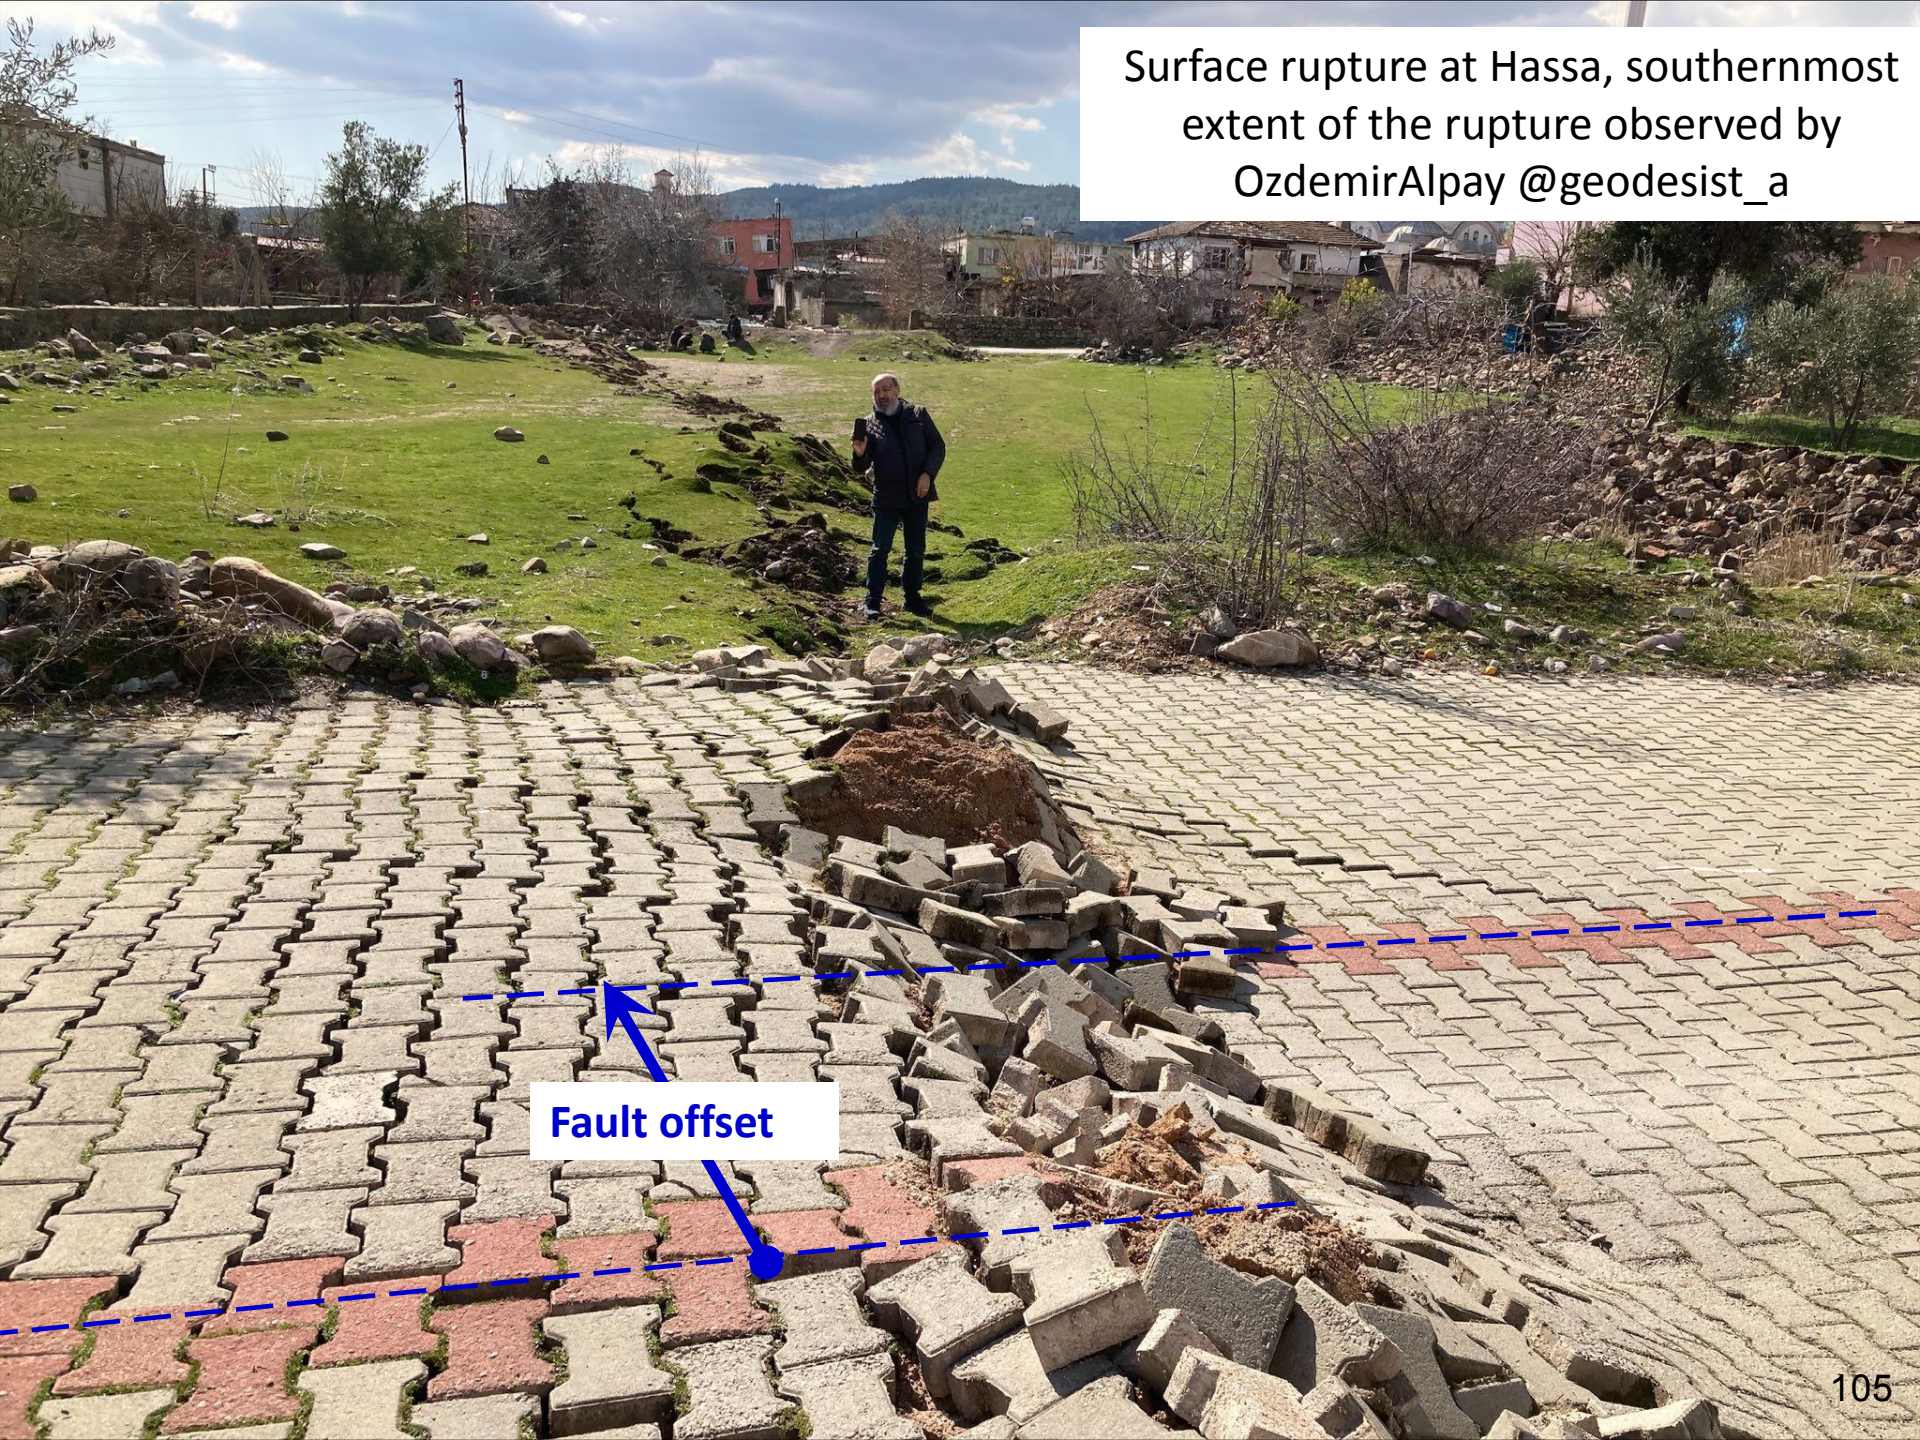
Surface rupture at Hassa, southernmost
extent of the rupture observed by
OzdemirAlpay @geodesist_a

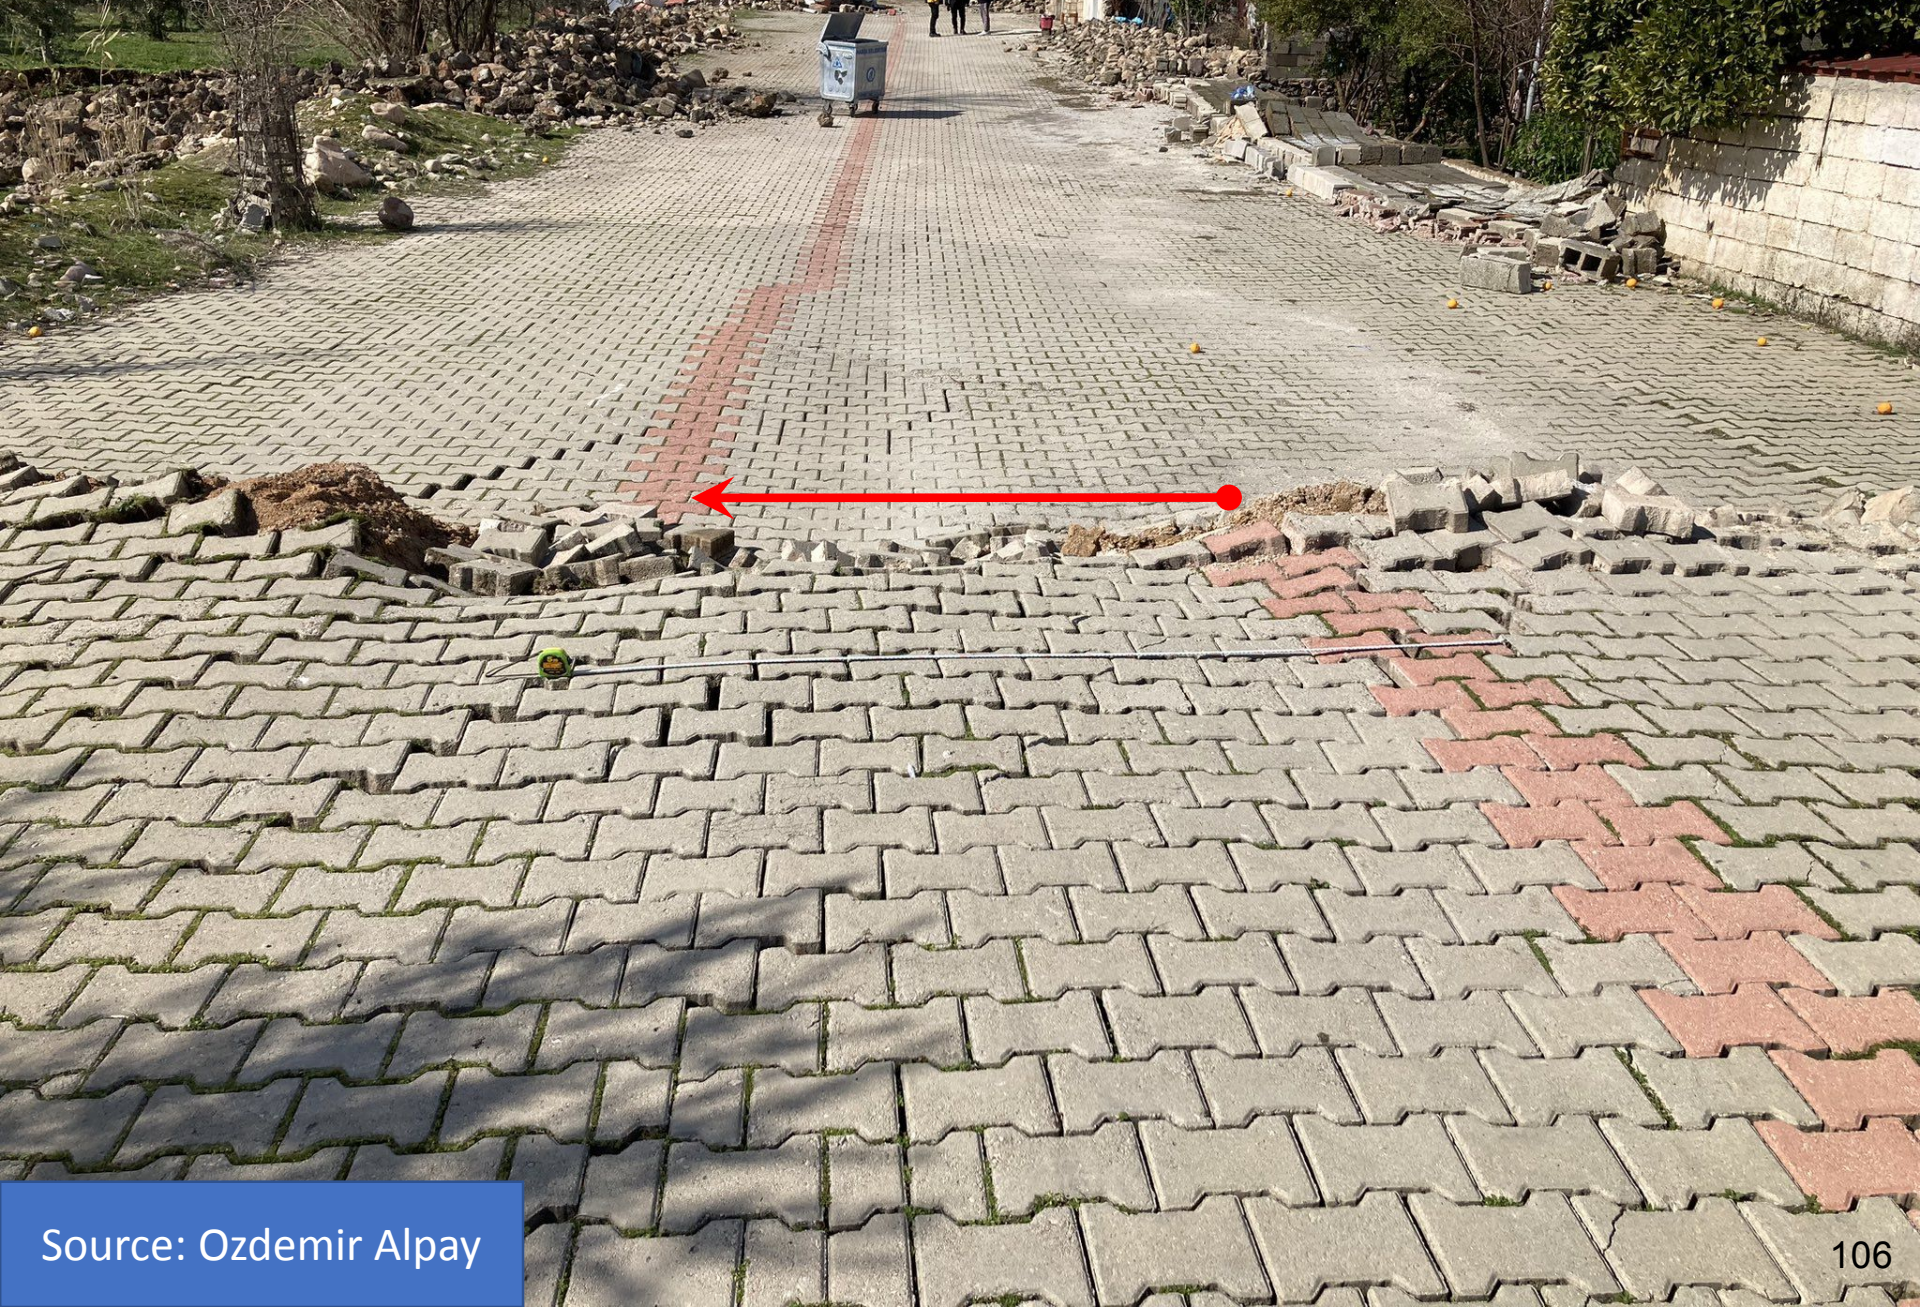
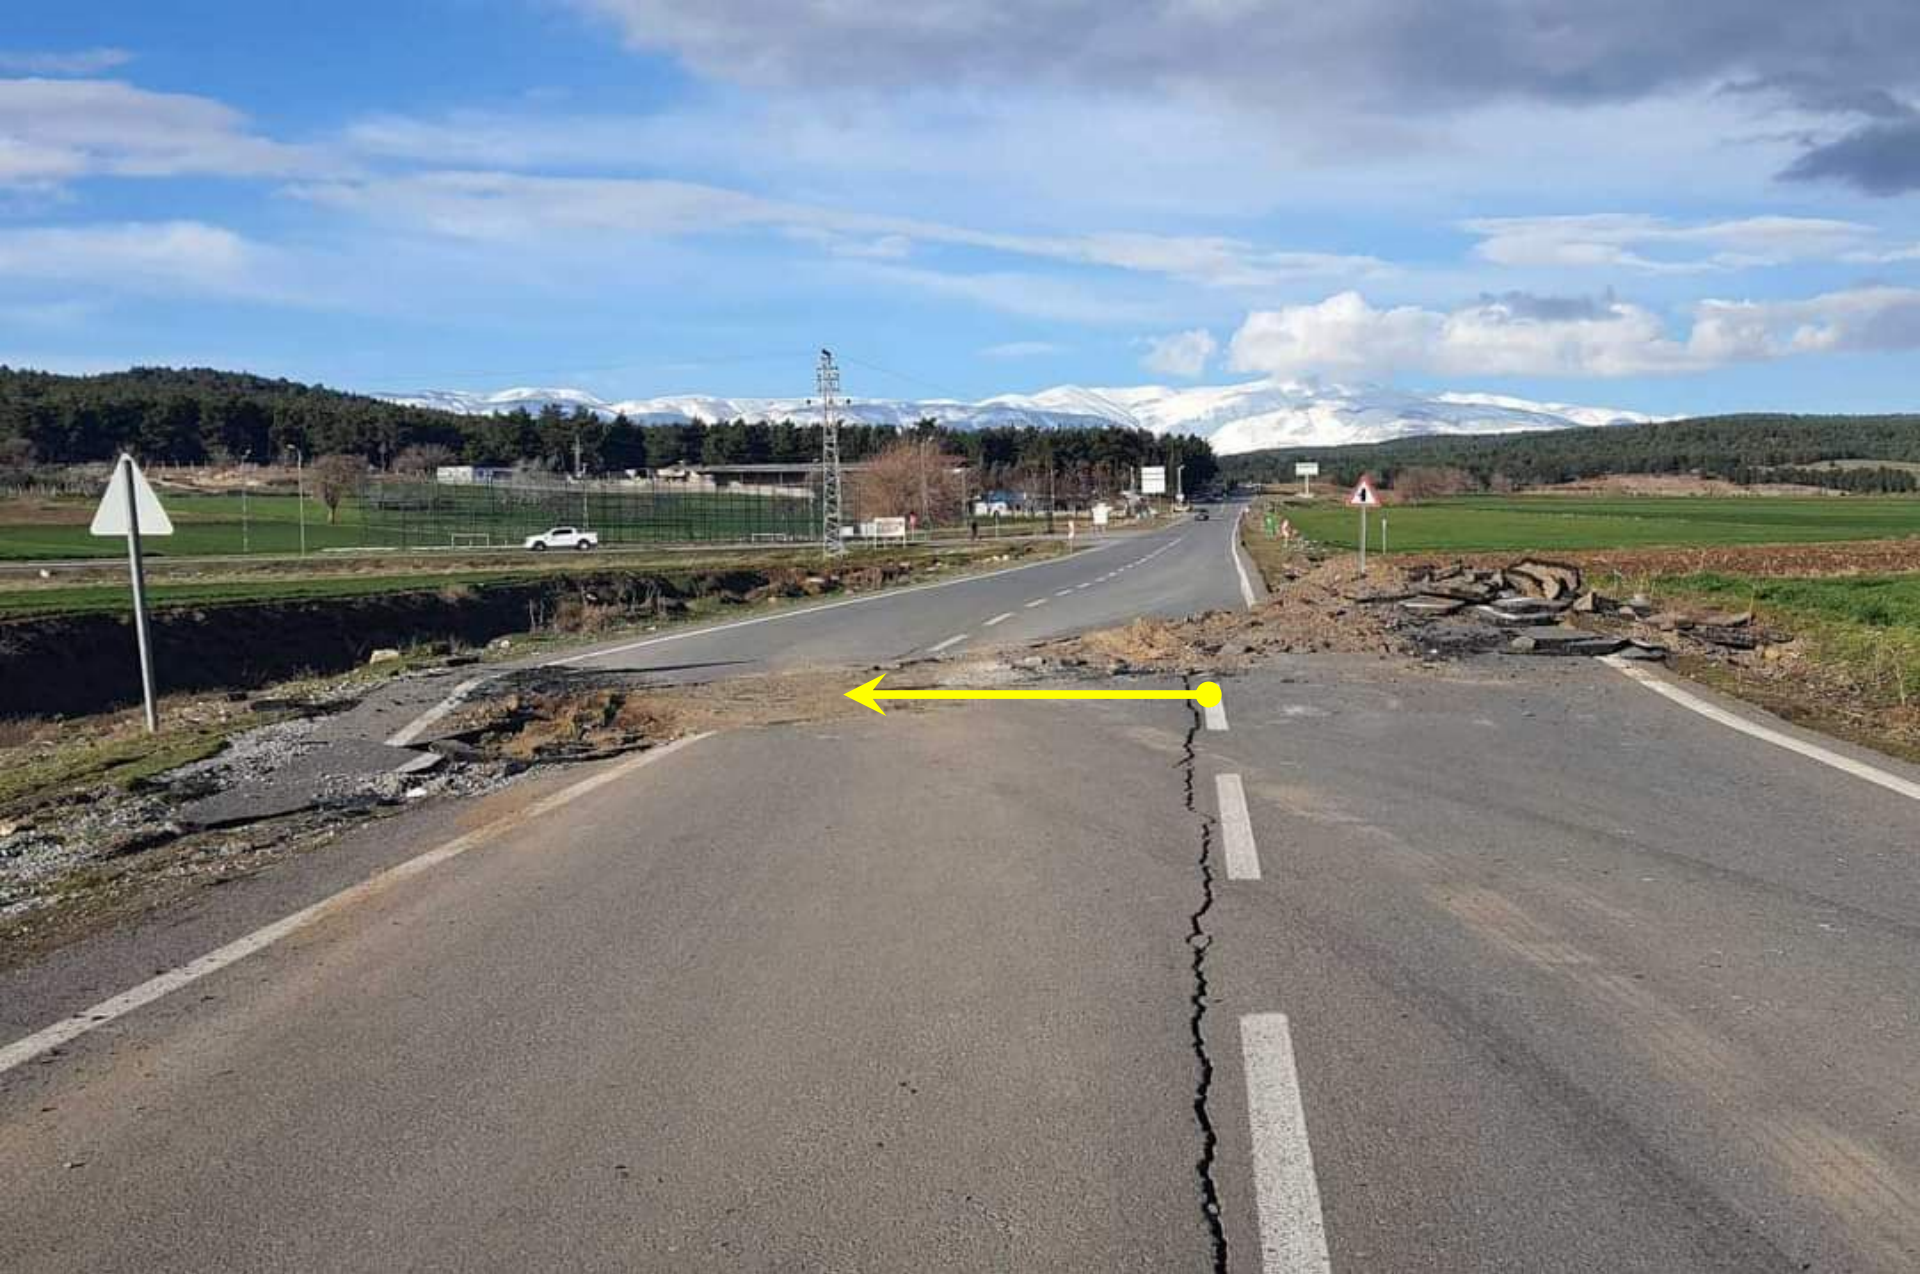
Fault offset

Surface rupture at Hassa Town

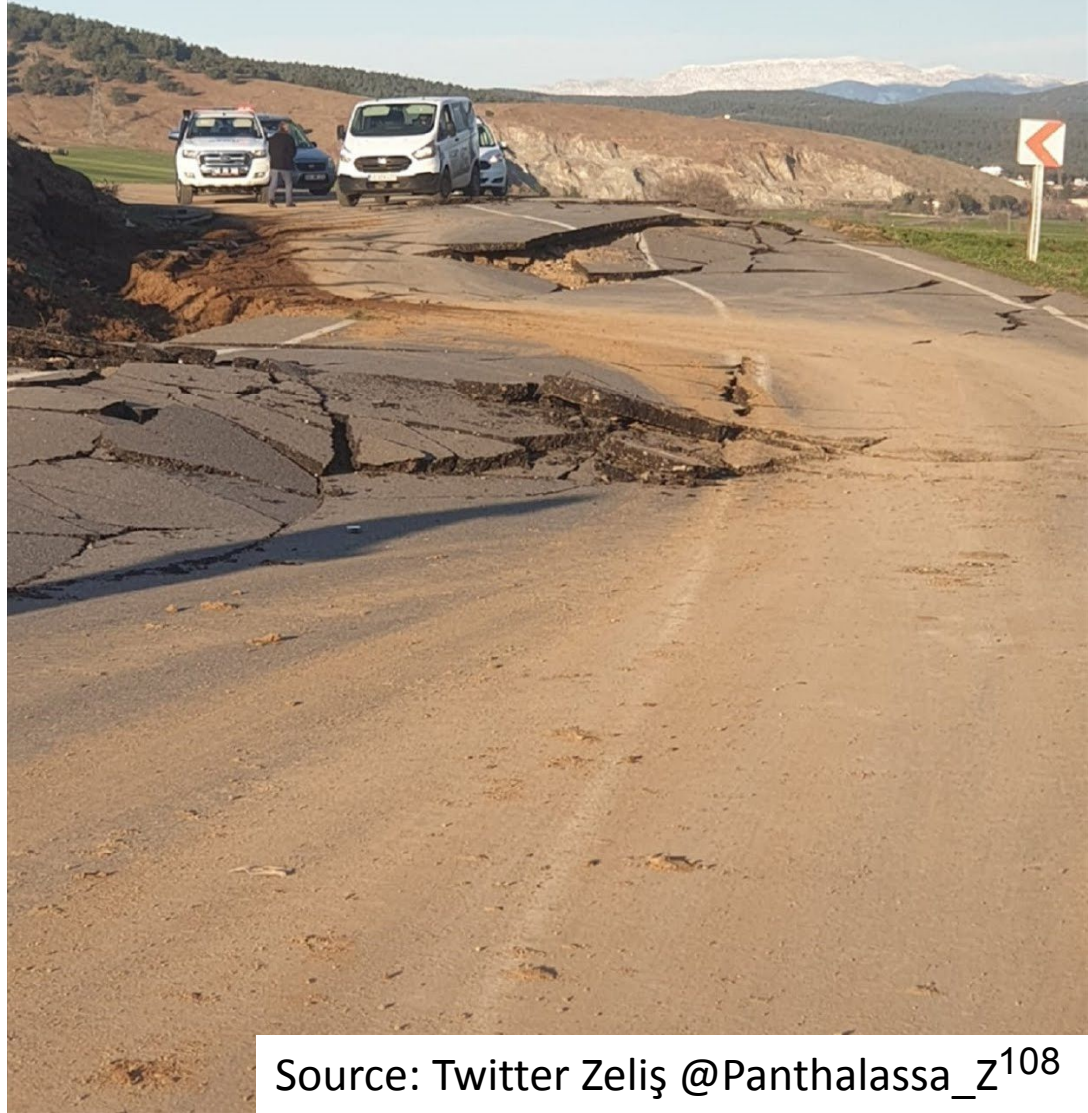
**Surface rupture observed in Tevekkeli,
Tevekkeli Village Road, 46090**

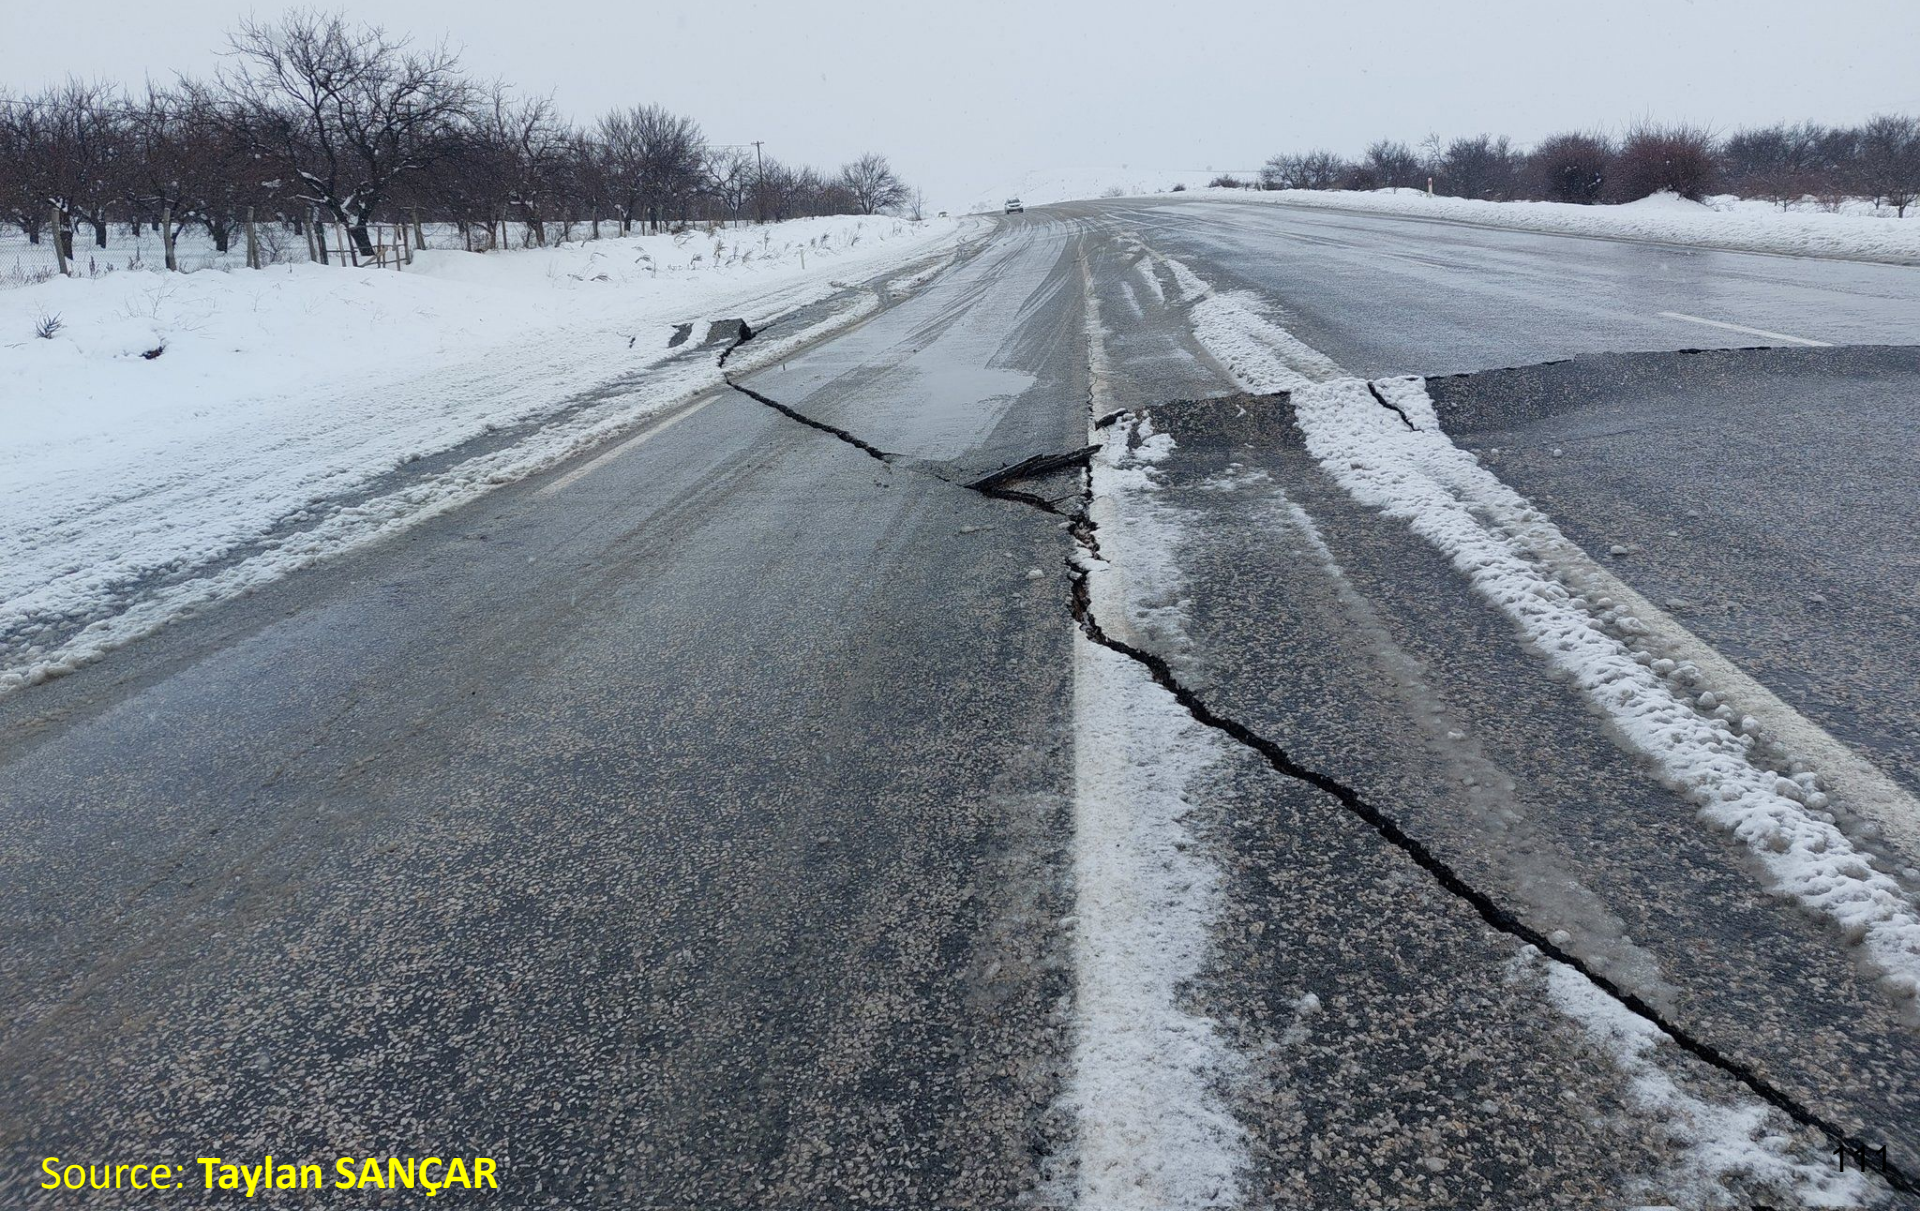
NE-SW orientated fracture systems formed within the deformation zone of the Malatya

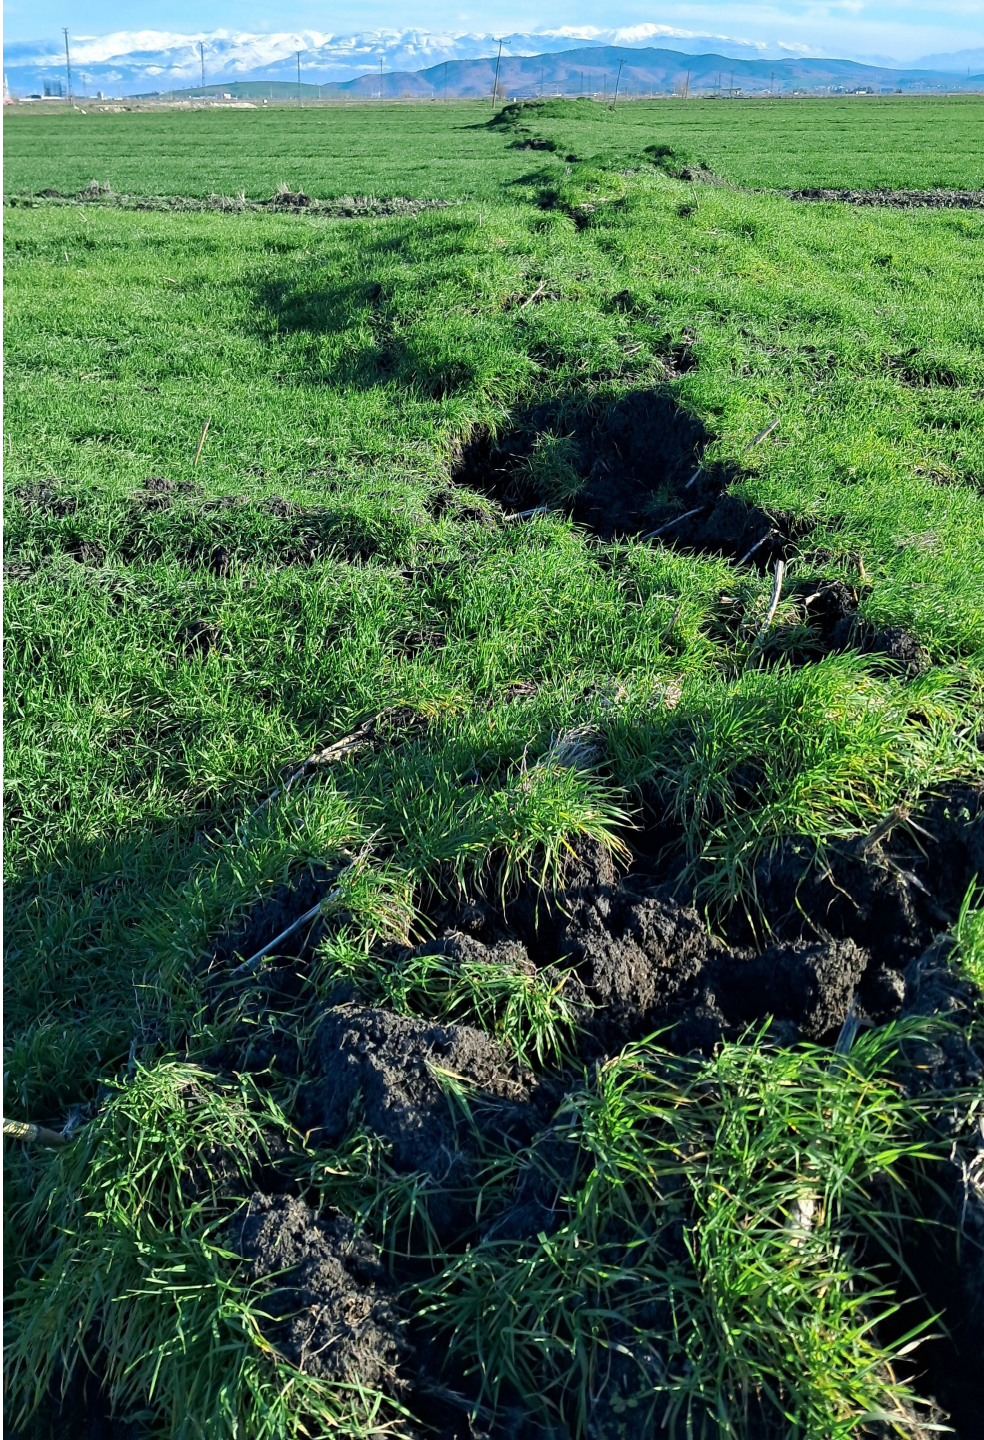
**The fault rupture at the surface
in the east of Türkoglu.**

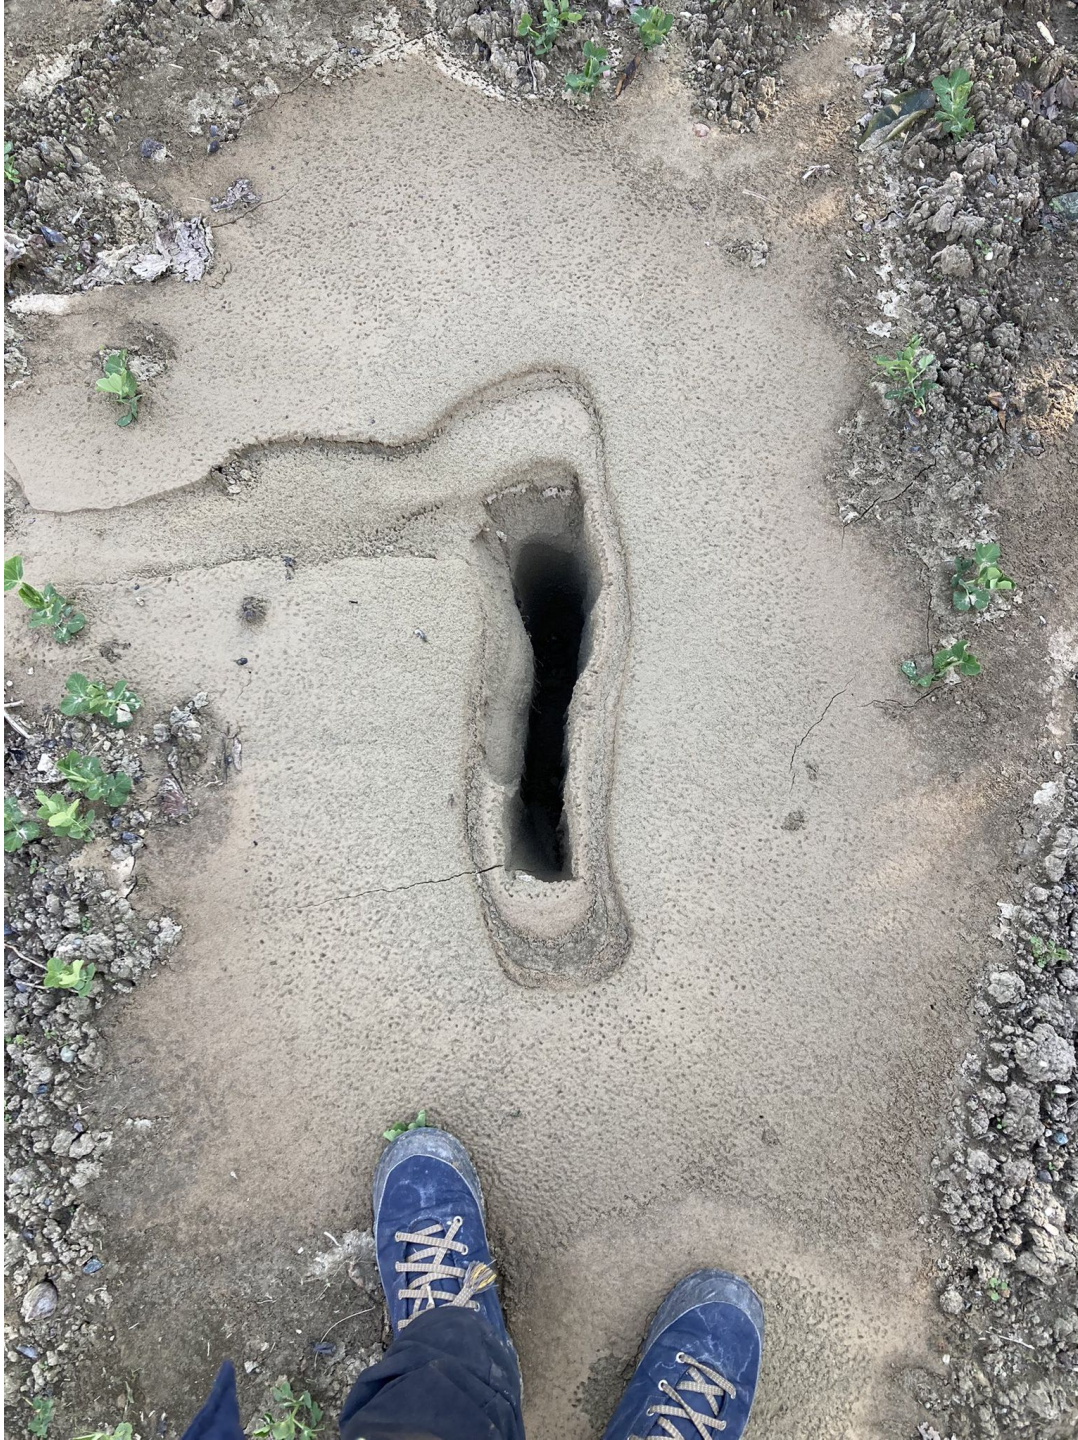
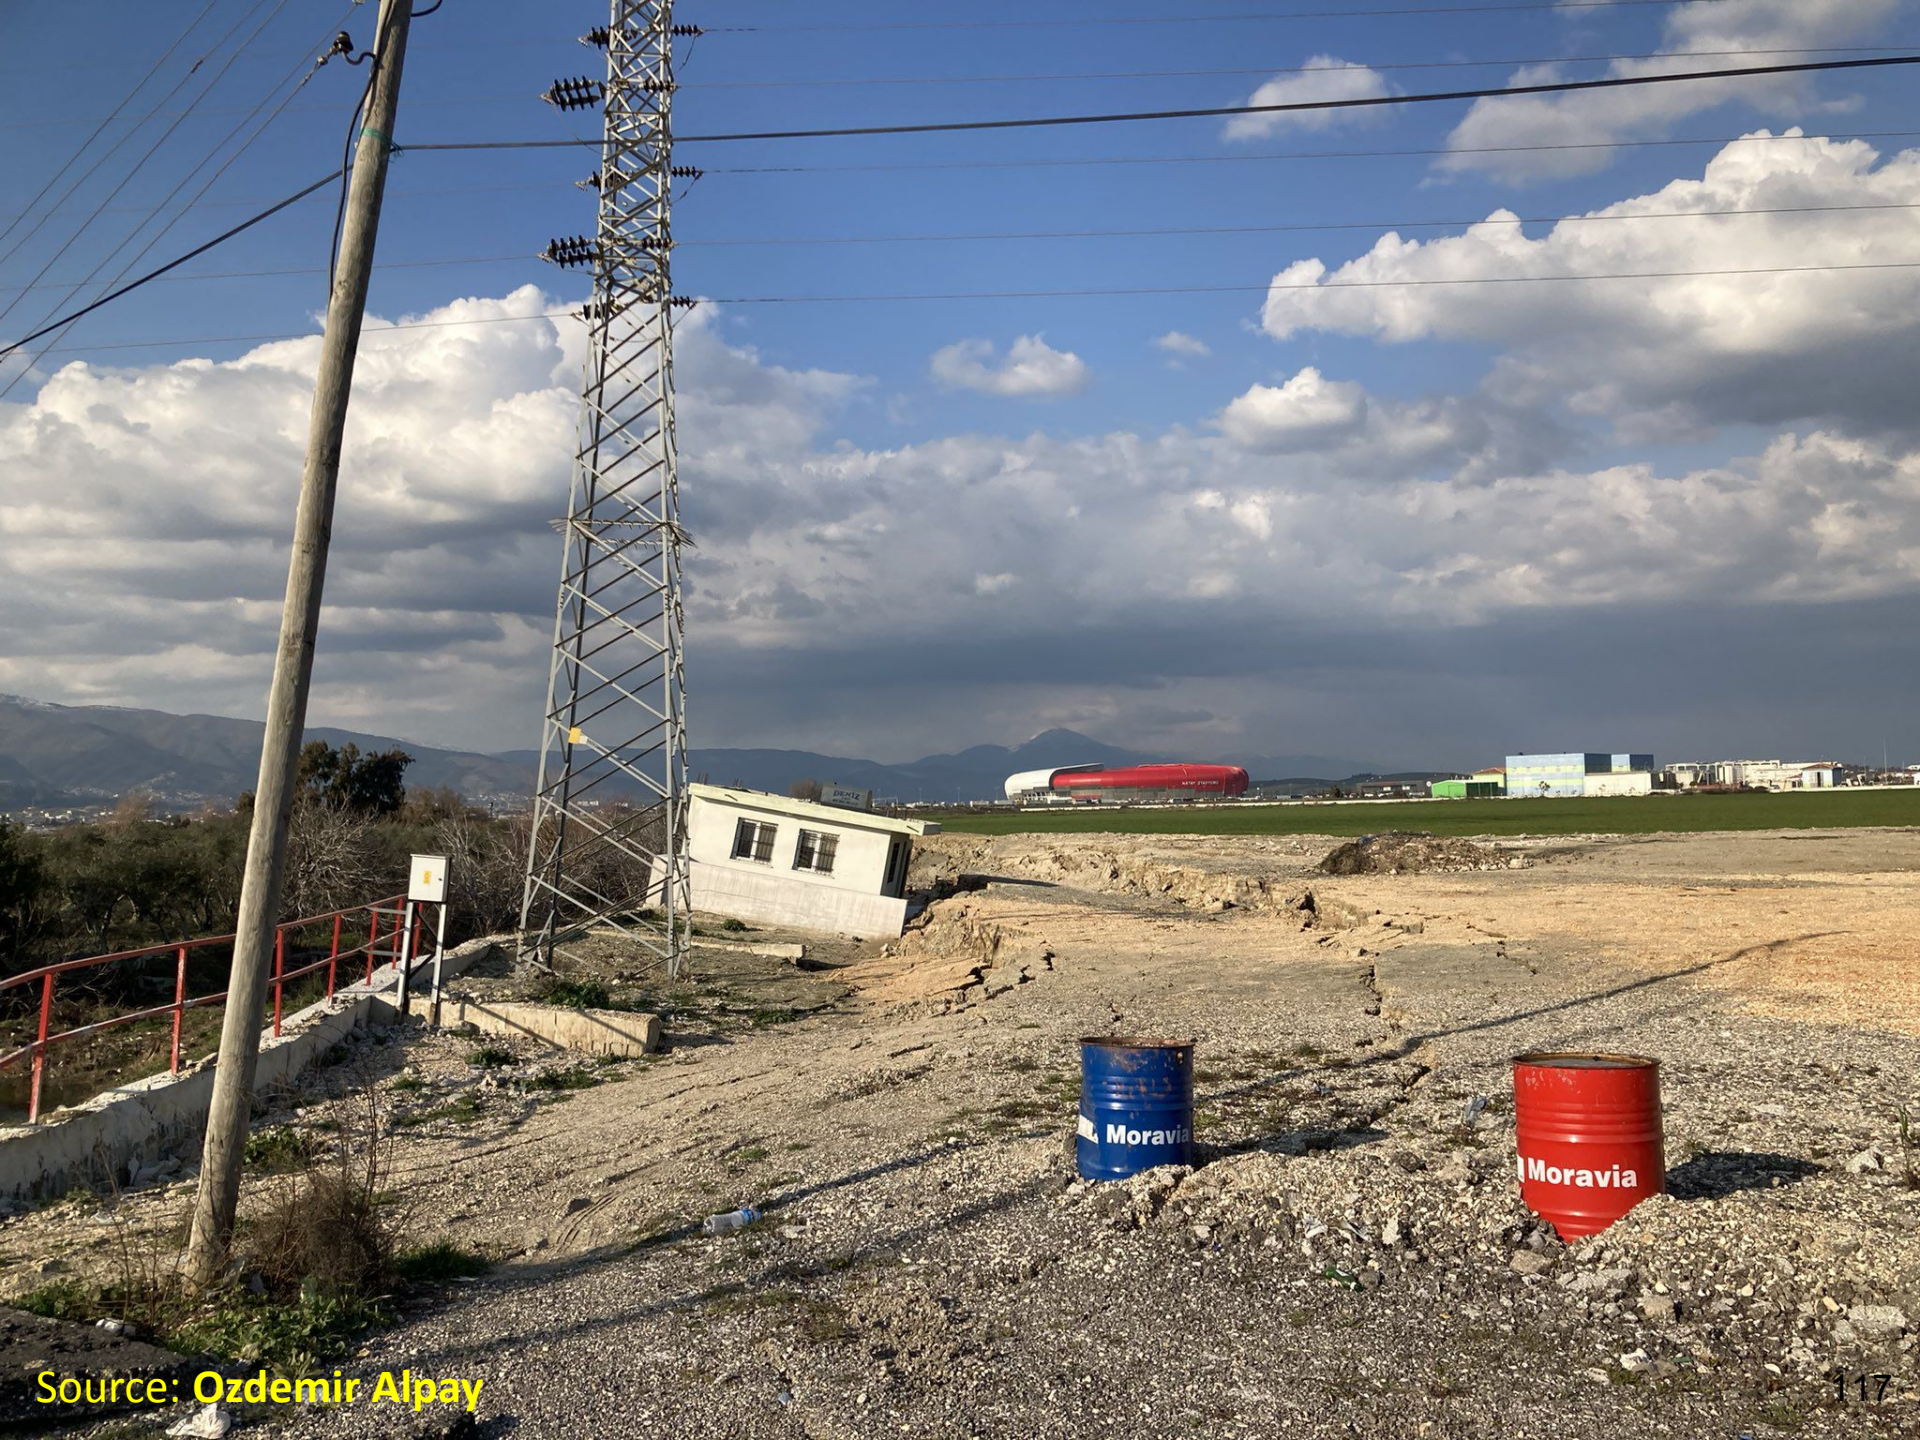
Soil liquefaction in northern Syria after the M7.8 earthquake
